**Sandilands
Housing Complex
PRO 0755**

**Detailed Engineering Evaluation
Quantitative Assessment Report**

Sandilands Housing Complex

Date: March 2014
Reference: 6-QC400.00
Status: Final

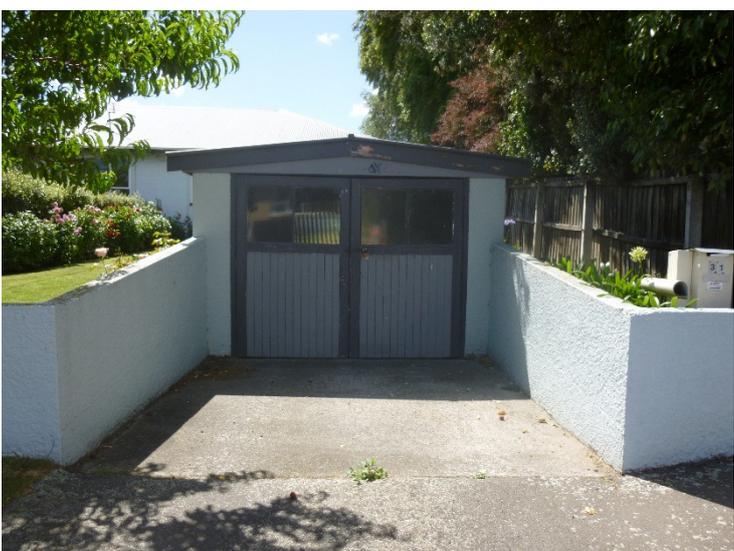
The garage at 31 Griffiths Ave is a poured in situ concrete structure to the roof level. The walls of this garage are reinforced with 12mm bars (assumed) at 300mm centres. The roof is clad with lightweight metal roofs and timber rafters. The foundation is a concrete slab.

<p>24.</p>	<p>Garage at 31 Griffiths Ave</p>

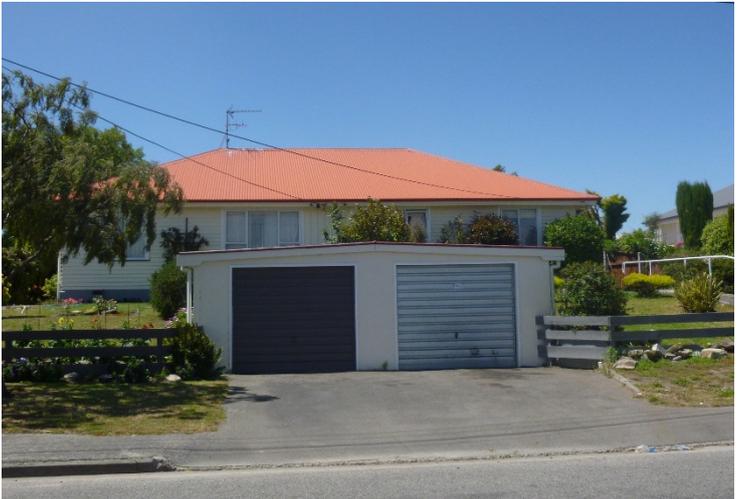
The double garages at 9, 11 and 17, 19 Coulter St are composite concrete and timber framed buildings with weatherboard veneers. The external walls are retaining walls to mid height (1.13m) of the back and side external walls with timber framing to roof height. These retaining walls are reinforced with bars horizontally at 150mm, 400mm and 800mm from the floor. The dividing wall is a concrete block wall. The roof structure consists of a timber truss supporting a light weight, flat metal roof. The foundations are concrete slabs.

<p>26.</p>	<p>Garage at 17 and 19 Coulter St (front exterior elevation)</p>

- The timber garages at 12 Nicholas Drive and 18 Griffiths Avenue be strengthened to support gravity loads and to at least 67%NBS.
- Strengthening schemes be developed to bring the capacities of the garages at 9-11 and 17-19 Coulter Ave to at least 67%NBS.
- Concrete header tanks be removed.
- Cosmetic repairs be undertaken as required.
