Scarborough Fare Tearooms BU 1471-001 EQ2

Detailed Engineering Evaluation
Quantitative Report
Version FINAL

147, Esplanade, Sumner

Date
2nd October 2012

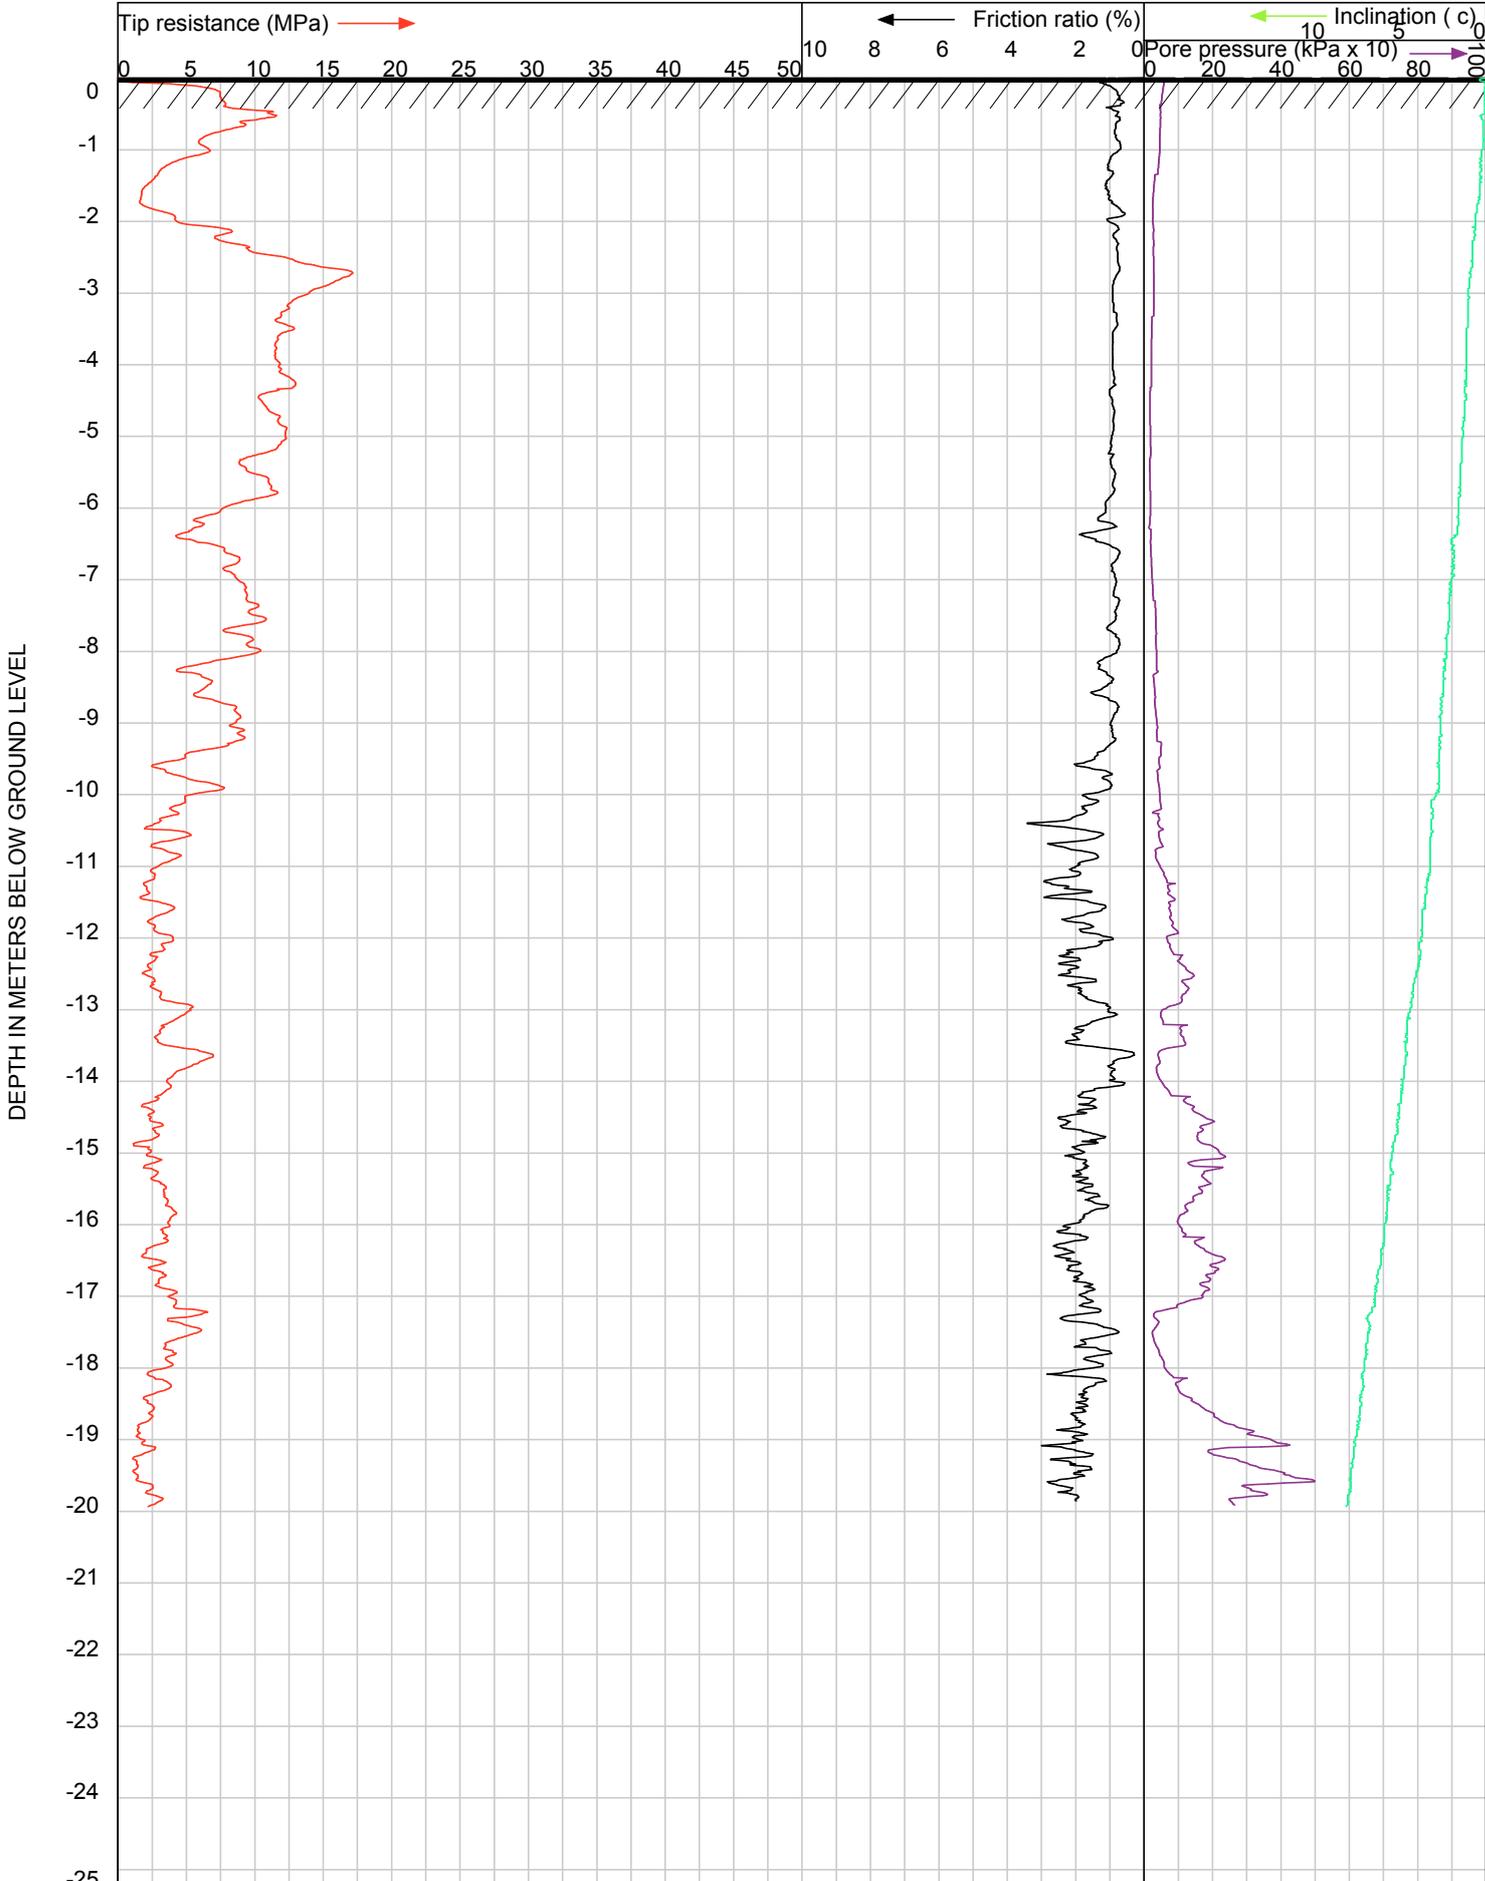
CLIENT : GHD
 LOCATION : Christchurch Various (CCC Properties)
 DATE : 4-4-2012
 OPERATOR : H. Pardoe
 REMARK 1 : CPTu31
 REMARK 2 : Target Depth

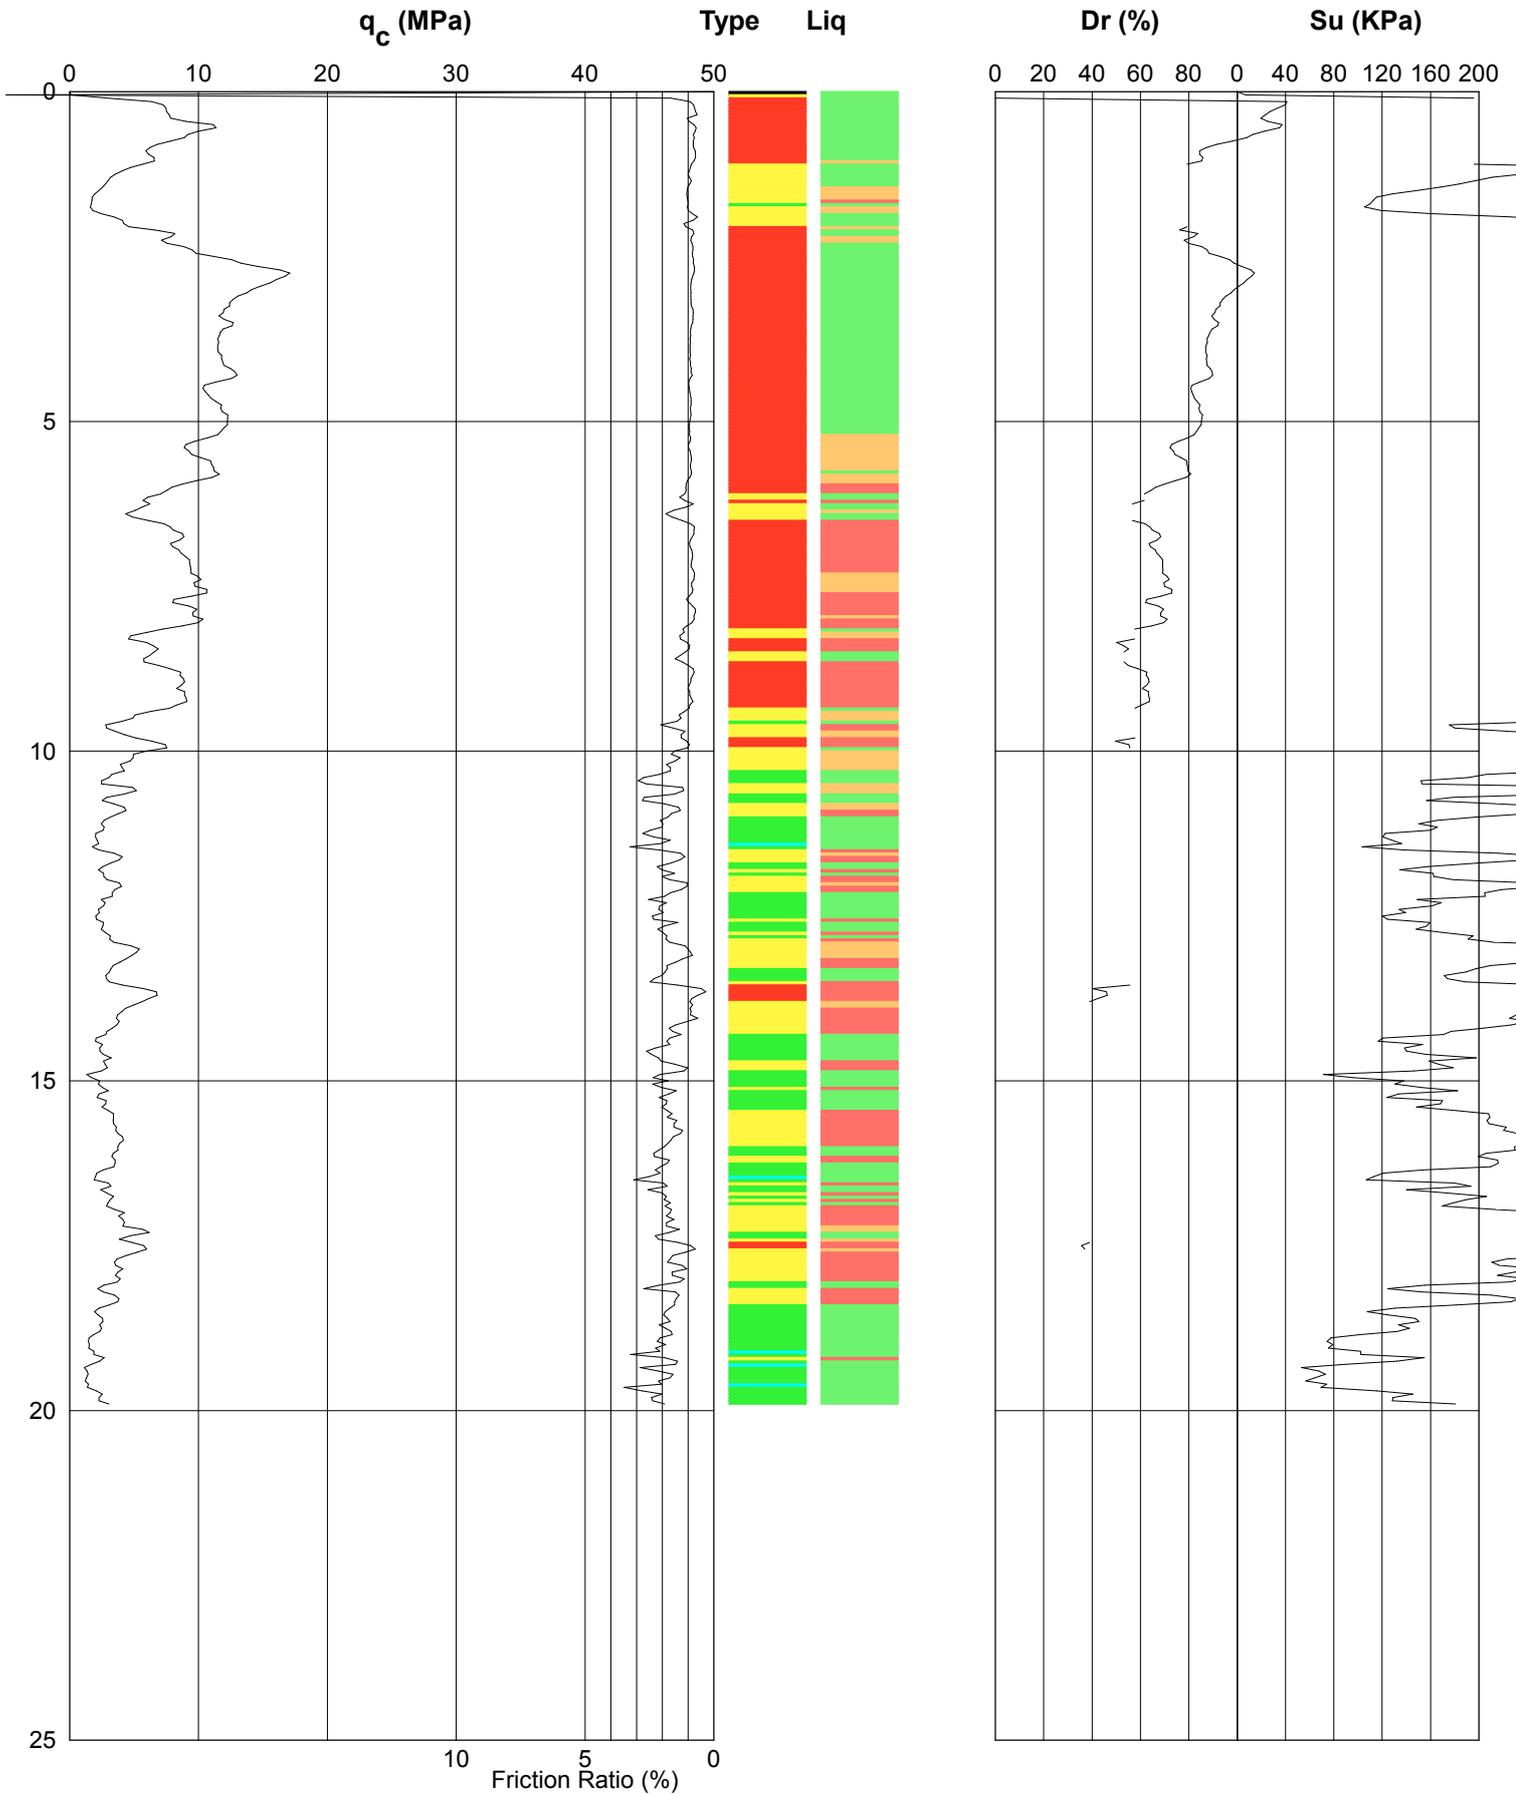
Job No: 10386
 CPT No: CPTu31
 Project: GHD
 Location: Christchurch Various (CCC Properties)

Total Estimated Settlement (mm)
242
