Christchurch City Council

PRK_1409_BLDG_008 EQ2
Scott Park Ferrymead - Double Garage
2 Main Road

QUALITATIVE ASSESSMENT REPORT FINAL

- Rev B
- 05 November 2012

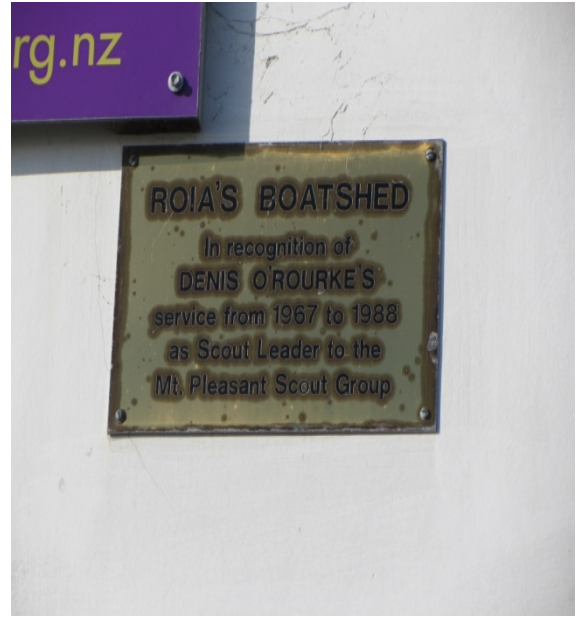
Photo 2: Close up view of plaque above garage door

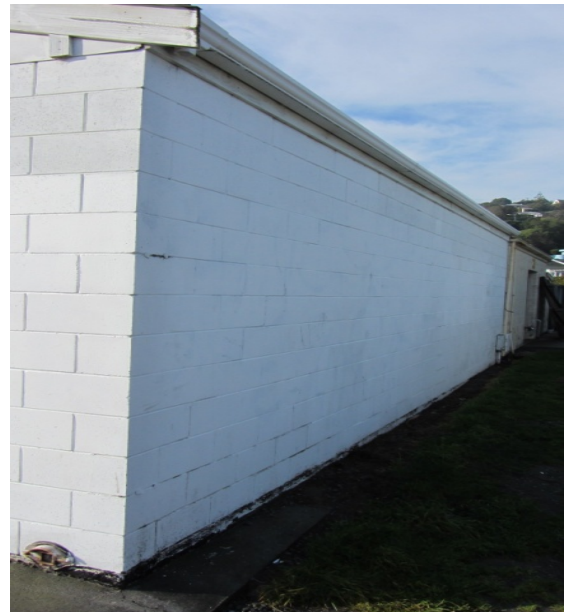
- 0.3mm step cracks in the masonry block joints on the west face of the building

Photo 6: View along the west elevation

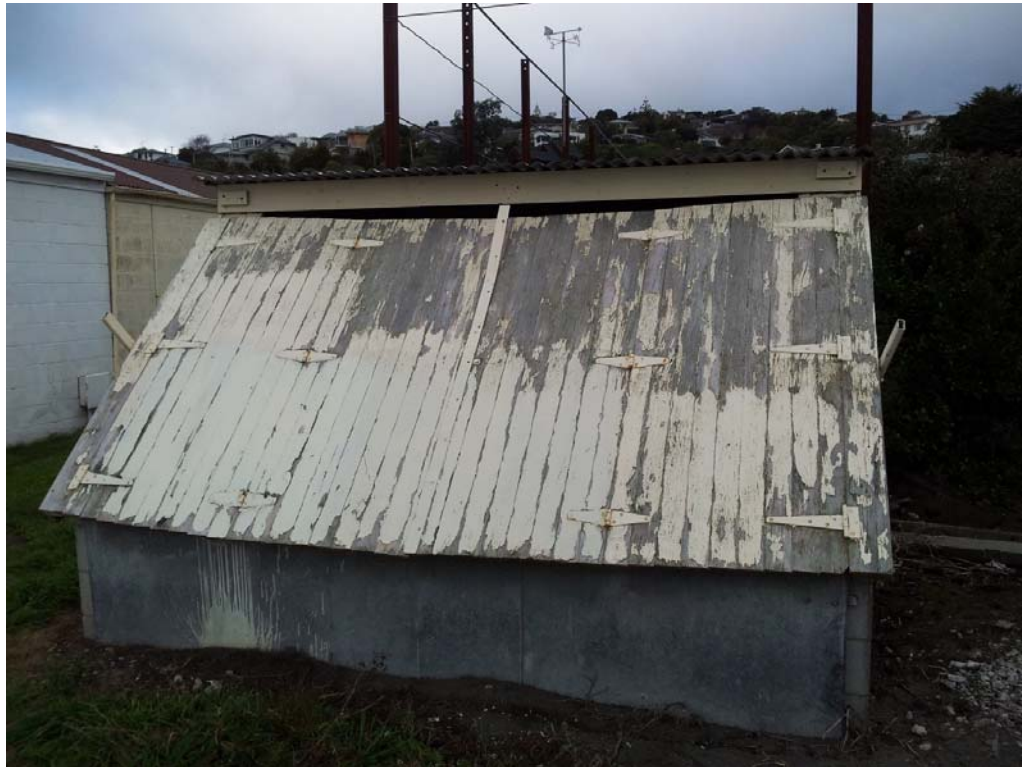
There was no significant structural damage noted on any of the buildings. The gap between the double garage and shed appeared slightly wider at the base of the building and narrowed with height; however, this is not believed to be as a result of earthquake damage.

■ **Figure 7 Overview of the storage shed (PRK_1409_BLDG_007)**

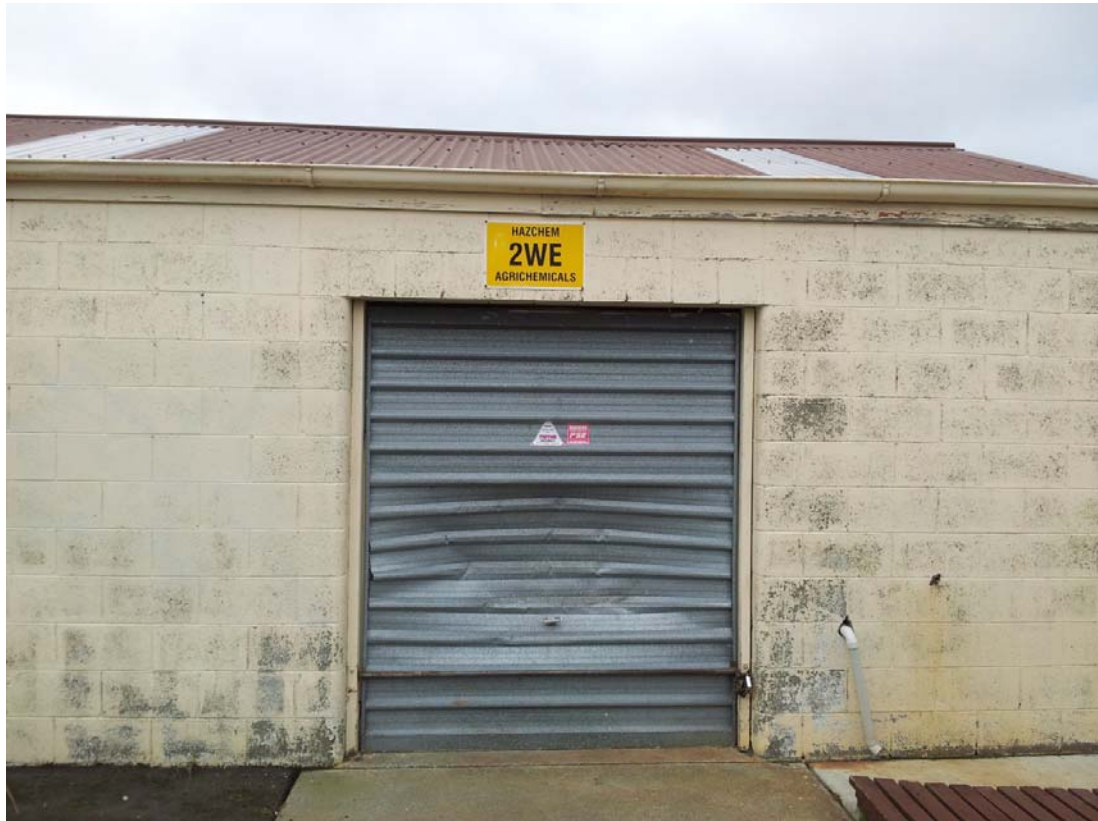
■ **Figure 9 Overview of the shed (PRK_1409_BLDG_009)**
