Christchurch City Council
PRK_1409_BLDG_009 EQ2
Scott Park Ferrymead – Storage Shed
2 Main Road

QUALITATIVE ASSESSMENT REPORT
FINAL

- Rev B
- 24 September 2013

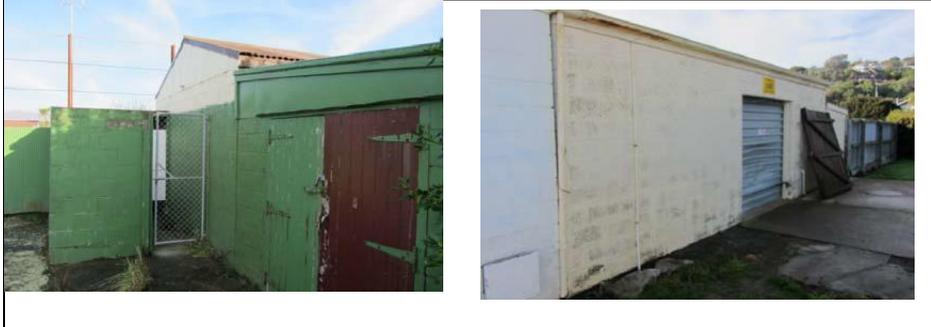
1.1 Photos (attach sufficient to describe building)

The building is a small single storey shed. It is constructed from masonry with a timber framed corrugated iron clad roof. Based on the apparent ageing of the building it appears the building was constructed in the 1980s
