Spencer Park Surf Club
Quantitative Engineering Evaluation

Reference: 228701
Prepared for:
Christchurch City Council

Functional Location ID: PRK 2971 BLDG 001

Date: 19 June 2013

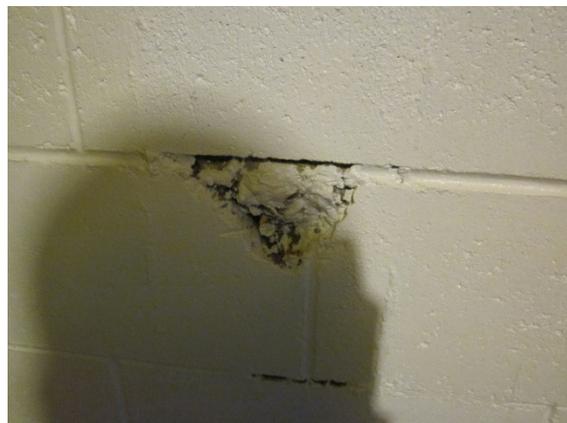
Non-seismic related damage - impact damage to the face shell at about mid height on the Northern concrete masonry wall interior.
