Spencer Park Toilets
Qualitative Engineering Evaluation

Reference: 228899

Prepared for:
Christchurch City
Council

Address: Spencer Park, 100 Heyders Road

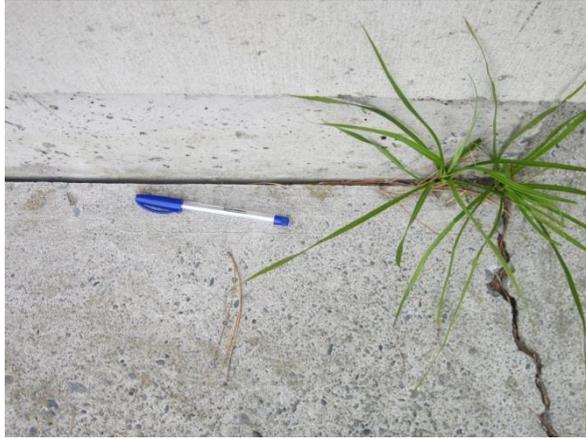
The floor levels for the Spencer Park Toilets were found to be within acceptable levels with the slopes prescribed in the plans similar to those measured.

3% FALL CALLED FOR IN PLANS
2.5% FALL TYPICAL
