## CHRISTCHURCH CITY COUNCIL

PRK\_1099\_BLDG\_007 EQ2

Spreydon Domain – Pavilion & Toilets

### QUALITATIVE ASSESSMENT REPORT FINAL

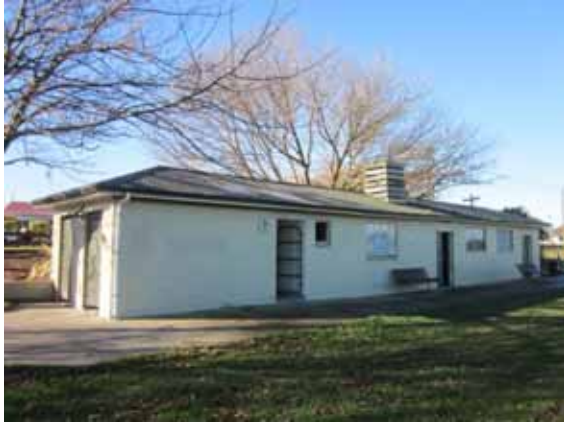
Photo 1: The east and south elevations of the building

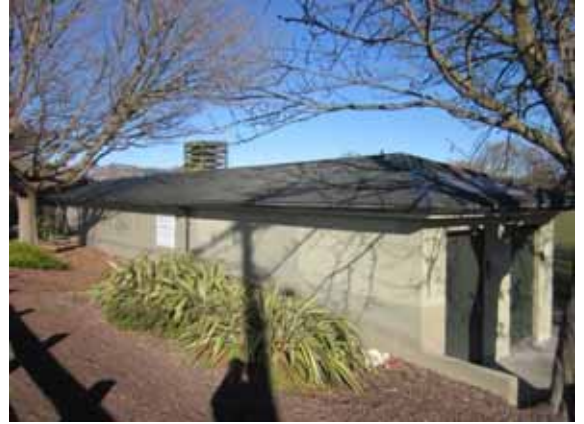
Photo 2: The north and east elevations of the building

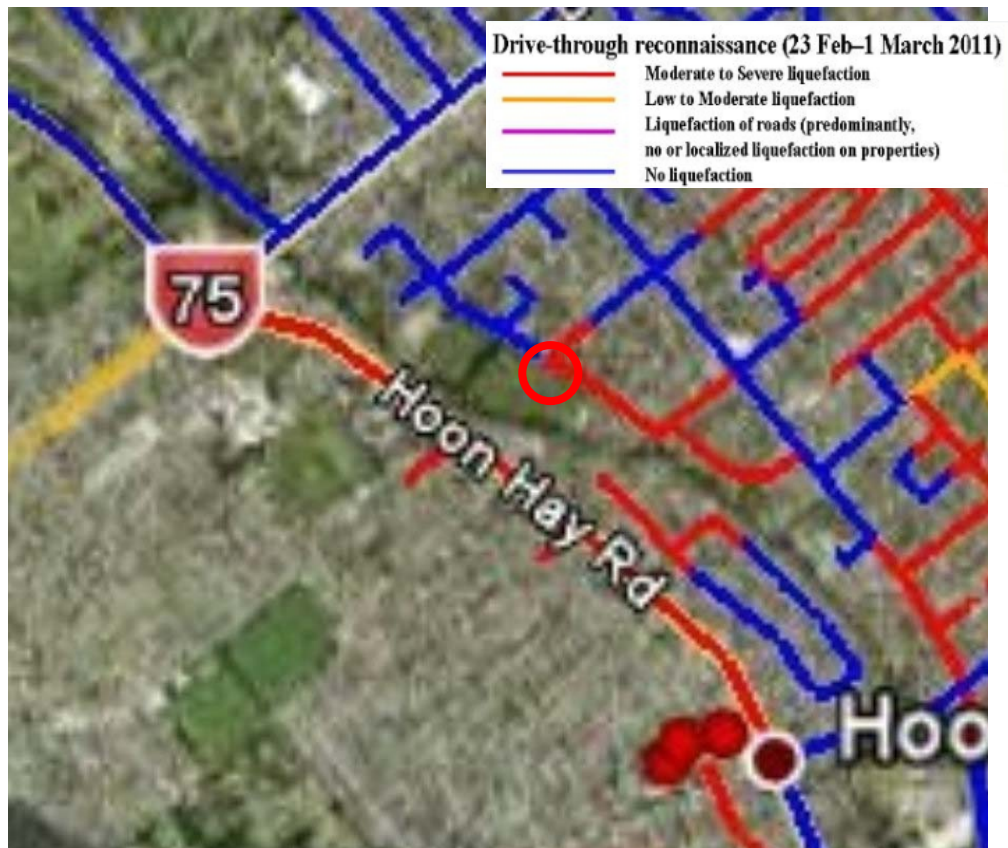
■ **Figure 4 – Liquefaction map (Cubrinovski & Taylor, 2011). Site marked in red.**

Following the 22 February 2011 event drive through reconnaissance was undertaken from 23 February until 1 March by M Cubrinovski and M Taylor of Canterbury University. Their findings show moderate to severe liquefaction on Domain Terrace. However, this observation may be an over-estimate, given the comments made by local residents (see section 5.8).

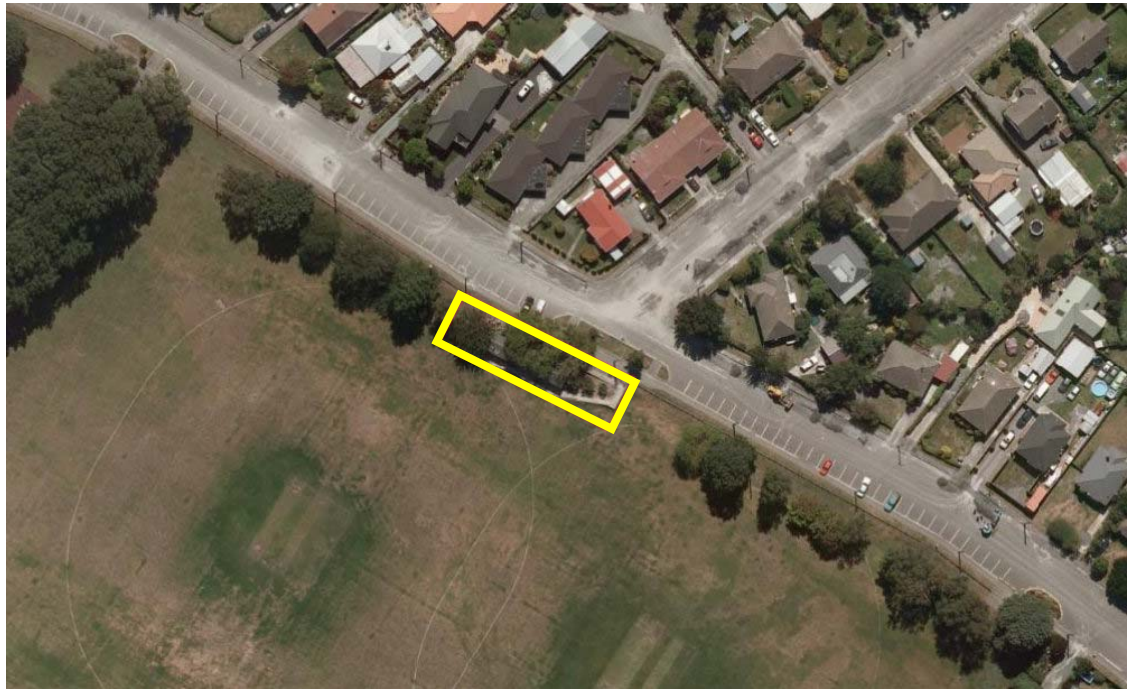
- **Figure 5 – Aerial photography from 24 Feb 2011 (<http://viewers.geospatial.govt.nz/>)**

Aerial photography shows moderate liquefaction after the 22 Feb 2011 event, particularly on the road to the north. The absence of liquefaction to the south west (on the field) appears to correspond with the change to alluvial gravel identified in the geological maps.

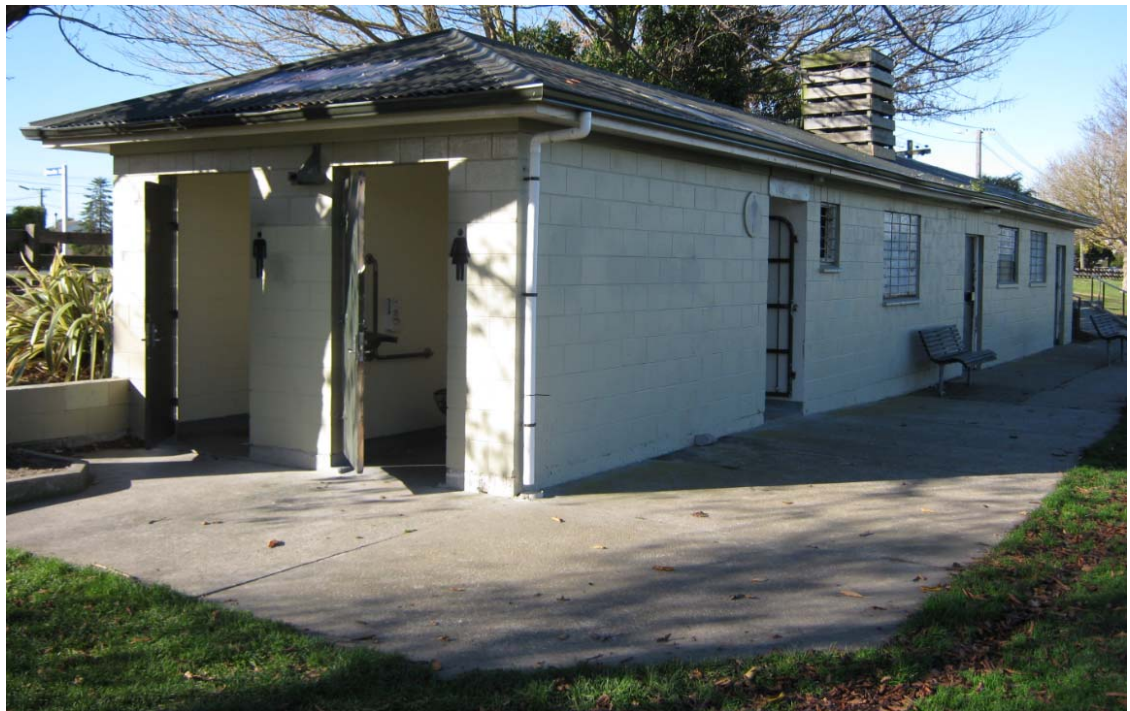
The toilet block/pavilion is a masonry block building with corrugated iron roof and has a concrete slab on grade foundation. Only minor damage to land and building was observed. Paving slabs at the front of the building did exhibit minor tilting probably due to settlement of fill. In addition minor damage due to shaking was observed which included isolated hairline cracks in the masonry walls and minor oscillation gaps between the building and concrete paving.

■ **Figure 7** Toilet and Pavilion block at Spreydon Domain.
