**St Johns Courts
Housing Complex
PRO 0853**

**Detailed Engineering Evaluation
Quantitative Assessment Report**

**20 St Johns Street, Woolston,
Christchurch 8062**

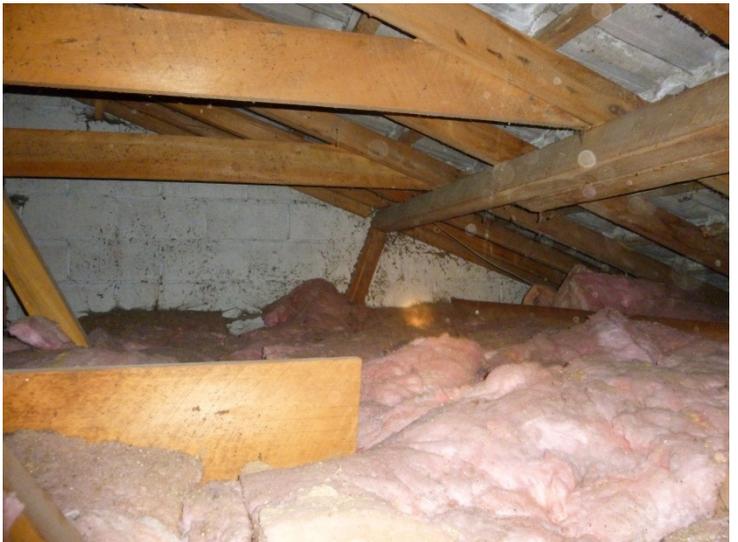
<p>11.</p>	<p>Typical roof void (Unit 4)</p>

The roof structure at this site has not performed well, some structural members have broken or buckled in Unit 4 (photo 12), and some other units as well. Sagging of the rooflines is visually evident externally and requires repair.

- Blocks A-C be strengthened to at least 67%NBS.
- Veneer at height (gable ends) have the veneer ties checked.
- Cosmetic repairs be undertaken as required.
- The timber roof framing requires repair in Unit 4. Other roof spaces should be fully inspected to confirm no further damage has occurred.
