Templeton Courts Housing Complex PRO 1672

**Detailed Engineering Evaluation
Quantitative Assessment Report**

Templeton Courts Housing Complex

Date: February 2014
Reference: 6-QC404.00
Status: Final

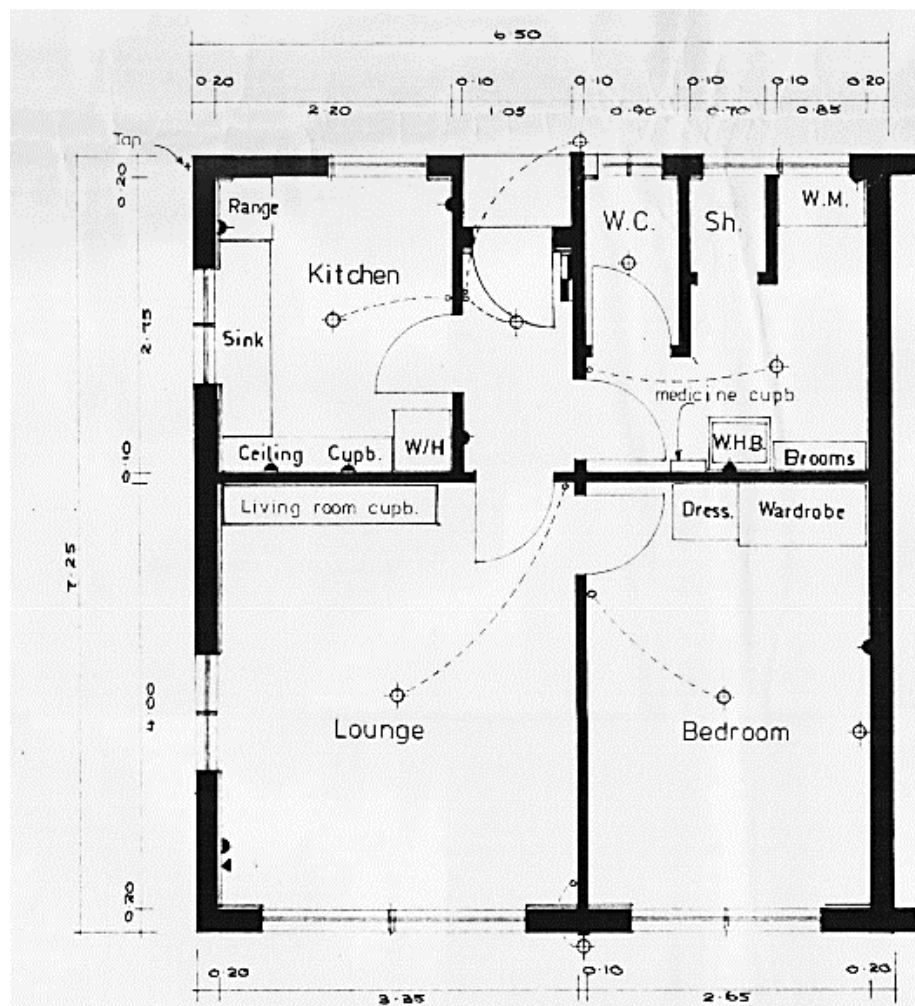
Figure 4: Typical floor plan of residential unit blocks.

Figure 4 shows a typical floor plan, and Figure 5 shows a cross section, which were used in calculations. Both drawings are from original drawings provided by the Christchurch City Council, dated 1977 (refer to section 4.3).

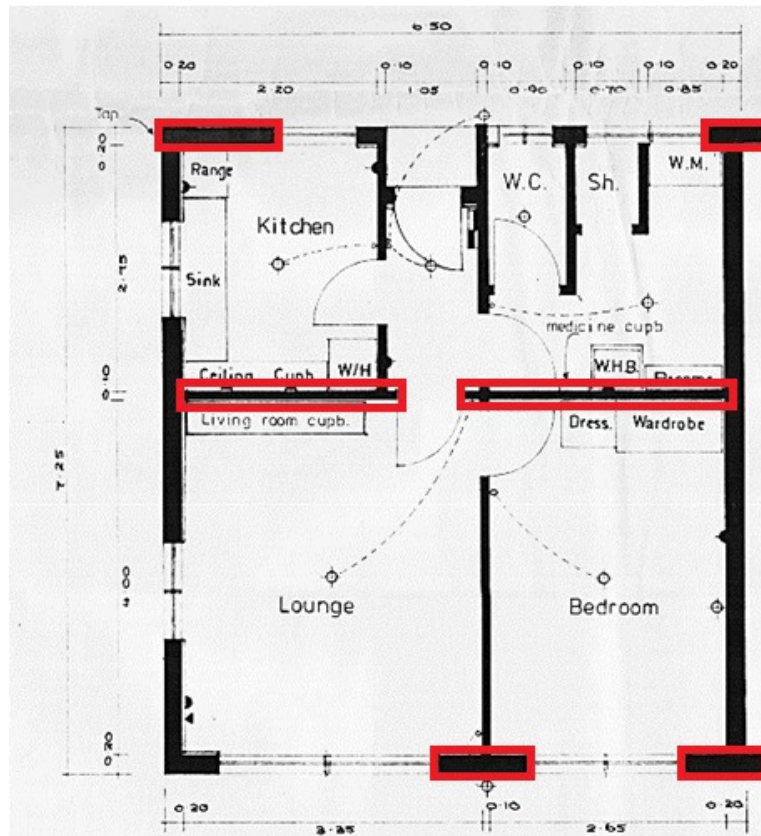
Figure 6: Walls used for bracing in the longitudinal direction.

The walls, highlighted in Figure 6 and Figure 7, were used for bracing in their respective directions.

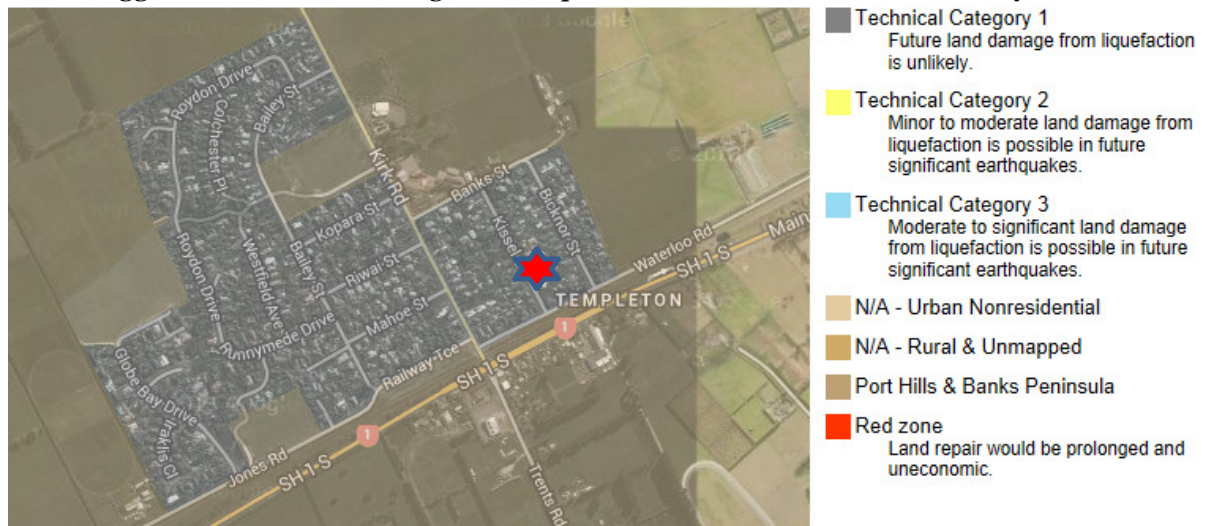
Figure 8: CERA Technical Categories map (loc. starred).

CERA indicates that Templeton Courts is located in a TC1 zone (as shown in Figure 8). This classification suggests future land damage from liquefaction and settlement is unlikely.

There is no evidence to suggest that further geotechnical investigation is warranted for this site.
