Veronica Place Housing Complex PRO 0317

**Detailed Engineering Evaluation
Quantitative Assessment Report**

Veronica Place Housing Complex Quantitative Assessment Report

Date: March 2014
Reference: 6-QC411.00
Status: Final

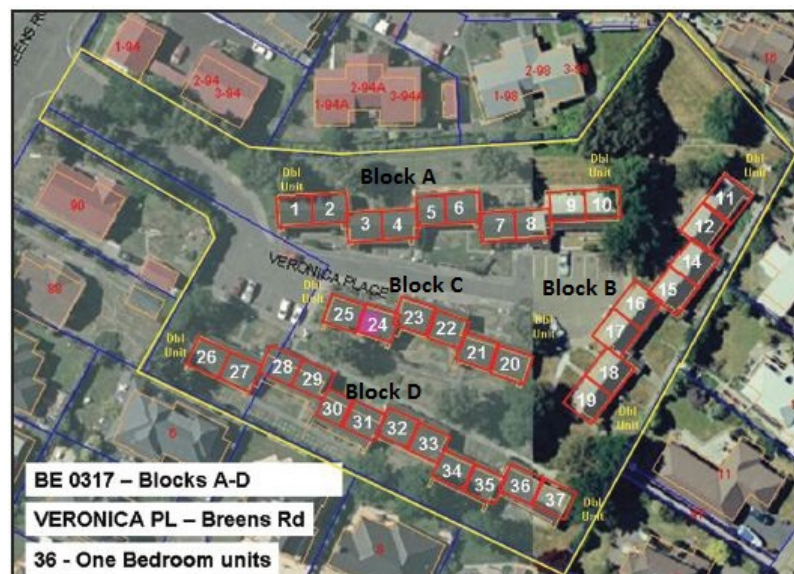
Figure 2: Site plan of Veronica Place Housing Complex.

The site contains 36 residential units which were constructed in 1978. A site plan showing the location of the units, numbered 1 to 36 (there is no unit 13), is shown in Figure 2. Figure 3 shows the location of the site in Christchurch City. Units 1, 10, 11, 19, 20, 25, 26, 37 are double units and are larger than other units onsite. The units are grouped together to form blocks of either six, eight, ten or twelve units.

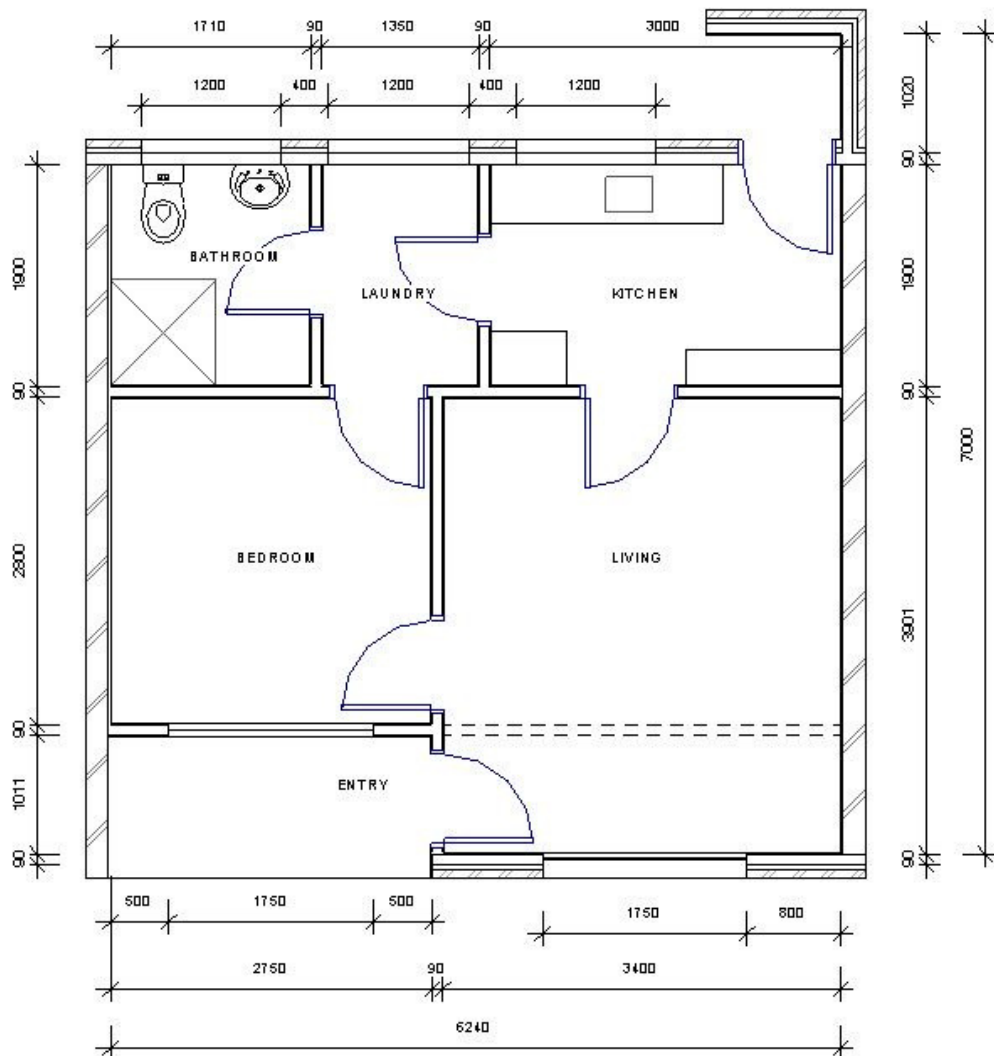
Figure 4: Typical partial floor plan of single residential units.

Figure 4 and 5 show typical floor plans of single and double residential units respectively produced from site measurements by Opus. Figure 6 shows a cross section used in calculations.

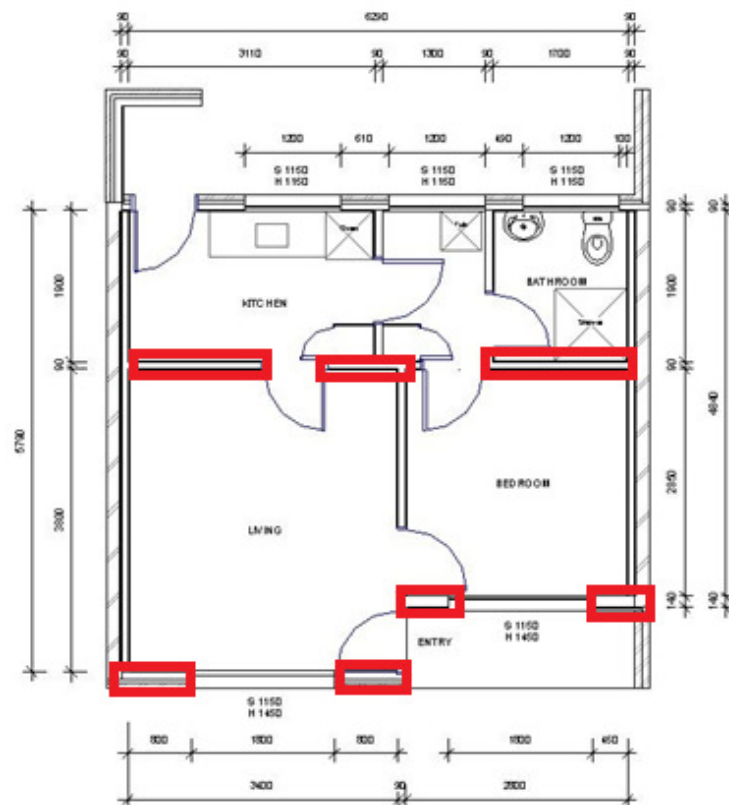
Figure 7: Walls used for bracing in the longitudinal direction.

Hand calculations were performed to determine seismic forces from the current building codes. These forces were applied globally to the structure and the capacities of the walls were calculated and used to estimate the %NBS. The walls, highlighted in Figure 7 and Figure 8, were used for bracing in their respective directions.

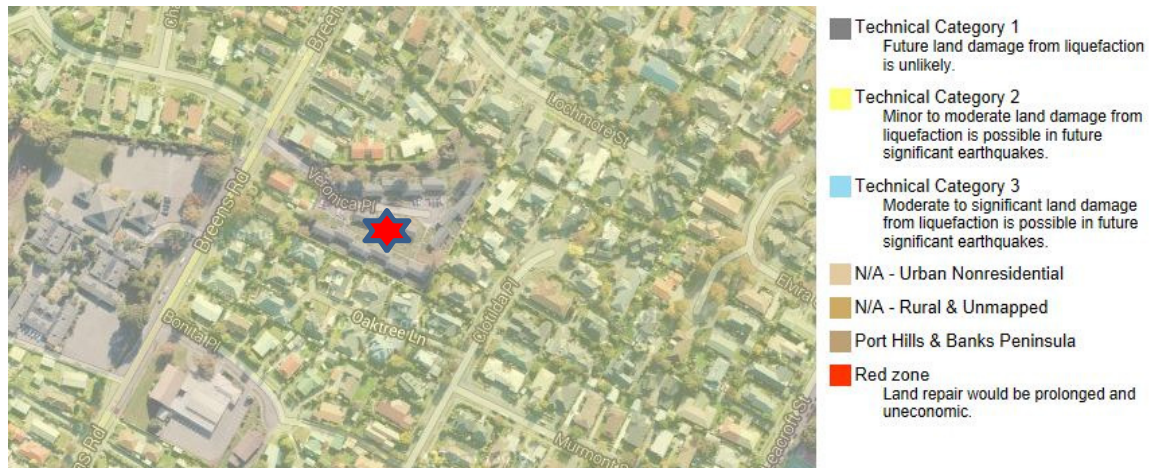
Figure 9: CERA Technical Categories map (loc. starred).

CERA indicates that Veronica Place is located in a TC2 zone (as shown in Figure 9. This classification suggests future significant earthquakes will cause minor to moderate land damage due to liquefaction and settlement.

There is an open water course just to the north of Block A. A geotechnical investigation is likely to establish why only Unit 6 has suffered damage due to ground movement.
