Waimairi Cemetery
Toilets/Shed/Office
PRK 0291 BLDG 001 EQ2
Detailed Engineering Evaluation
Quantitative Report
Version FINAL

195a Grahams Road, Burnside

Christchurch City Council

Date
19 March 2013

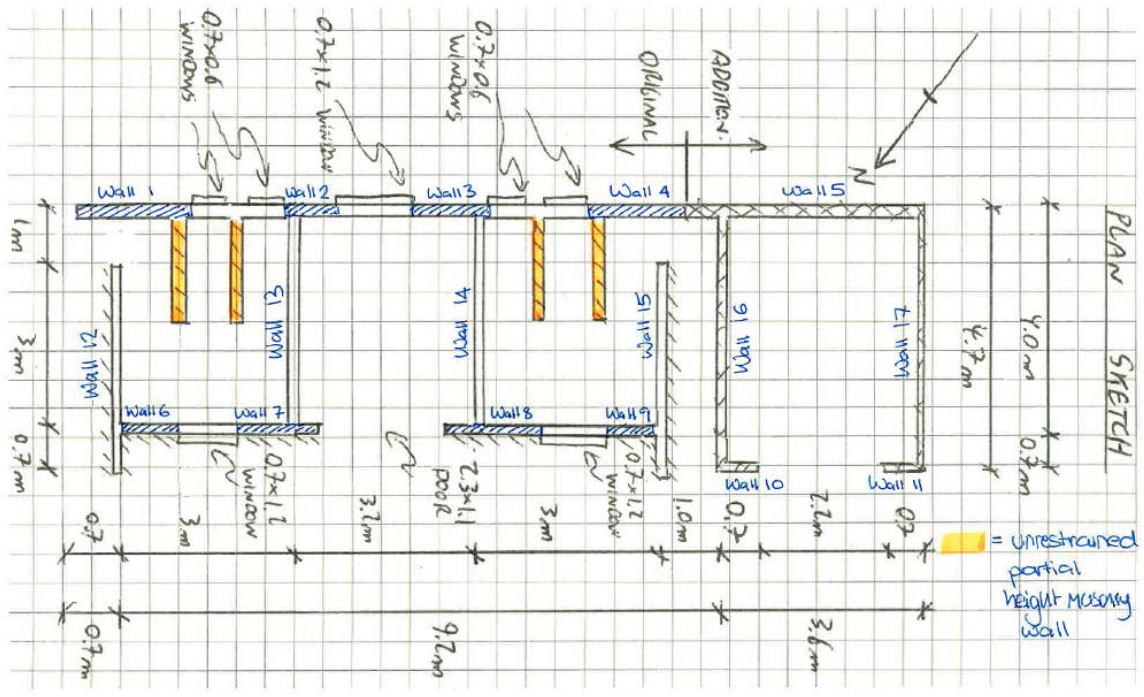
Figure 2 Floor plan of the building

The original building consists of unreinforced concrete masonry walls supporting a lightweight timber framed roof. The north-west, north-east and south-west external walls of the original structure consist of unreinforced 100mm thick partially filled concrete masonry units clad externally with a 100mm brick veneer. The rear concrete masonry wall along the south-eastern side of the original building and the internal transverse concrete masonry walls (Walls 13 and 14, Figure 2) are 150mm thick and unreinforced.

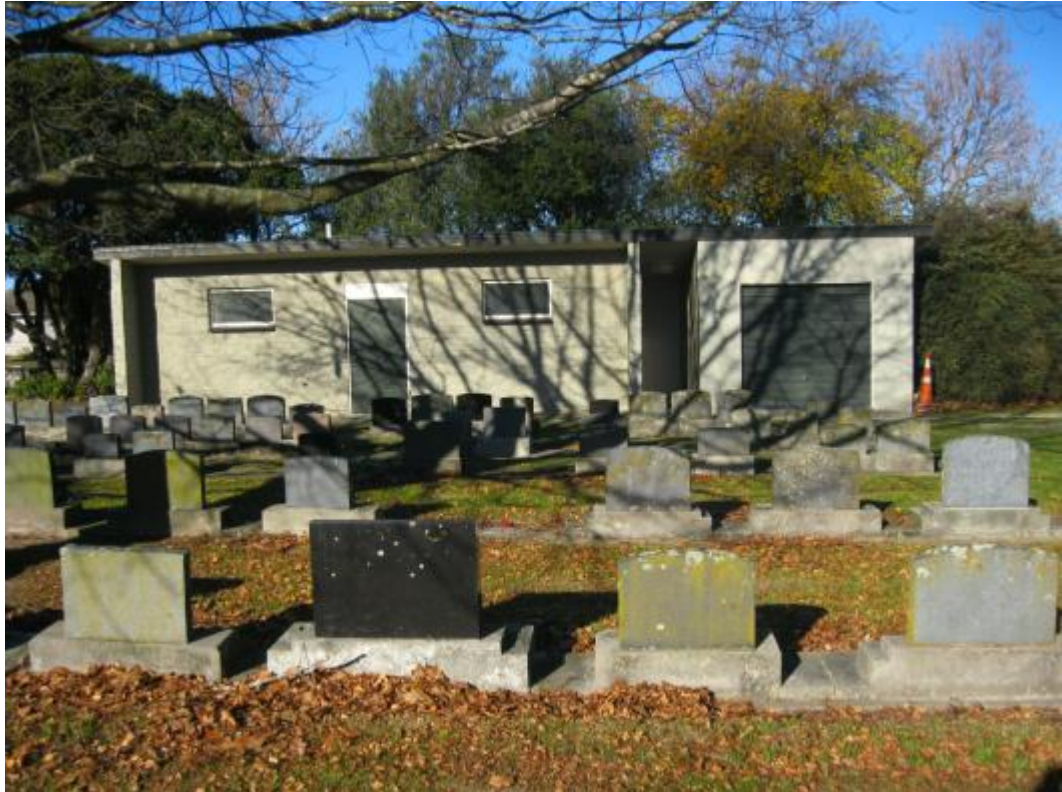
Photograph 1 North-western elevation of the building

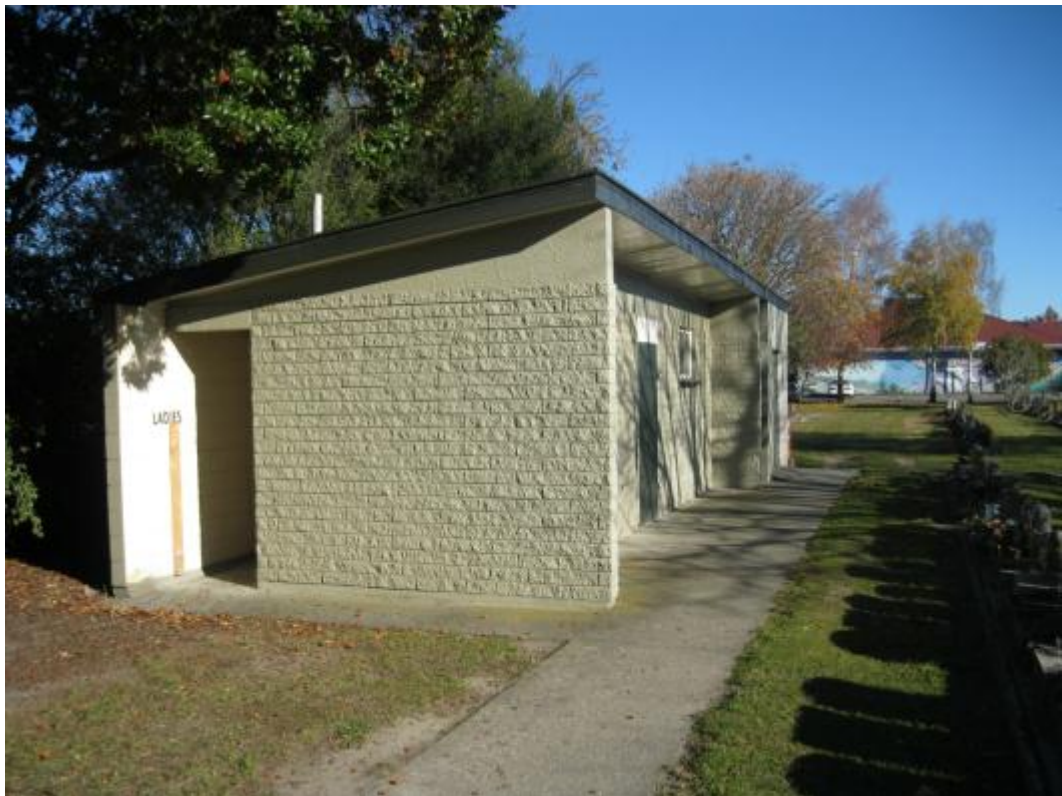
Photograph 2 View of the building from the north

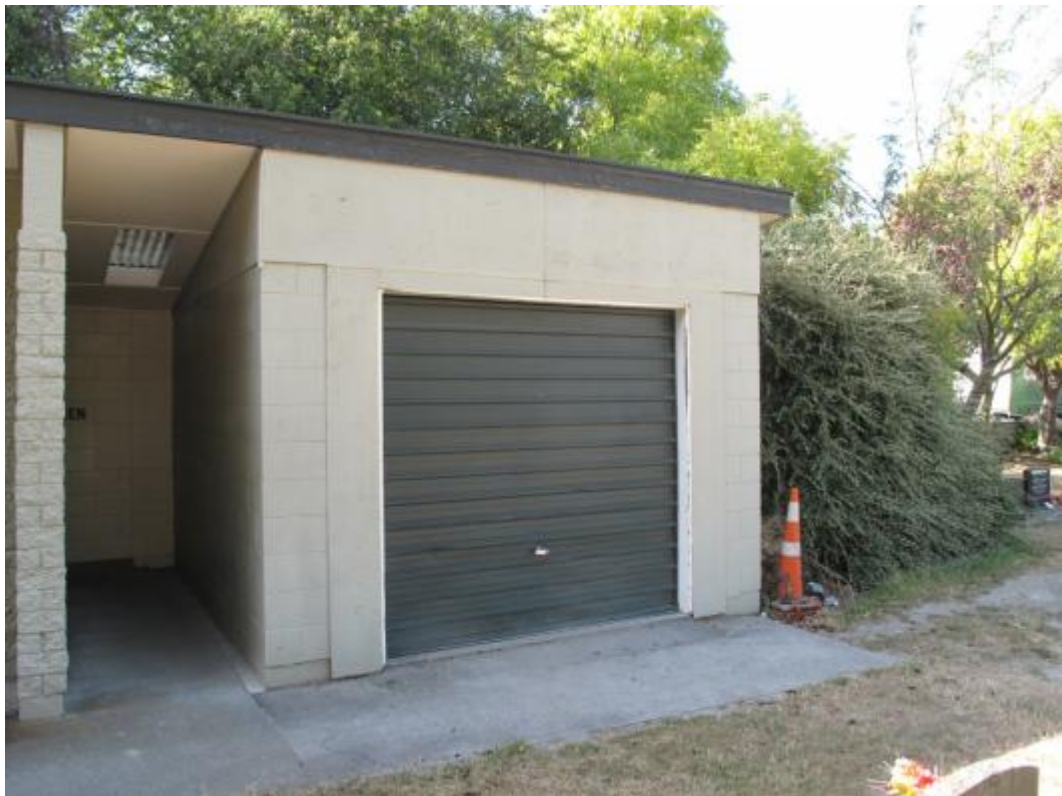
The structure of the extension to the south-west of the original building consists of partially filled concrete masonry walls reinforced with 12mm vertical reinforcing bars at 800mm centres. The rear south-eastern wall of the extension is 150mm thick. The other walls are 200mm thick. There is a large door opening on the north-western wall of the extension. The roof structure is similar to that of the original structure, consisting of corrugated sheet metal supported by timber purlins and rafters and a hardboard panel ceiling. Lightweight timber framed infills above the walls support the mono-pitch roof.

Photograph 4 Extension to the south-west of the original building
