Waltham Courts Housing Complex PRO 1049

**Detailed Engineering Evaluation
Quantitative Assessment Report**

Waltham Courts Housing Complex Quantitative Assessment Report

Date: March 2014
Reference: 6-QC414.00
Status: Final

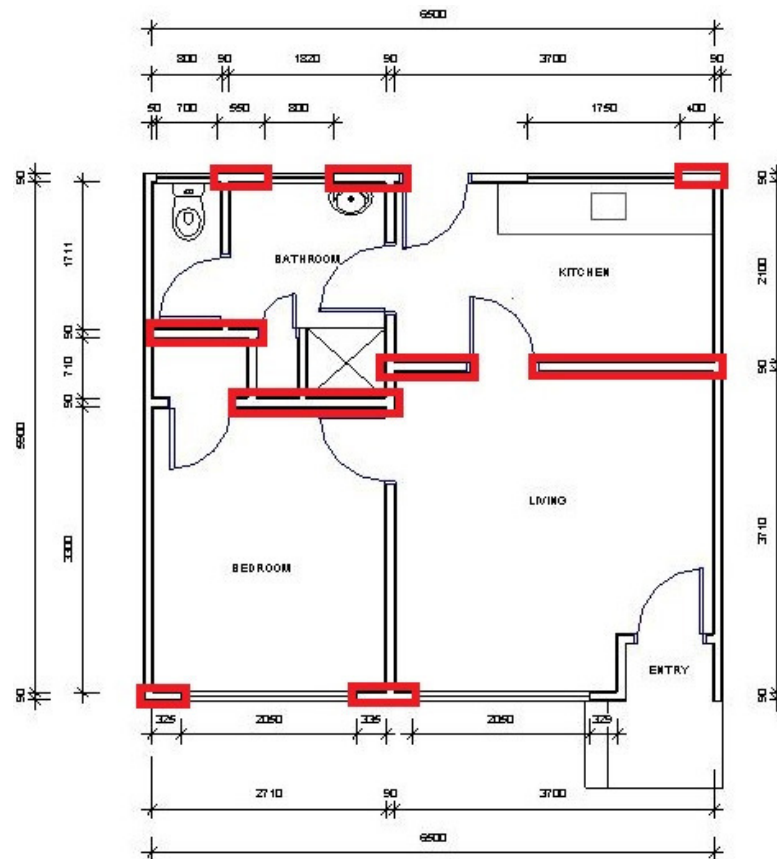
Figure 6: Walls used for bracing in the longitudinal direction.

Hand calculations were performed to determine seismic forces from the current building codes. These forces were applied globally to the structure and the capacities of the walls were calculated and used to estimate the %NBS. The walls, highlighted in Figure 6 and Figure 7, were used for bracing in their respective directions.

The piles are not attached to the foundations. Some of these piles are now not load bearing so cannot transfer forces in friction. The sub-floor height is low but there is potential for the buildings to slide off their foundations hence the sub-floor has been given a rating of 23-30%NBS. Actual numbers will depend upon the number of piles that have sunk within a building. Due to the low height of the potential drop it is not considered likely to cause collapse of the super structure.

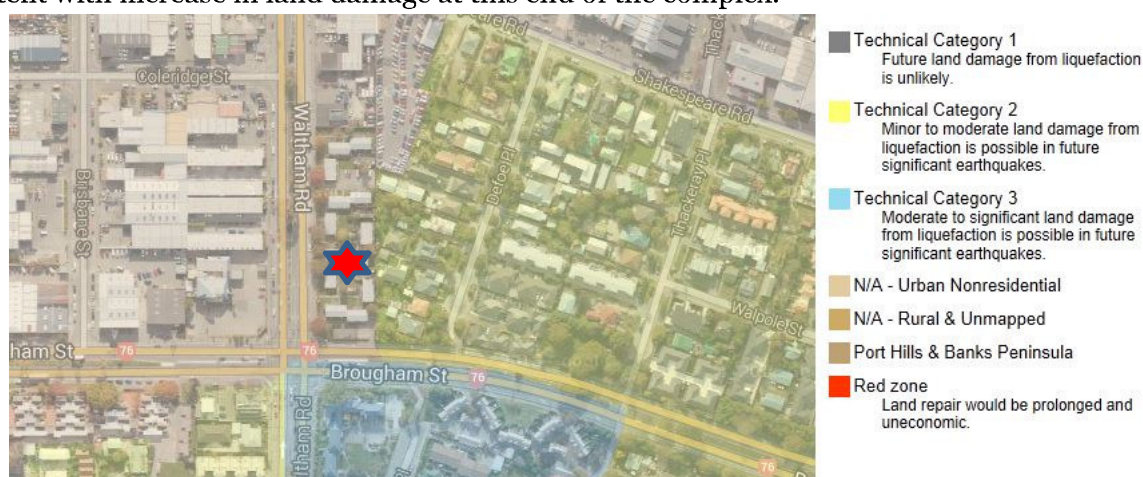
Figure 8: CERA Technical Categories map (loc. starred).

CERA indicates that Waltham Courts is located in a TC2 zone (as shown in Figure 8). This classification suggests future significant earthquakes will cause minor to moderate land damage due to liquefaction and settlement. However the site is across the road from a TC3 zone. This is consistent with increase in land damage at this end of the complex.

There is no evidence to suggest that further geotechnical investigation is warranted for this site given the light weight form of construction of the buildings.

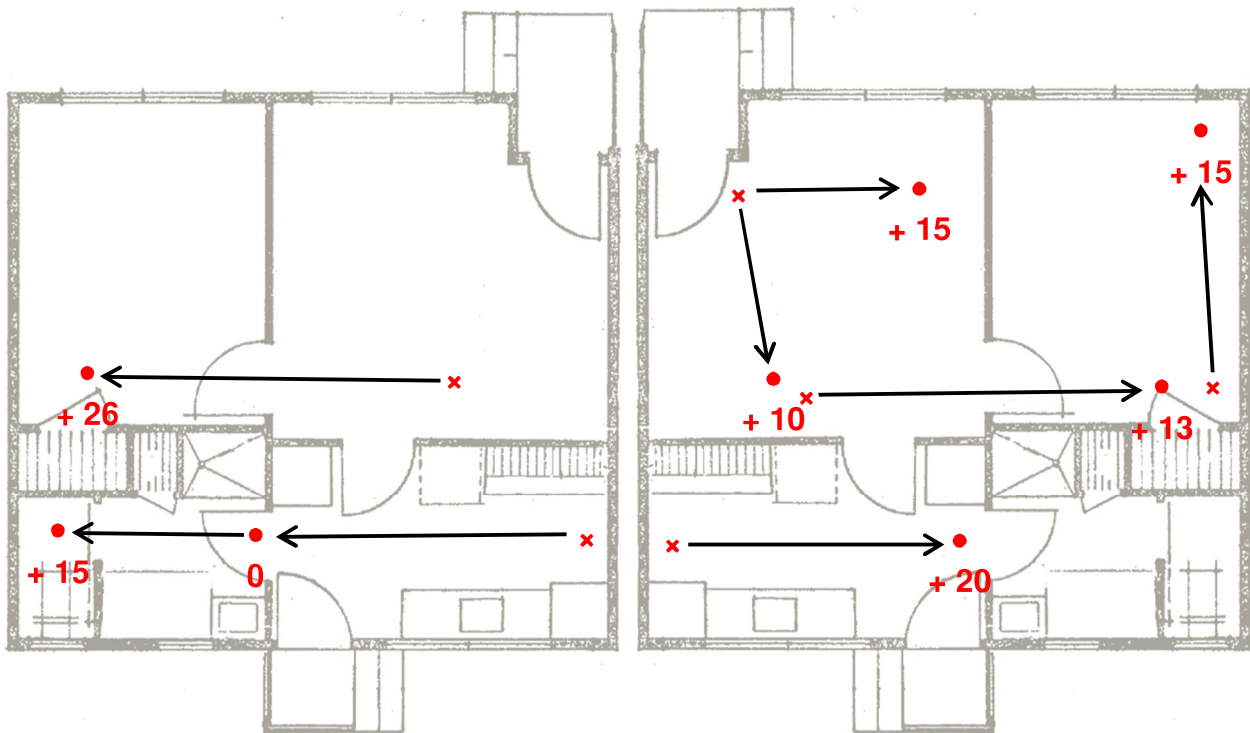
Block	Unit No.	Comment	Maximum Fall*
A	1	Fail	6 mm/m
	2	Fail	6 mm/m
	3	Fail	7 mm/m
	4	Fail	10 mm/m
B	5	Fail	7 mm/m
	6	Pass	-
C	7	Fail	10 mm/m
	8	Pass	-
D	9	Pass	-
	10	Fail	12 mm/m
	11	Pass	-
	12	Pass	-
E	13	Pass	-
	14	Pass	-
F	15	Pass	-
	16	Pass	-
G	17	Pass	-
	18	Pass	-
	19	Pass	-
	20	Pass	-
H	21	Fail	9 mm/m
	22	Fail	6 mm/m
I	23	Pass	-
	24	Pass	-
	25	Pass	-
	26	Pass	-

Unit 1

Unit 2

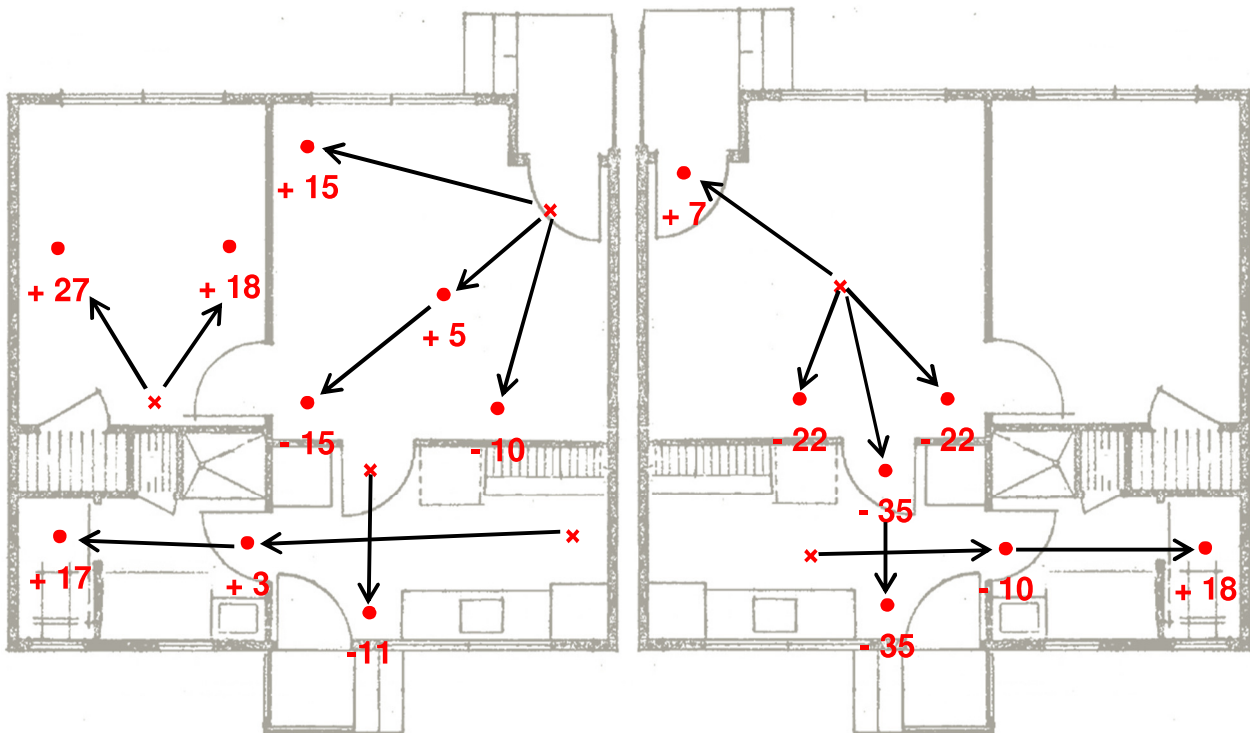
Unit 3

Unit 4
