CHRISTCHURCH CITY COUNCIL
PRK_1044_BLDG_006 EQ2
Waltham Park -Toilets
30-40 Waltham Rd, Waltham

QUALITATIVE ASSESSMENT REPORT

FINAL

- Rev C
- 24 April 2014

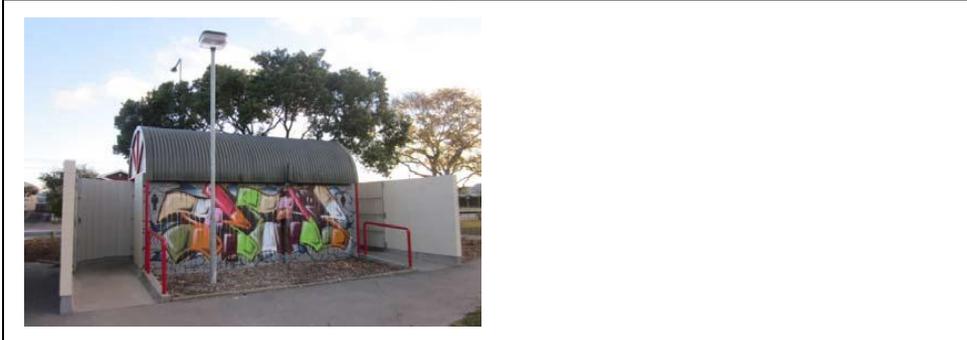
1.1 Photos (attach sufficient to describe building)

Building 6 is a single storey amenities block constructed from stack bond concrete masonry. The structure has a steel canopy supported on steel posts and is tied in to the block walls. The building has one internal concrete masonry wall and the canopy is clad in corrugated steel roof sheeting. The masonry walls are founded on a concrete strip footing and there is an internal floor slab.
