Waltham Pool Tank
BU 1044-004 EQ2
Detailed Engineering Evaluation
Qualitative Report
FINAL

Waltham Park, 30-40 Waltham Road,
Christchurch

Christchurch City Council

Date
07/12/12

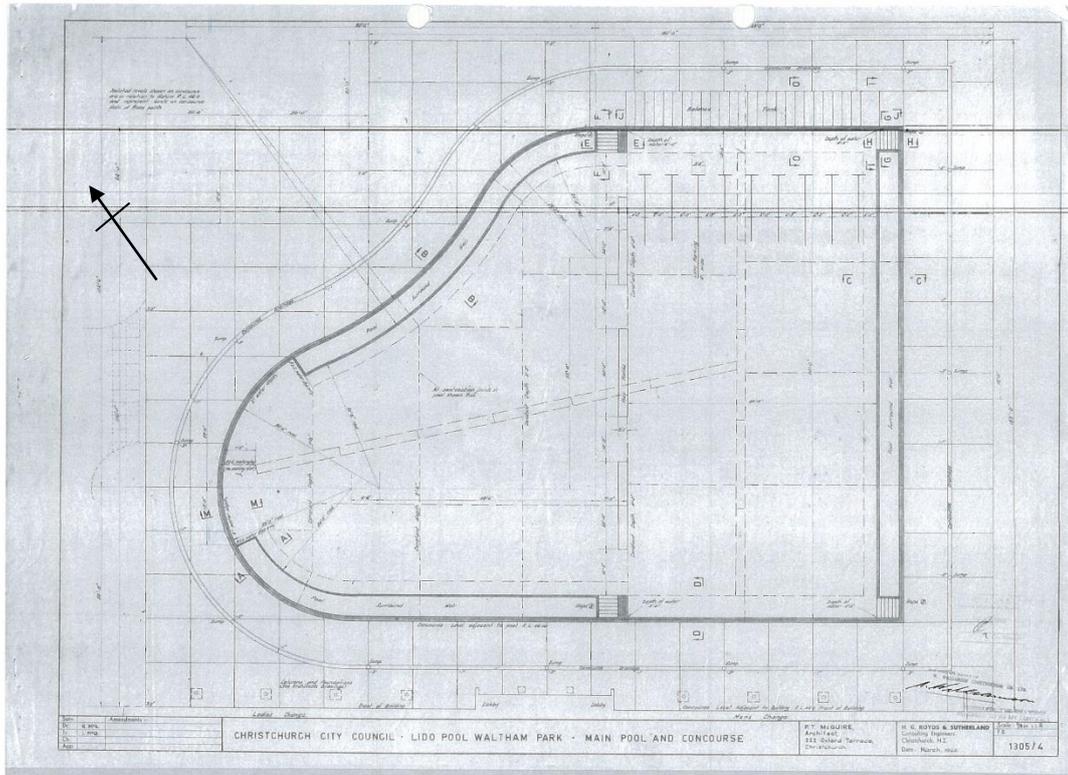
Figure 2 Plan of Pool Tank

Figure 2 shows a plan view of the structure, and the available drawings of the structure are located in Appendix B. Photographs which further exhibit the structure are contained in Appendix A of this report.
