**William Massey
Housing Complex
PRO 0925**

**Detailed Engineering Evaluation
Quantitative Assessment Report**

**182 Ensors Road, Woolston,
Christchurch 8023**

Date: September 2013
Reference: 6-QC418.00
Status: Final

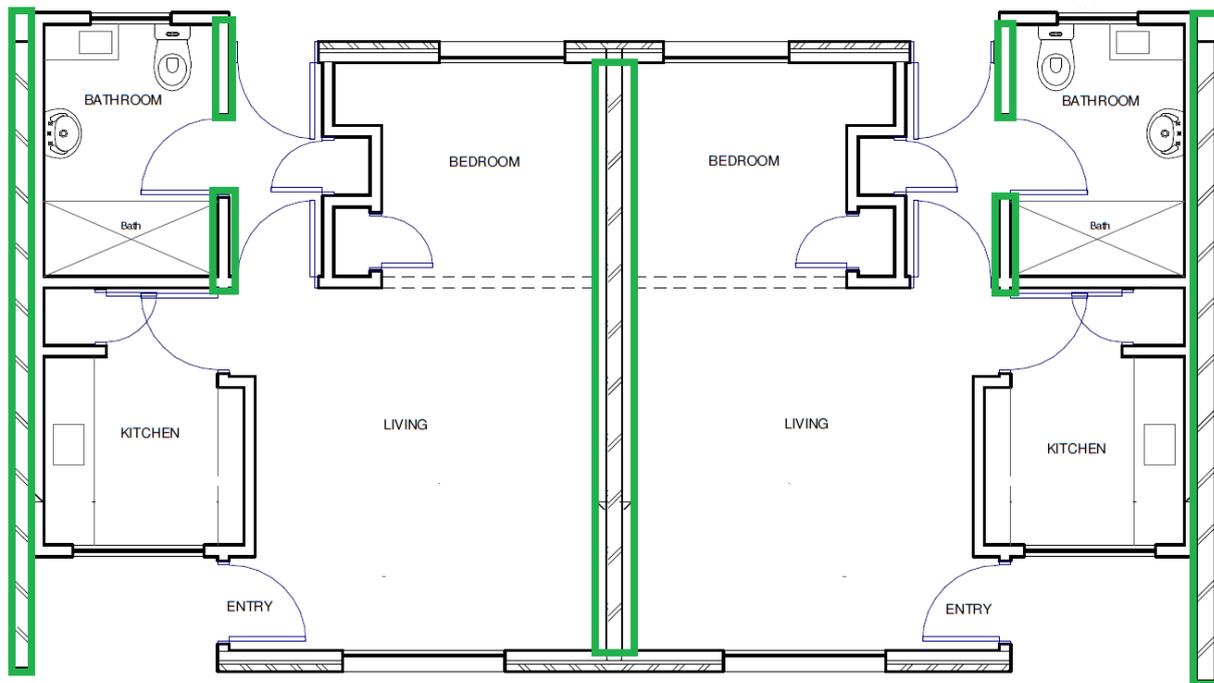
Figure 7: Walls used for bracing in the transverse direction.

Hand calculations were performed to determine seismic forces from the current building codes. These forces were applied globally to the structure and the capacities of the walls were calculated and used to estimate the %NBS. The walls, highlighted in Figure 6 and Figure 7, were used for bracing in their respective directions.

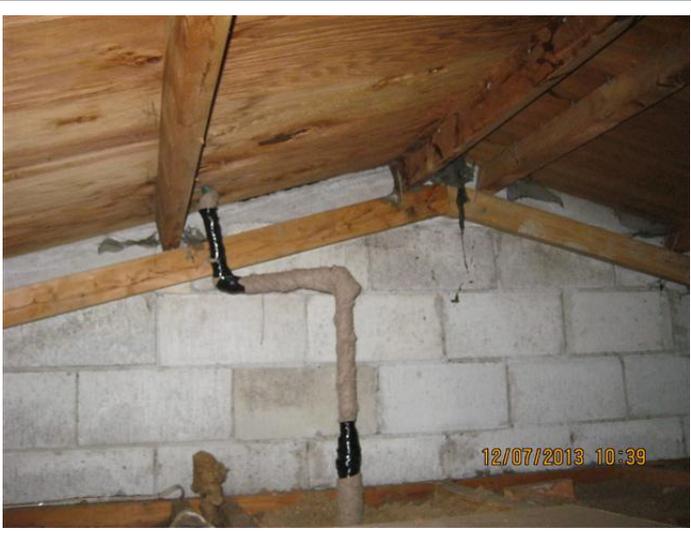
4.	Typical ceiling space showing fire wall
