Repairing Damaged Heritage Buildings

Guidelines for building owners

GUIDELINE 3 – Reconstruction of elements

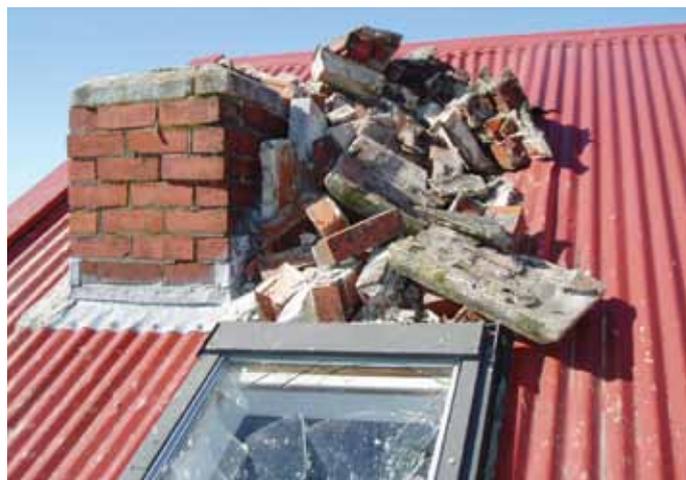
Earlier chimneys that were constructed with lime mortar tend to collapse into piles of individual bricks. Although the bricks may have been damaged, they are relatively easy to clean for reuse.

Later chimneys used cement mortar and these often topple as whole units. These bricks are more difficult to salvage.

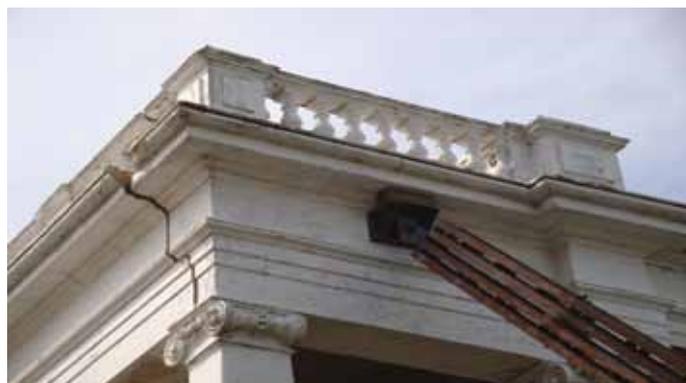
Parapets, if they are not strengthened can suffer badly in an earthquake and subsequent after-shocks. In the case of the Canterbury Earthquake in some instances entire sections of the parapets were lost, while elsewhere parapets were loosened and became dangerous.

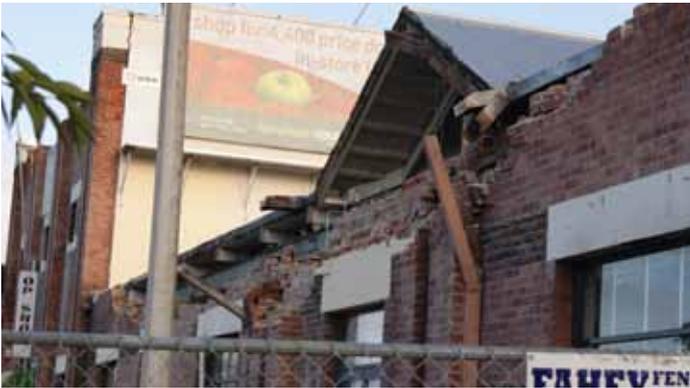
Gable ends are relatively easy to reconstruct and can be secured to the roof structure as they are rebuilt.

Horizontal tie rods can be built into the masonry as the work proceeds. A steel plate welded to the outer end can be bolted to timber rafters or other structural elements within the roof.

The roof then acts as a diaphragm which resists the force of an earthquake and provides support to the gable end.
