PROPOSED RYMAN COMPREHENSIVE CARE RETIREMENT VILLAGE

BISHOP'S CHAPEL
100 PARK TERRACE, CHRISTCHURCH

TECHNICAL REPORT - HERITAGE
March 2020

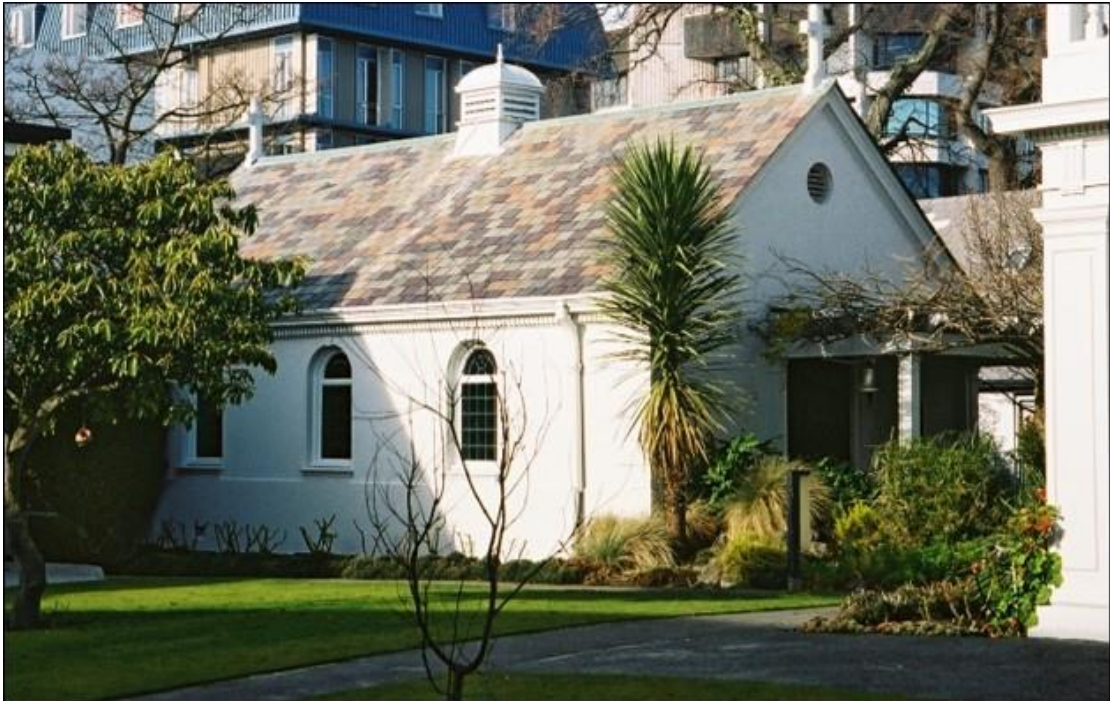
Figure 2
Bishop's Chapel prior to the earthquakes. Note the roof ventilator and the pergola that connected the chapel with the Bishop's residence.

Externally, an original roof ventilator has been removed, probably following the earthquakes. A covered way that formerly connected the chapel to the Bishop's residence is believed to have been removed when the Bishopspark site became a retirement village. A pergola that replaced the covered way was removed after the earthquakes to enable the installation of a series of steel braces to support the end walls.

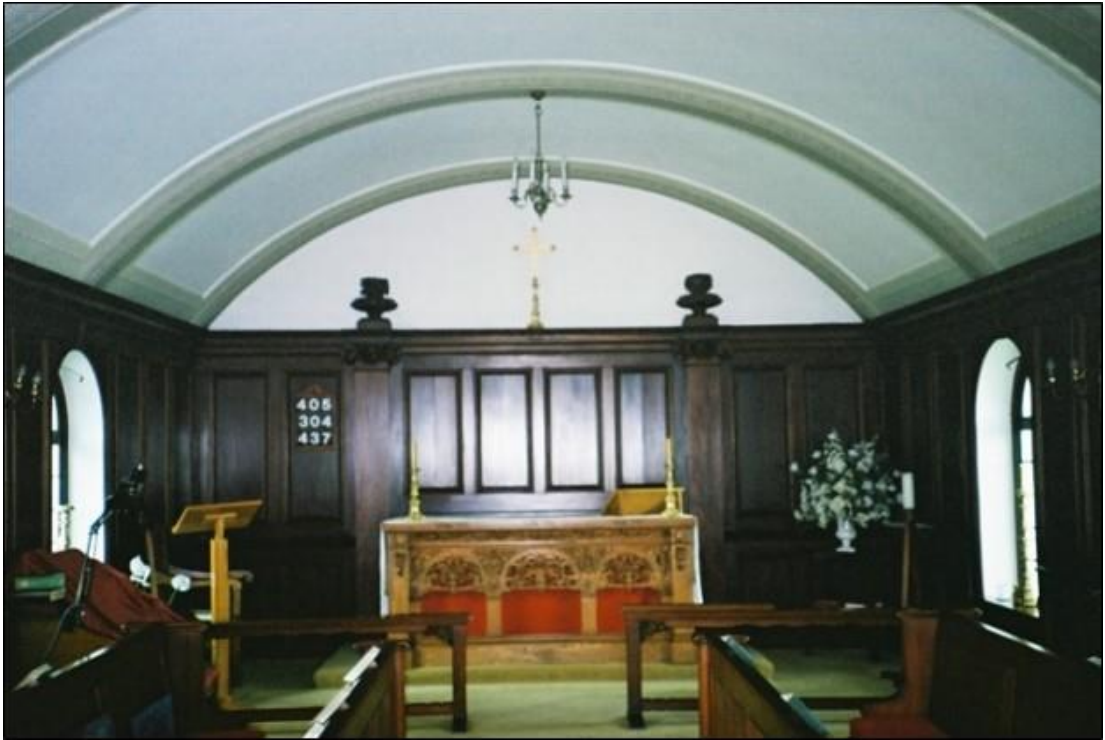
Figure 3

Interior of chapel prior to earthquakes. Note vaulted ceiling, altar and lectern.

Internally, since the earthquakes which saw the collapse of the plaster ceiling, the altar and some of the other fittings including the lectern have been removed. The pews which previously faced other across the aisle and panelled front pieces remain within the building.

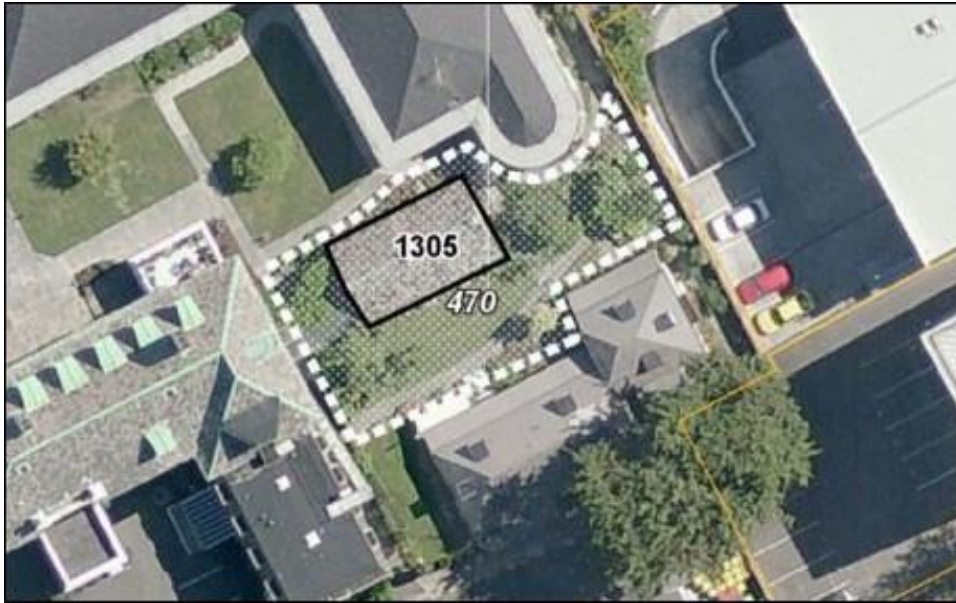
Figure 4
Christchurch District Plan listing - Bishop's Chapel and setting.

Prior to the Canterbury earthquakes, Bishopspark/former bishop's residence and chapel and setting were listed as a Category 1 Historic Place in the Christchurch City Plan (no longer operative). With the demolition of the residence, the listing has been amended in the new Christchurch District Plan to read "Former Bishop's Chapel and Setting". The Bishop's Chapel is rated as "Highly Significant" which equates to the previous Category 1 listing. The setting extends around the four sides of the chapel as shown in the aerial photograph below.

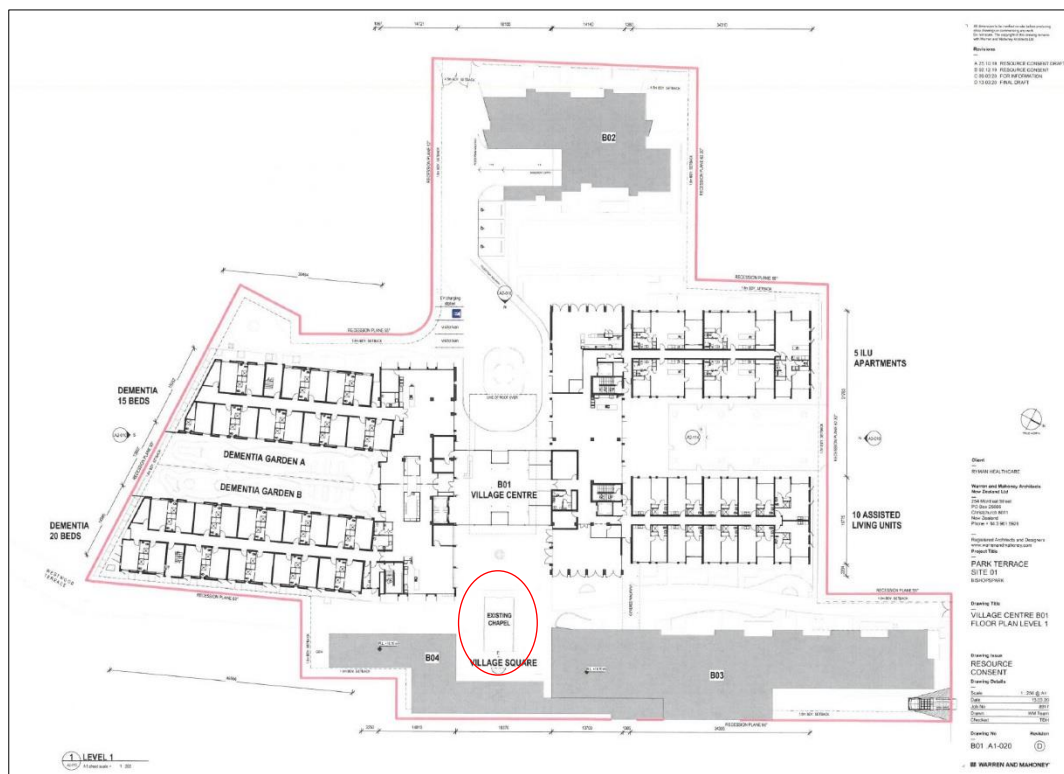
Figure 5.
Proposed layout of village centre, with Bishop's Chapel circled in red.
Source: Warren and Mahoney Architects New Zealand Ltd. 2020

The existing Chapel will be the only building on the Bishopspark site to be retained within the Proposed Village. It will be visible beyond the reception area and will be positioned within a village square. The area immediately surrounding the Chapel will be landscaped with paving, low plantings and grassed areas. An accessible ramp to the Chapel will be provided.

The majority of the Bishopspark site including the proposed buildings and landscaped areas will all be founded on a base isolation system surrounded by a seismic strip to protect the complex from future seismic events. The chapel and the area immediately surrounding it will not be base isolated.

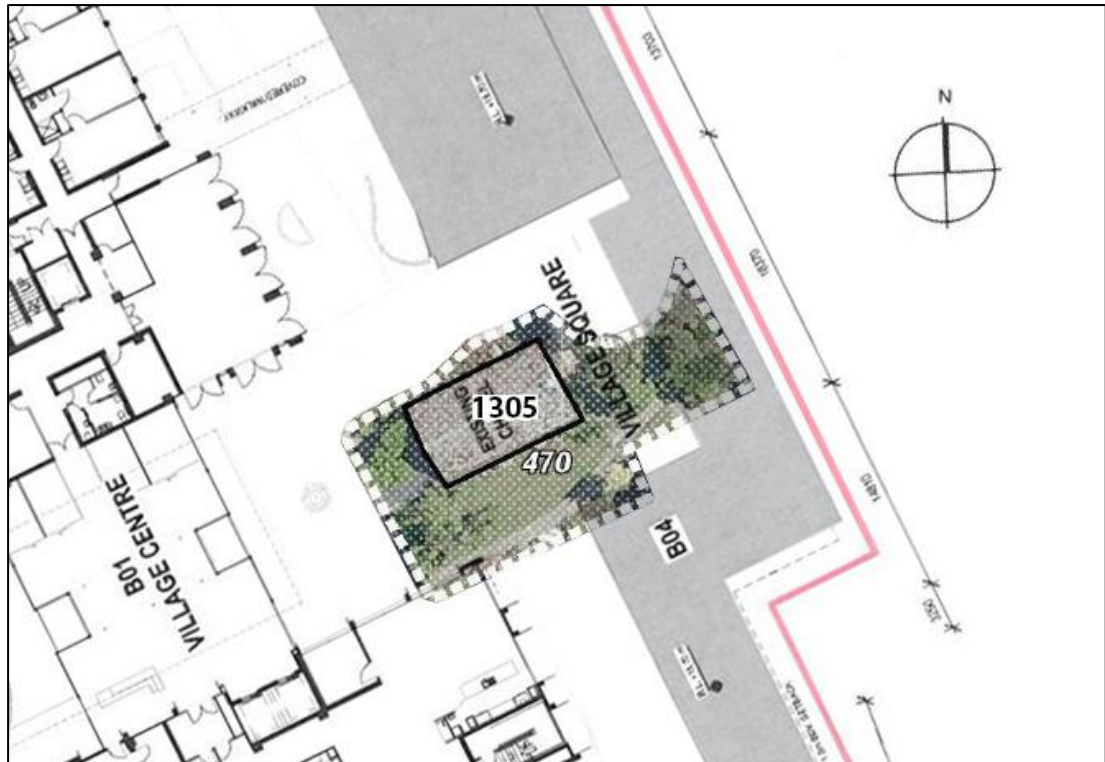
Figure 6.

The existing Heritage Setting (Item No. 470 indicated by white dashed line) and the Bishop's Chapel (Item No. 1305) within the context of Proposed Village. Source: Warren and Mahoney Architects NZ Ltd and Canterbury Maps.

The Proposed Village will impact on the heritage values of Chapel and its setting as a more intensive development comprising a number of buildings that are considerably larger than the previous two storeyed structures. The new building to the south of the Chapel and a low-level pavilion to the north east will intrude into the Heritage Setting surrounding the Chapel.

The closest building to the Chapel is a four-level building (Building B01) located five metres off the south corner. Other buildings to the northwest of the Chapel are positioned approximately eight metres away, which is still further away than the previous buildings along that side of the chapel. There will also be views through to the Chapel from three sides.
