**Linwood Library &  
Service Centre  
Building  
PRO 1982 001**

**Detailed Engineering Evaluation  
Quantitative Assessment Report**

# **Linwood Library & Service Centre Building**

**Detailed Engineering Evaluation**

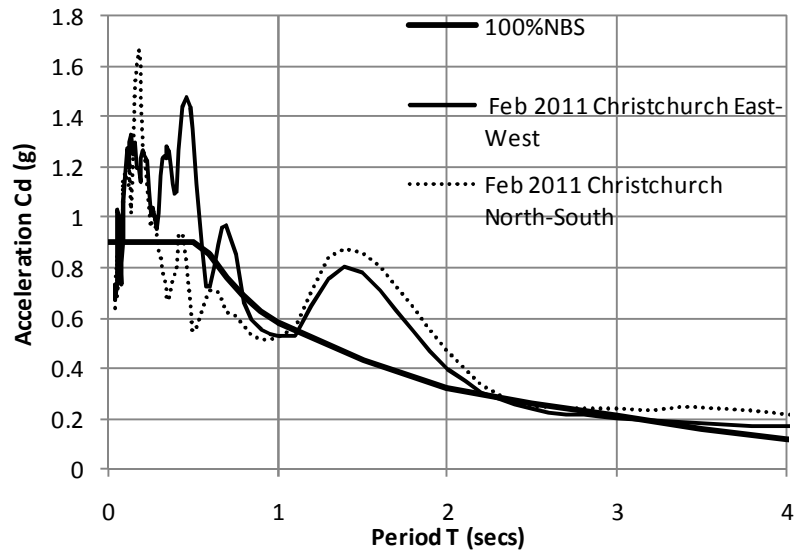
Figure 2 shows the 5% damped response spectra for ground motions from the 22 February magnitude 6.3 Christchurch earthquake recorded at the PRPC station, along with the current design standard spectrum.

**Figure 2: Acceleration response spectra from ground motions recorded by Geonet station PRPC near to Linwood Library, compared with the current design standard 100%NBS acceleration spectrum for the site**

The north-south natural period of vibration of the building is in the 0.15 to 0.25 second range. It can be seen from Figure 2 that the loads experienced were similar to or in excess of the code loads in this period range.
