CHRISTCHURCH CITY COUNCIL
PRK_1673_BLDG_002 EQ2
Templeton Domain Changing Room
39 Kirk Road, Templeton

QUANTITATIVE ASSESSMENT REPORT

FINAL

- Rev C
- 04 June 2013

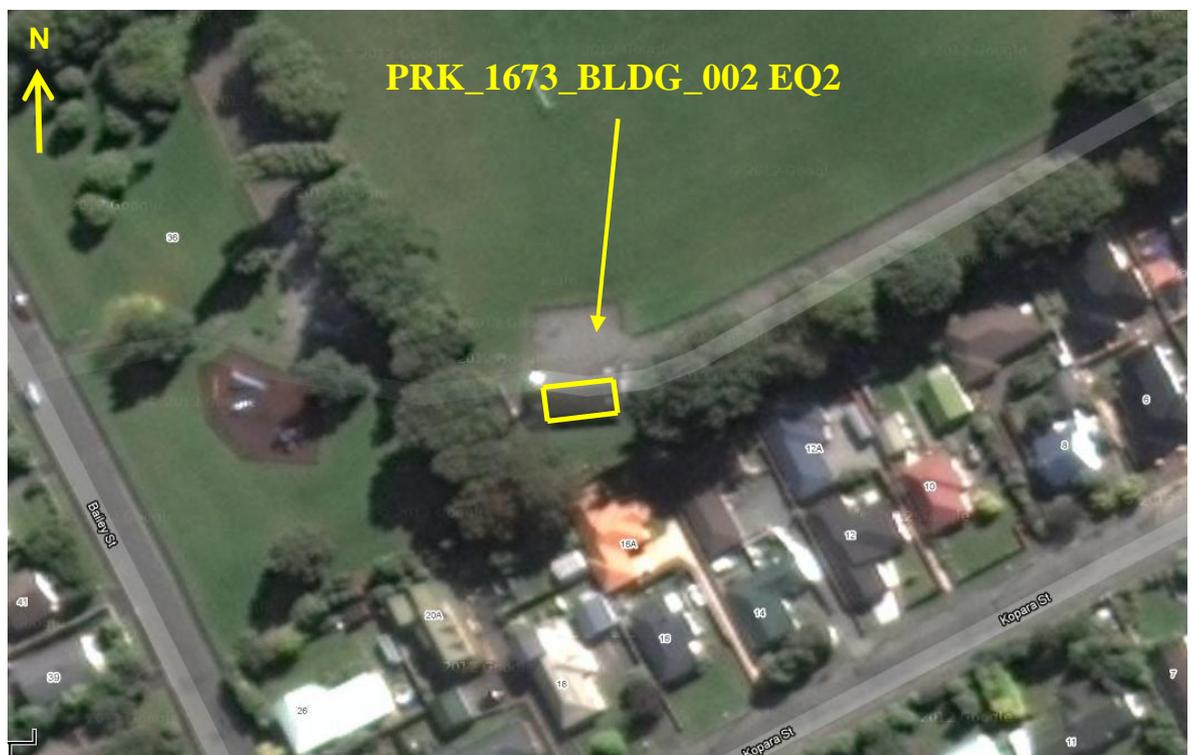
■ **Figure 1: Aerial photograph of the changing rooms in Templeton Domain**

A quantitative assessment was carried out on building PRK_1673_BLDG_002 EQ2 located at Templeton Doman on 39 Kirk Road, Templeton. This is a single storey building that is currently utilised as changing rooms. The building is constructed from concrete block units, with a timber framed roof. An aerial photograph illustrating the buildings location is shown below in Figure 1. Detailed descriptions outlining the buildings age and construction type are given in Section 5 of this report.
