Spencer Park Chemical Sheds

Qualitative Engineering

Evaluation

Functional Location PRK 0157 BLDG 025

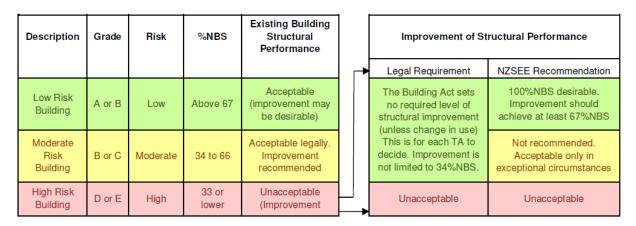
Figure C1: NZSEE Risk Classifications Extracted from table 2.2 of the NZSEE 2006 AISPBE Guidelines

The New Zealand Society for Earthquake Engineering has proposed a way for classifying earthquake risk for existing buildings in terms of %NBS and this is shown in Figure C1 below.
