Below Ground Wellheads Benchmark

22/12/2017

Works carried out at Main Pumps Station Well 2 as a part of the repairing of below ground wellhead project are:

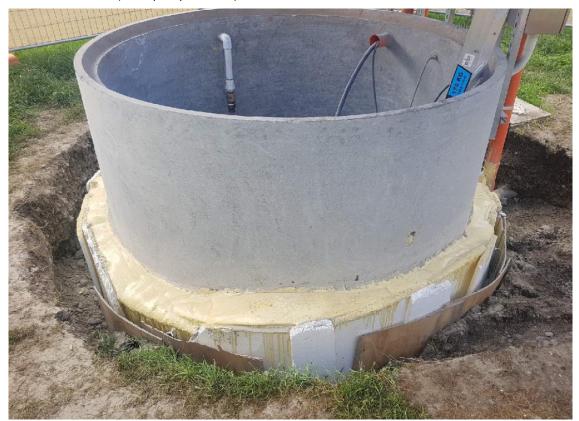
2. External Grouting

1.External Grouting

Ideal Well Picture (Main pumps Well 2)

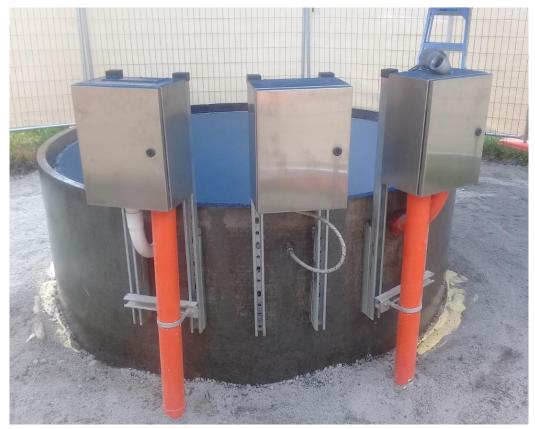
3. Cable Relocation

4.Cable Relocation

Ideal Picture (Main Pumps Well 2)

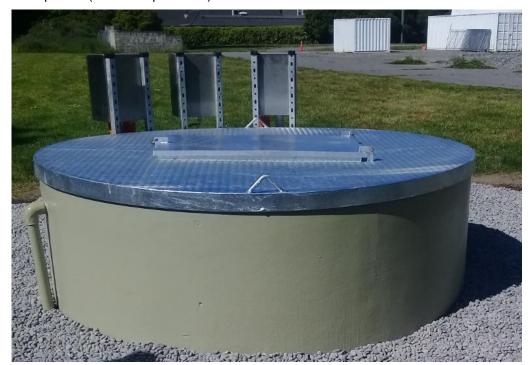
5. Install Secure Accessible Well Cover

7. Installation of Secure, Accessible Well cover

Ideal picture (Main Pumps Well 2)

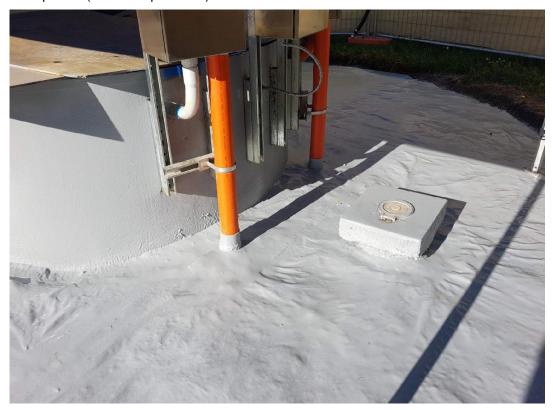
6. Construction of 2m Apron around well cover

9. Construction of a 2m Apron around Well

Ideal picture (Main Pumps Well 2)
