From: Official Information
Sent: Friday, 9 March 2018 4:54 p.m.
To: '██████████@fairfaxmedia.co.nz'
Subject: LGOIMA 18/029 response - wellheads material

- o Correspondence between the engineers who carried out the assessments of the wellheads, and Council staff members.
- **CityCare report** dated 22 December, concerning the assessment of the below ground wellheads, and the works undertaken as part of the project to repair the wellheads.

Christchurch City Council (CCC) commissioned CH2M Beca Ltd (CH2M Beca) to carry out a review of 25 water supply wells at 9 primary water supply pump stations against *Bore Water Security Criterion 2 (bore head must provide satisfactory protection)* of the Drinking Water Standards New Zealand 2005 (revised 2008) (DWSNZ). The scope of works included inspecting the bores and determining their compliance with Criterion 2, recommending upgrades to improve bore head protection and DWSNZ compliance, and summarising the findings with one report per water scheme. This report summarises the findings for the wells supplying Dunbars Pumping Station.

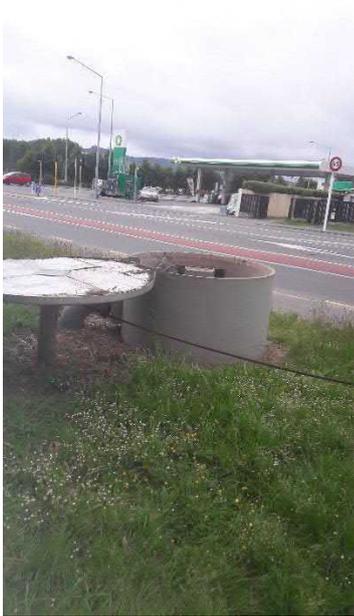
Well chamber is located adjacent to the road with a gas station across the street.

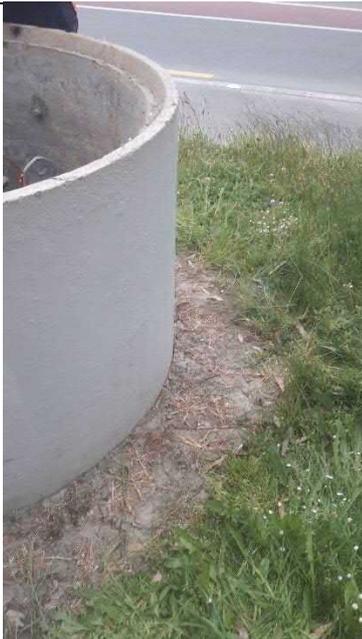
Chamber is located in a slight low point. Ponding may occur around the exterior.

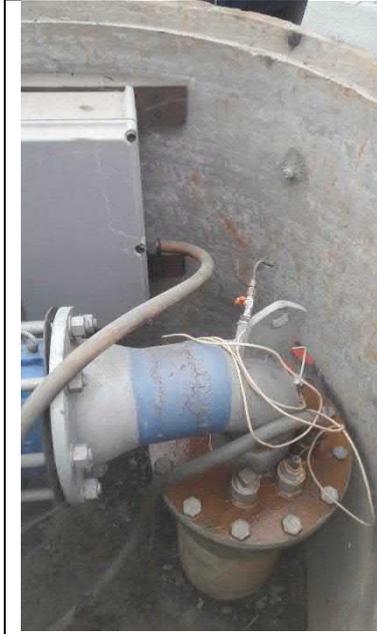
Water present on top of casing to pipe flange. The source of the water is unknown. It may be the pipe or it may be the sample tap.

7. Actions Arising		
Identify issues and rank them in terms of whether they require:		
First Priority	<ul style="list-style-type: none"> ■ Locate source of leak and seal. The source is potentially the sample tap. ■ Seal chamber floor to prevent inundation of chamber from groundwater and install a sump pump with level sensor and alarms ■ Seal cable entry points ■ Install a downward facing air vent 0.5 m above 100 year flood level (unless the well is not located in a flood prone area) 	
Second Priority	<ul style="list-style-type: none"> ■ Modify sample tap so that it is either outside the chamber, or so that it contains a length of flexible hose that can be pulled outside the chamber when samples are collected

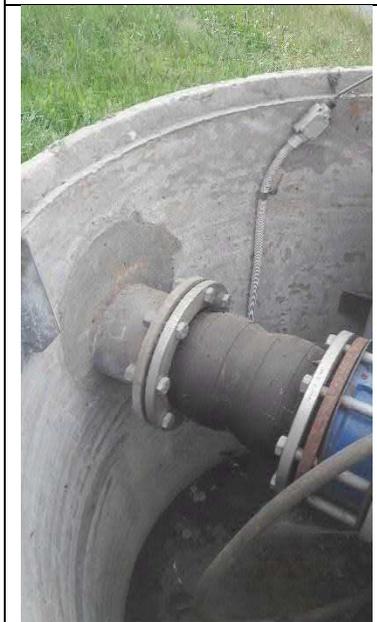
Pipe sealed at chamber connection.

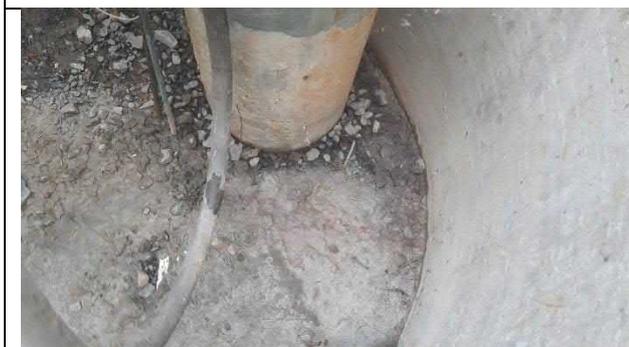
Chamber floor is gravel and so is not sealed from below. Casing is not sealed to chamber.

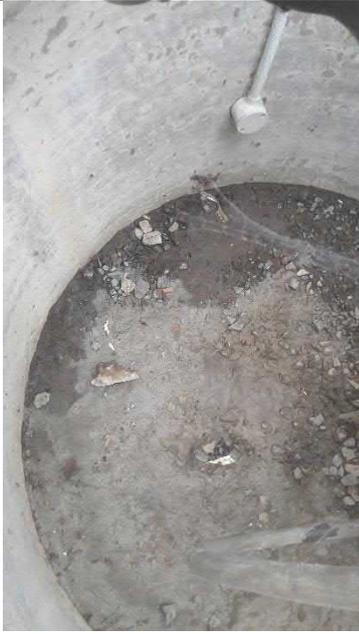
Signs of groundwater entering the chamber through the floor from outside.

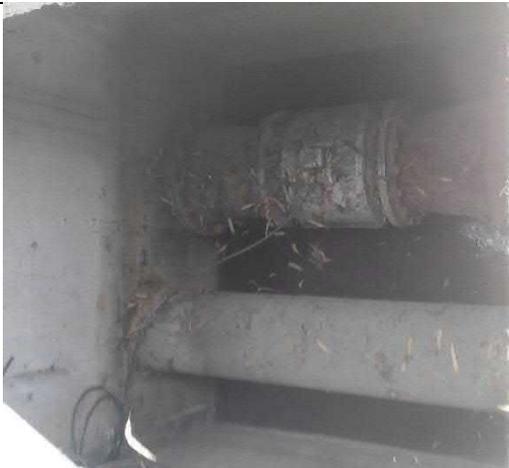
Flow meter chamber near Dunbars Well 1 with water in the base and no sump pump

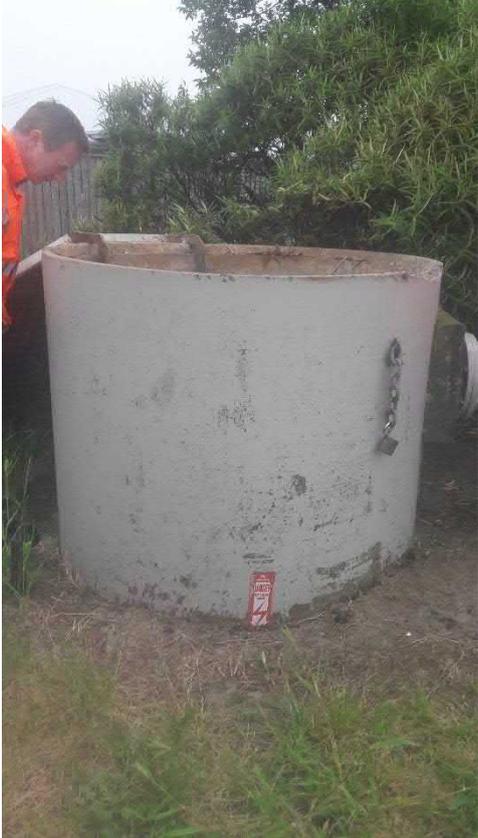
Well chamber is 1.1m above ground. Located on the side of the road.

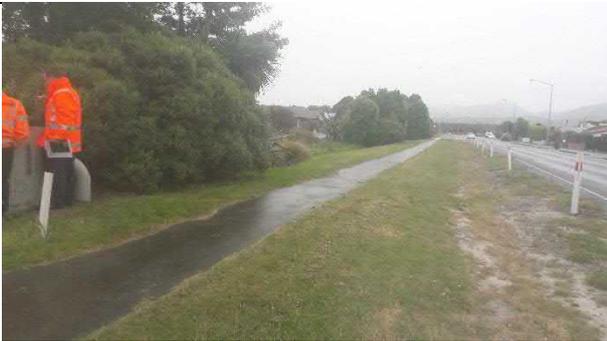
Well is adjacent to sidewalk and road. A creek is on the other side of the well.

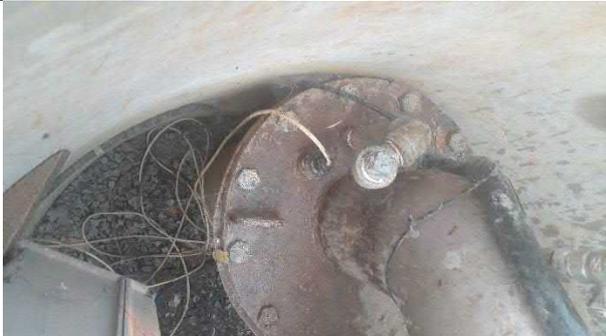
<p>Cables appear to be sealed</p>

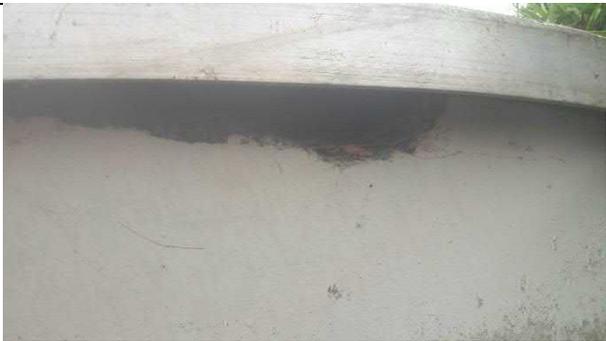
<p>A hole in the top of the chamber was seen. This is a possible source of water, or vermin, ingress</p>
<p>5. Diagram with Well Measurements</p>

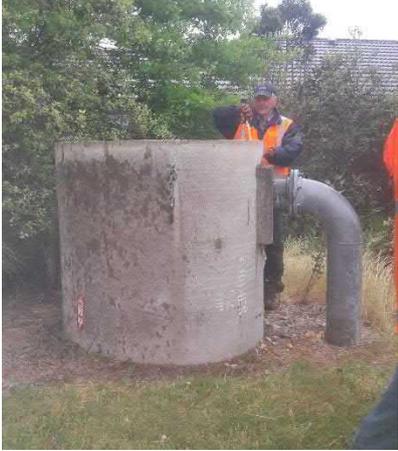
Chamber sits on ground (not a below ground installation)

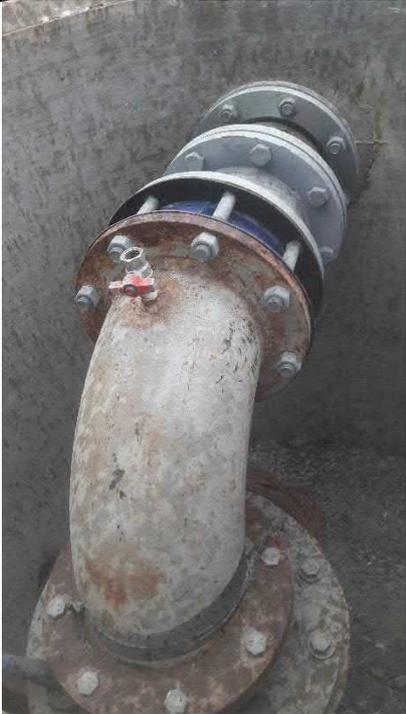
<p>Pipework sealed with the chamber sidewalls. Sample connection point on top of pipework. A sample tap is brought to site for sampling.</p> <p>Gravel in bottom of chamber which allows water to come up through the ground and into the chamber.</p>

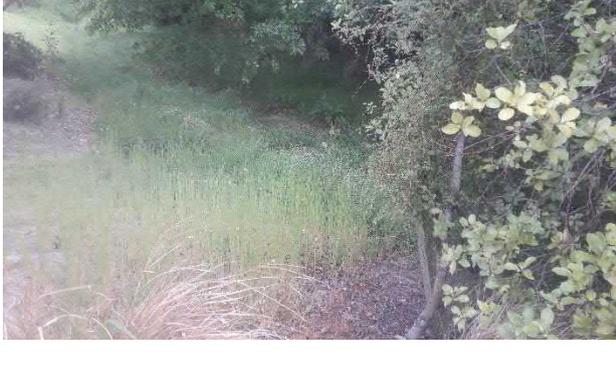
<p>Adjacent creek</p>

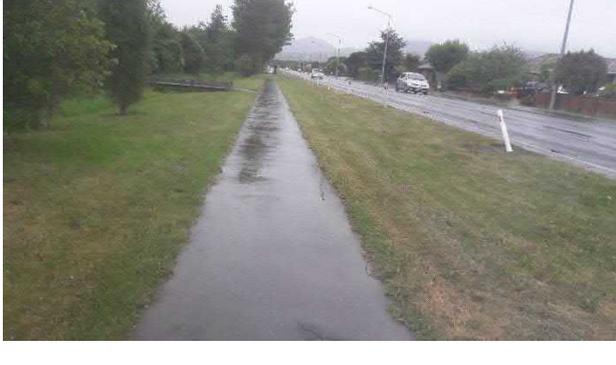
<p>Adjacent road</p>

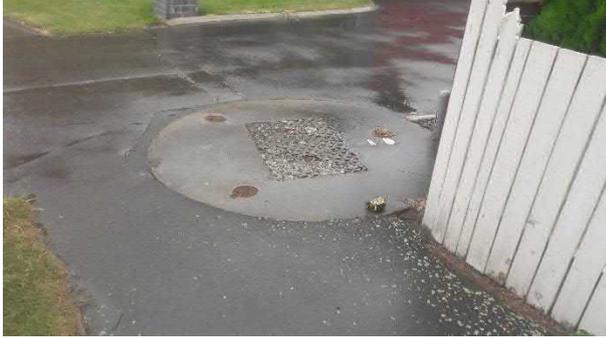
<p>An aerial photograph showing a circular concrete well head located at the end of a paved driveway. The driveway is bordered by a white fence on the right and a road on the left. The well head has a central grate and is surrounded by a concrete curb.</p>	<p>Well is located at the end of a driveway, on the sidewalk and adjacent to a busy road.</p>

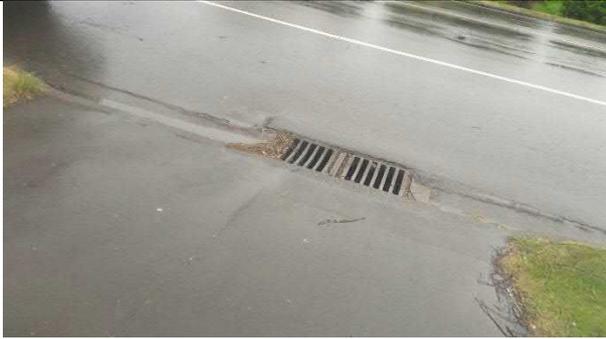
<p>A photograph of a stormwater drain on a road. The drain is a rectangular grate set into the asphalt pavement. The road surface is wet, and there is some debris around the drain.</p>	<p>Stormwater drain on road approximately 2m away</p>

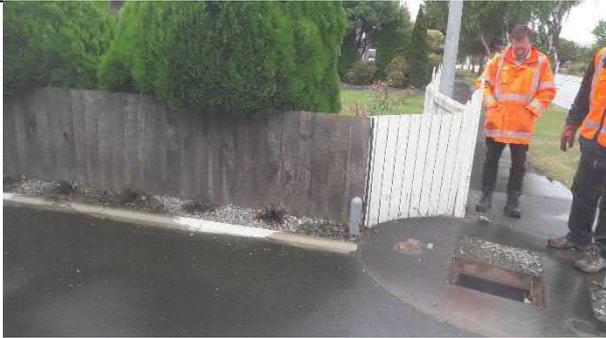
<p>A photograph showing a drain from a driveway directed towards a well. Two workers in orange safety vests are standing near the well head. The drain is a small pipe that runs along the driveway and ends near the well head.</p>	<p>Drain from driveway directed towards well.</p>

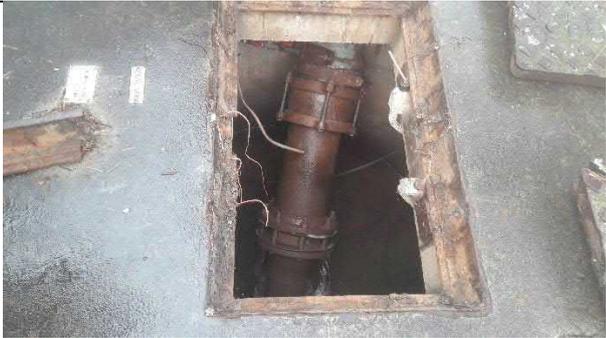
- Dunbars Well 4 – significant amounts of water in the chamber, the sump pump was not running, and water was leaking out of the cable gland. This well is in a driveway/footpath and has a level entry unsealed chamber lid (see photos);
- Denton Well 3 – garbage and vandalism in the chamber and its vicinity, open cable entry point (no cable glands), no sump pump (although dry), a bellow that looked to be sucked inwards indicating that the valve on the pump might need to be checked (see photos). If this chamber was inundated with water it would directly enter the well head.

<p>A photograph looking down into a well chamber. The chamber contains a large, rusted metal pipe. The pipe shows signs of poor condition, including rust and debris. The chamber is surrounded by concrete walls and a metal lid is visible at the top.</p>	<p>Well with water in chamber and evidence that the lid is not water tight. Poor pipe condition can also be seen.</p> <p>Note that the lid has a security alarm.</p> <p>Sample point drains into chamber.</p>

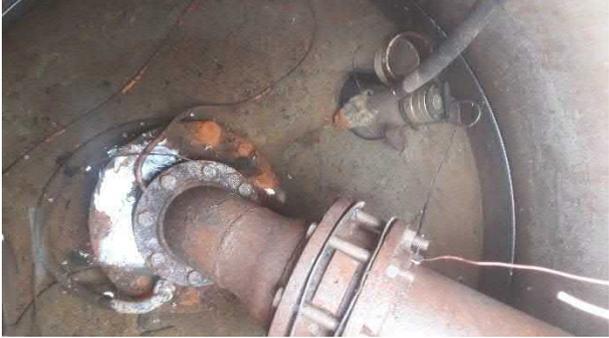
<p>Water in bottom of chamber. Sump pump outside of sump. Ripples in water imply that there is a leak from the side of the casing near the cable duct.</p>

<p>a) Water Ingress:</p>		
<p>Condition of seals (see NZS:4411 2.5.5.3 & 2.5.5.4)</p>	<p>Cabling</p>	<p>Could not inspect due to water in chamber but ripples in the water implied that there was a leak from the cable ducting or adjacent casing</p>

Dunbars Well 4 New sump pump was installed yesterday cable glands are sealed and are not leaking

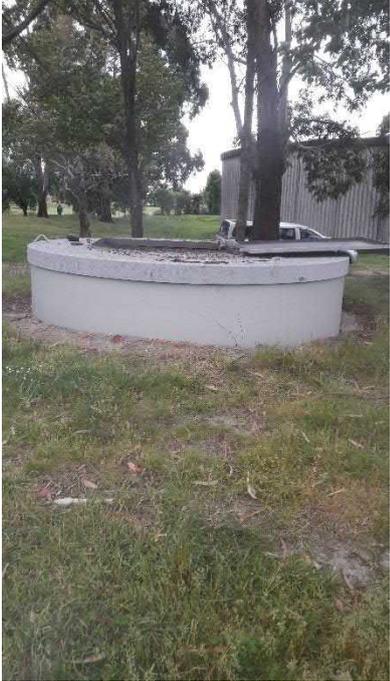
Ground surrounding chamber is slightly lower

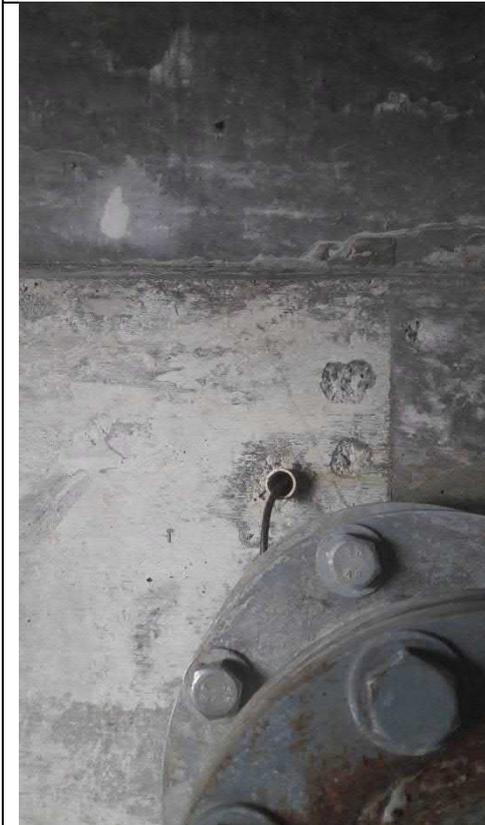
Cable entry at side wall is not sealed

a) Water Ingress:		
Condition of seals (see NZS:4411 2.5.5.3 & 2.5.5.4)	Cabling	Sealed at well, not at chamber side wall
	Pipework	Sealed
	Well casing	Reasonable rust at casing-chamber connection. This may no longer be sealed
Any history of E. coli transgressions? Historical and current levels of total coliforms?		No E. coli transgressions have been recorded in the data received (dating back to 2012-13 FY). Total coliform levels are unknown
Sanitary well seal watertight or elevated 0.5m above 100 year flood level		No Some of the site is below the 50 year flood level and so there is the potential for flooding
Downward facing air vent 0.5m above 100 year flood level		Not installed
Type and condition of borehead pipework (above ground)		Minor surface rust
Raw Water sample port?		Yes, in chamber
Concrete apron sloped to drain away from well?		No
100mm step above ground level?		No
Signs of ponding?		Not at time of inspection

7. Actions Arising	
Identify issues and rank them in terms of whether they require:	
First Priority	<ul style="list-style-type: none"> ■ Seal cabling at chamber side wall ■ Ensure that casing-chamber connection is sealed ■ Check casing integrity, treat rust and seal chamber/floor ■ Install a sump pump (with a level sensor that alarms to an operator) ■ Install a downward facing air vent 0.5 m above 100 year flood level (unless the well is not located in a flood prone area)
Second Priority	<ul style="list-style-type: none"> ■ Modify sample tap so that it is either outside the chamber, or so that it contains a length of flexible hose that can be pulled outside the chamber when samples are collected ■ Form an apron with a fall away from the chamber ■ Install a downward facing air vent 0.5 m above 100 year flood level (unless the well is not located in a flood prone area) ■ DWA to confirm that a single check valve in the headworks meets the backflow prevention

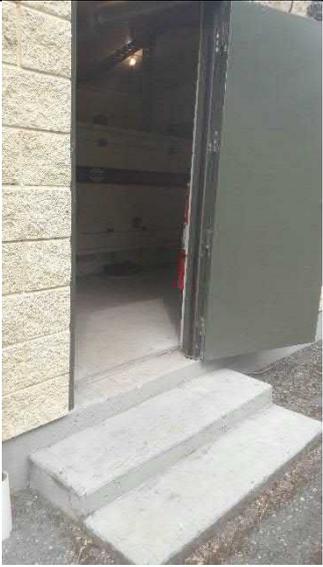
Step up into Brooklands Pump Station. Note that some of the site is below the 100 year flood level and so there is the potential for flooding

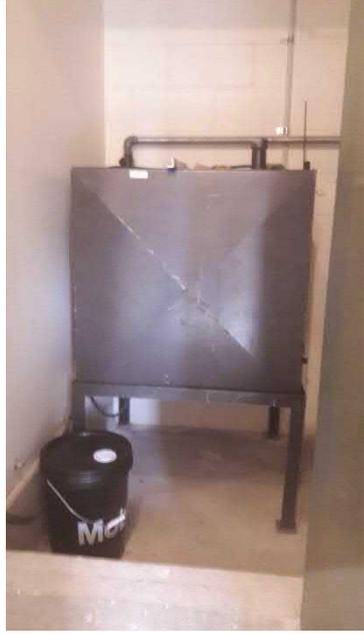
<p>Small diesel storage tank within a bund</p>

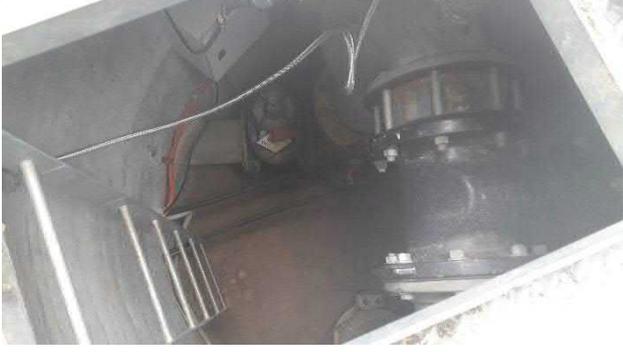
Deep chamber where access is not possible without meeting confined space requirements. Therefore, inspection was from above and by photo only.

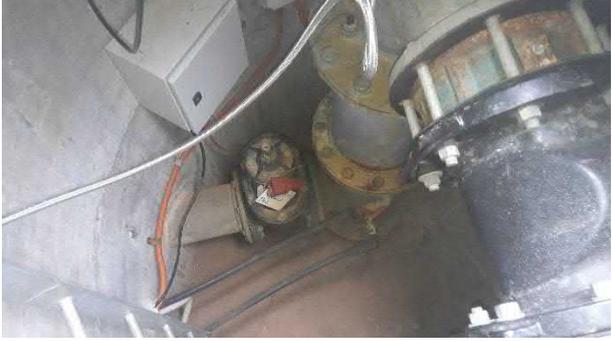
Cable glands appear sealed

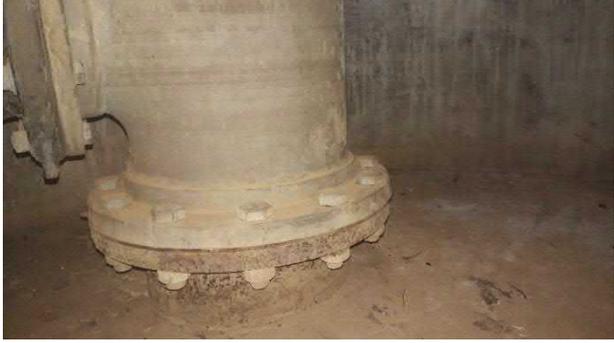
<p>Well casing appears to be sealed to the chamber floor from the photos collected</p>

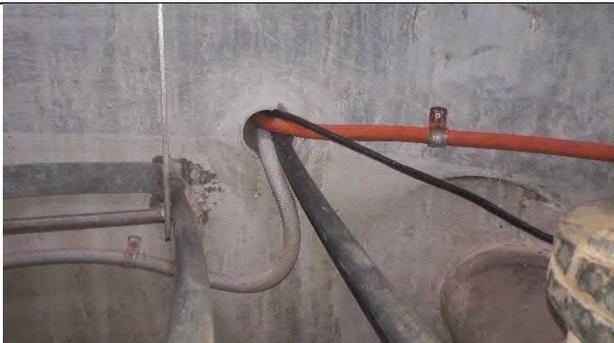
<p>Not obvious whether or not the cable penetrations through the chamber side wall are sealed</p>

a) Water Ingress:		
Condition of seals (see NZS:4411 2.5.5.3 & 2.5.5.4)	Cabling	Cabling appears sealed at bore entry but it is not clear if it is sealed at the wall penetration
	Pipework	Sealed with sidewall of chamber
	Well casing	Sealed with floor (from photos)
Any history of E. coli transgressions? Historical and current levels of total coliforms?		No E. coli transgressions recorded in the data received (dating back to 2012-13 FY). Total coliform levels are unknown
Sanitary well seal watertight or elevated 0.5m above 100 year flood level		No – casing is below ground level and the cabling penetrations through the wall may not be sealed Some of the site is below the 100 year flood level and so there is the potential for flooding
Downward facing air vent 0.5m above 100 year flood level		Not installed
Type and condition of borehead pipework (above ground)		Good condition
Raw Water sample port?		Yes, on the outside of the chamber in a cabinet

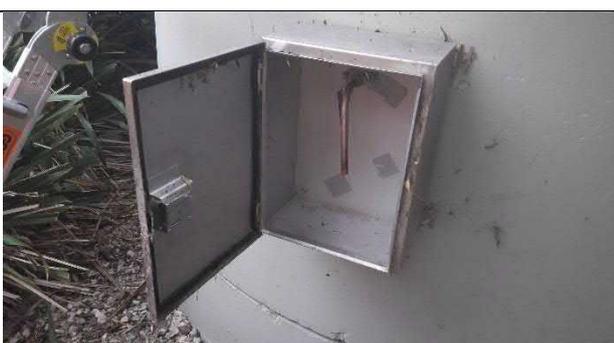
<p>Sample tap in cabinet on the outside of the chamber</p>

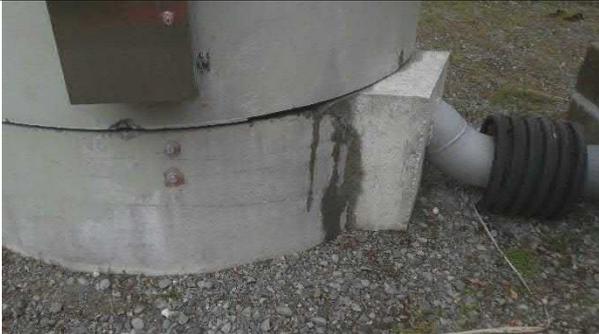
Signs of leaking from inside the chamber

a) Water Ingress:		
Condition of seals (see NZS:4411 2.5.5.3 & 2.5.5.4)	Cabling	Unknown
	Pipework	Unknown
	Well casing	Unknown
Any history of E. coli transgressions? Historical and current levels of total coliforms?	No E. coli transgressions recorded in the data received (dating back to 2012-13 FY). Total coliform levels are unknown	
Sanitary well seal watertight or elevated 0.5m above 100 year flood level	No – leaking from the chamber could be seen from the outside

First Priority	Second Priority	Third Priority	Ongoing
Well 2	<ul style="list-style-type: none"> ■ Ensure that safe access to the bore is available without bringing temporary equipment to site. This includes installation of a permeant ladder and railings ■ Re-inspect well once access is available ■ Seal leaks in chamber 			
All wells		<ul style="list-style-type: none"> ■ We consider a single check valve at the headworks meets the backflow prevention requirements. This should be confirmed with the DWA. ■ Grout seals must be retrofitted. Requirements will be based on how soon the well will be replaced (i.e. if the well is due for replacement within the next two years, then undertake grout sealing as part of new well construction), and the contamination risks in the immediate vicinity of the well. ■ Ensure that the WSP addresses contaminant sources and contaminant migration pathways. 	<ul style="list-style-type: none"> ■ For the as-built records, confirm backflow prevention on the well pump has been installed. 	<ul style="list-style-type: none"> ■ A sanitary inspection of the well should take place on a regular basis ■ Establish routine testing and verification of backflow prevention device

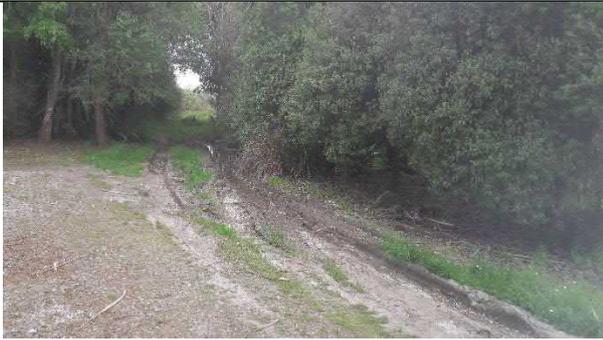
Evidence of ponding in the area

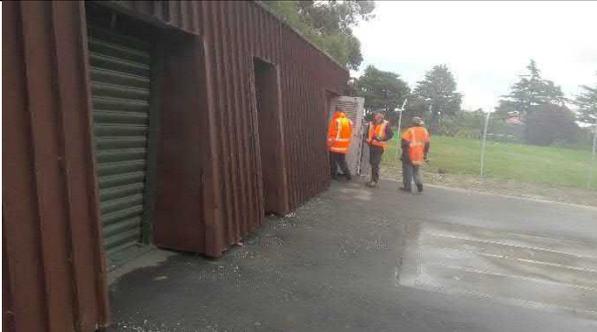
Pump station is within fenced area

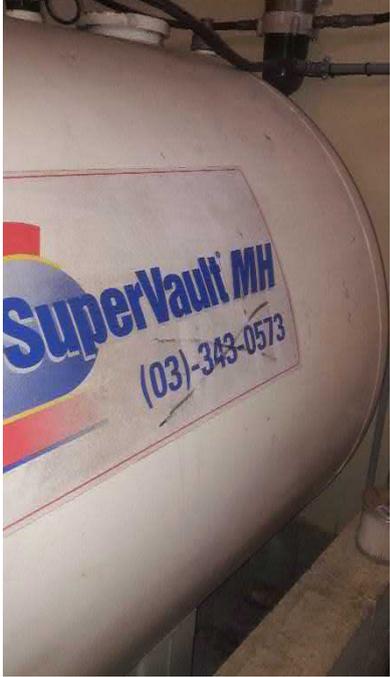
<p>Double skinned and banded diesel storage tank inside the pump station</p>

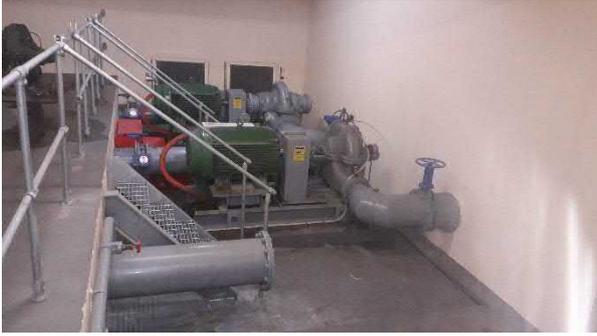
<p>Pump room (underground) Water leaking through the ceiling was noticed</p>

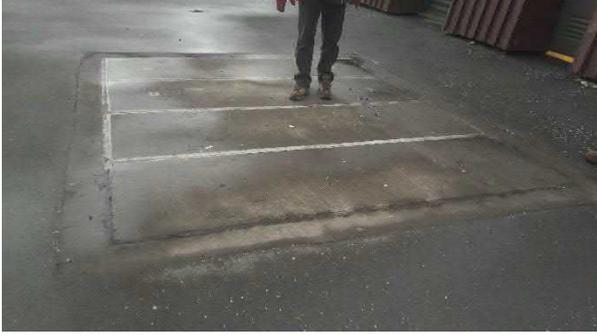
<p>Pump room access not sealed. Source of leaking into the pump room. This should be sealed.</p>		
<p>5. Risks from Surrounding Environment</p>			
<p>a) Within the site:</p>			
<p>Diesel/Chemical Storage</p>	<p>Yes</p>	<p><input type="checkbox"/> Underground <input checked="" type="checkbox"/> Aboveground</p>	<p>Fuel lines <input type="checkbox"/> Underground <input checked="" type="checkbox"/> Aboveground</p>
<p>Access by Animals</p>	<p>Fenced site and locked building</p>

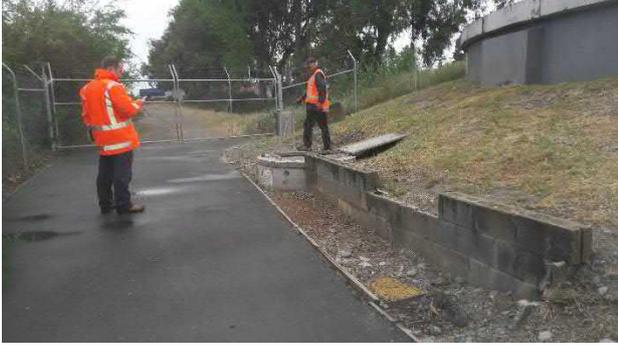
Well chamber is located adjacent to the pump station

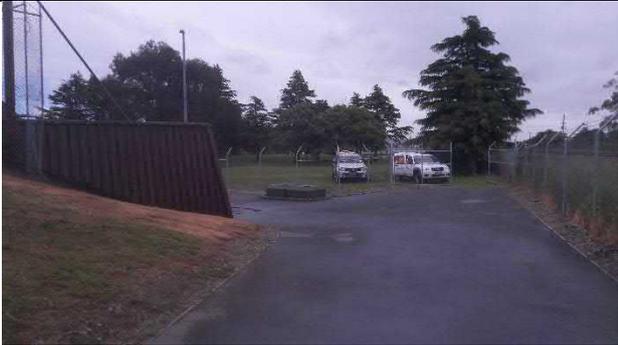
Well chamber is within a fenced area

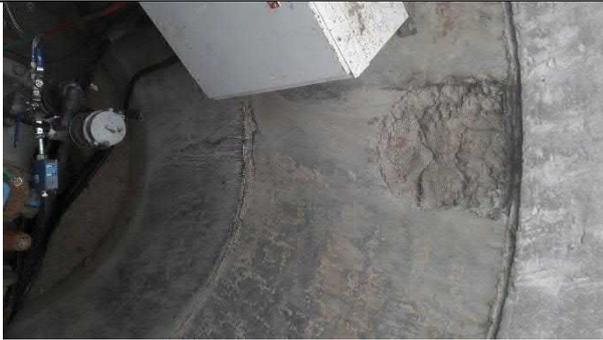
Some corrosion on the inside of the chamber. The source is unknown

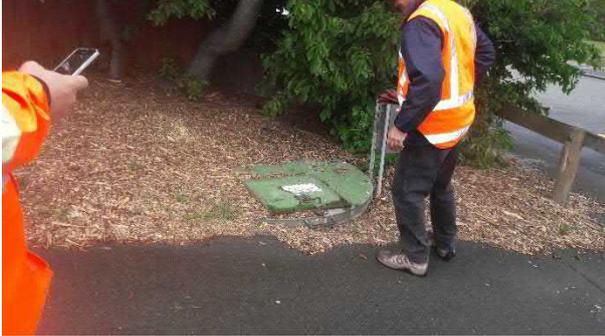
Well chamber lid flush with the ground and covered in bark and debris

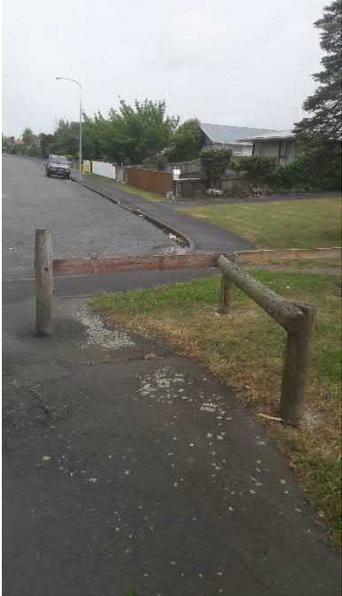
Well chamber is located on the edge of a park, close to the road

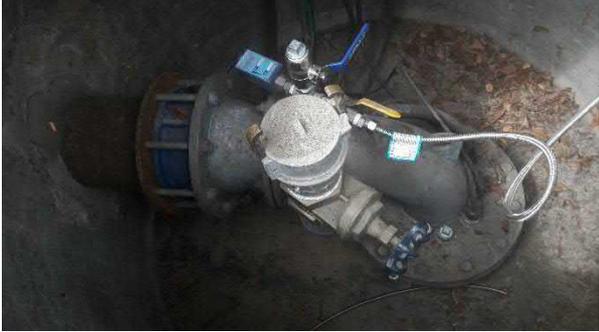
Bark can be seen in the bottom of the chamber

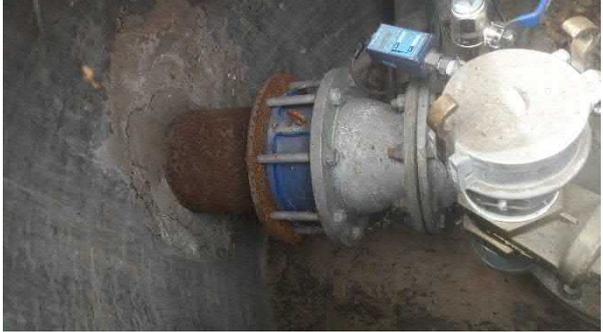
<p>Sealing on side entry to chamber has deteriorated</p>

<p>a) Water Ingress:</p>		
<p>Condition of seals (see NZS:4411 2.5.5.3 & 2.5.5.4)</p>	<p>Cabling</p>	<p>Sealed</p>
	<p>Pipework</p>	<p>Side entry to chamber not sealed</p>
	<p>Well casing</p>	<p>Sealed</p>
<p>Any history of E. coli transgressions?</p>		<p>20 distribution system E. coli transgressions have been recorded in the data received (dating back to</p>

Does the bore head meet the requirements of Criteria 2	No, see actions below
7. Actions Arising	
Identify issues and rank them in terms of whether they require:	
First Priority	<ul style="list-style-type: none"> ■ Seal side entry to chamber ■ Replace chamber lid so the chamber is protected from rainfall and runoff ■ Install a sump pump (with a level sensor that alarms to an operator) ■ Install a downward facing air vent 0.5 m above 100 year flood level (unless the well is not located in a flood prone area)
Second Priority	<ul style="list-style-type: none"> ■ We consider a single check valve at the headworks meets the backflow prevention requirements. This should be confirmed with the DWA. ■ Grout seals must be retrofitted. Requirements will be based on how soon the well will be replaced (i.e. if the well is due for replacement within the next two years, then undertake grout sealing as part of new well construction), and the contamination risks in the immediate vicinity of the well. ■ Ensure that the WSP addresses contaminant sources and contaminant migration pathways. ■ Address the risks associated with the below ground bore in the WSP. This includes treatment and raising above ground where practicable.

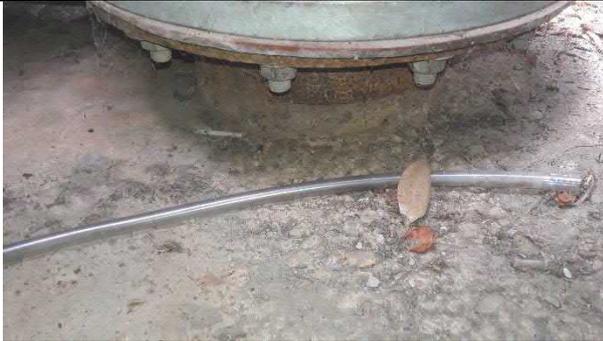
<p>Casing appears to be sealed to floor from photos</p>

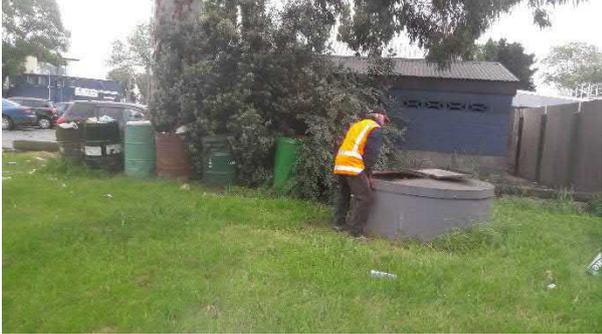
Well is located in a small park, adjacent to a car park, surrounded by trash

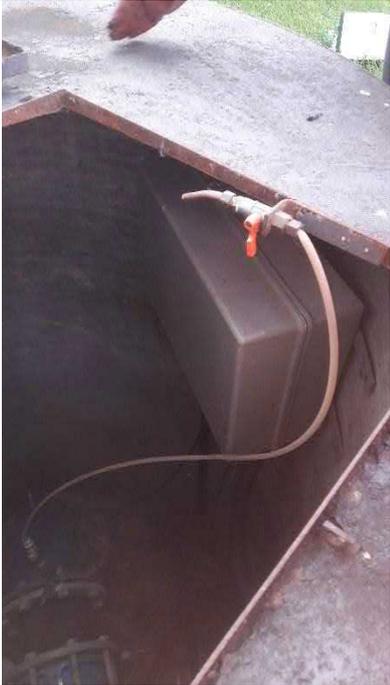
Sample tap is located in chamber

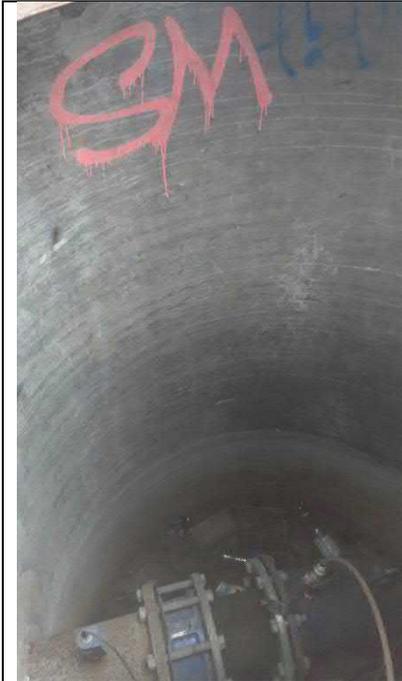
Graffiti in chamber implying that vandals have gained access

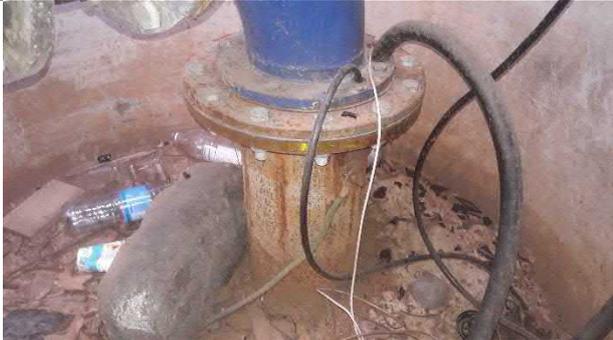
Trash and debris in the bottom of the chamber

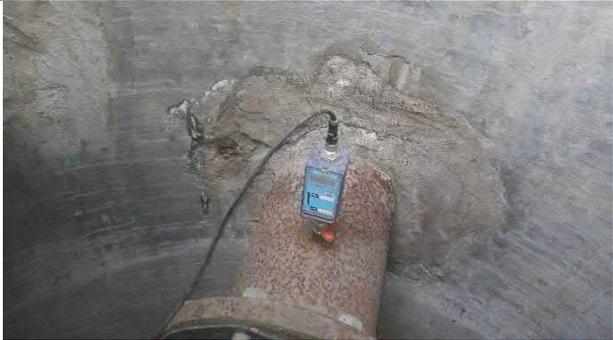
Rebar showing through the chamber wall

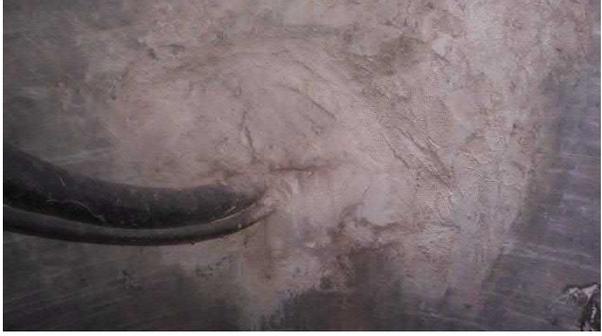
<p>Cable penetrations through wall are sealed</p>

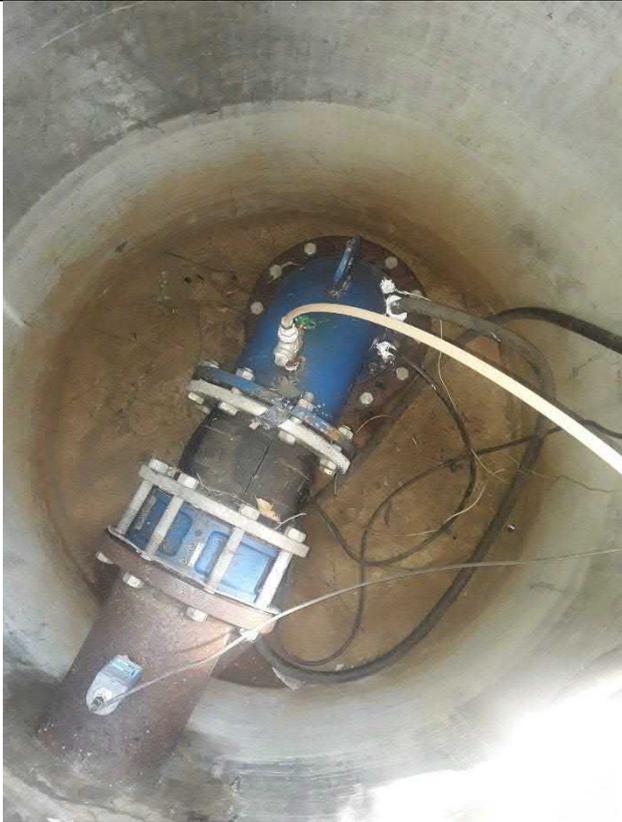
<p>Photo received 19 January 2018 following a clean-up of the well. The well chamber now appears clear of rubbish and debris, and the cable entry points into the well head appear to be sealed now.</p>

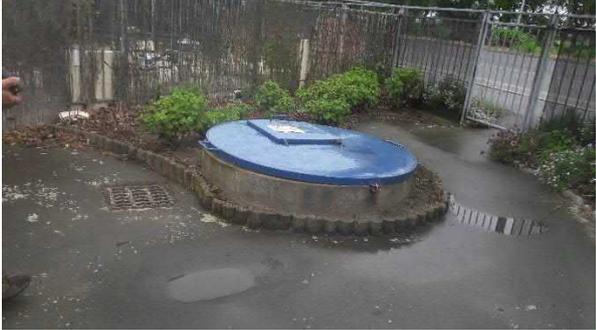
Well chamber within a partially fenced area, part of a residential community. Signs on ponding on footpath adjacent to well

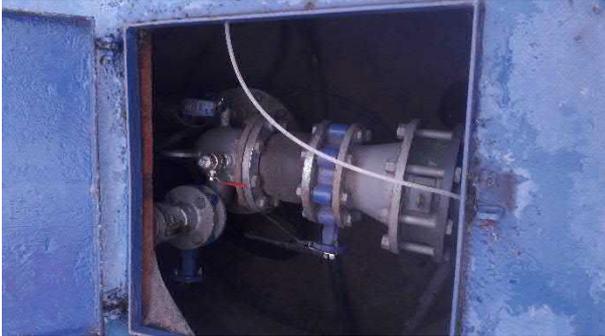
Pipework in reasonable condition

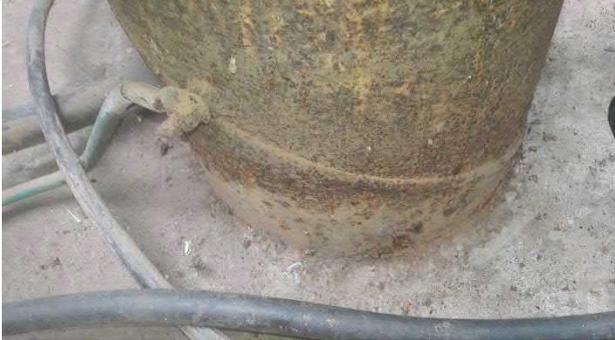
Casing sealed to chamber floor

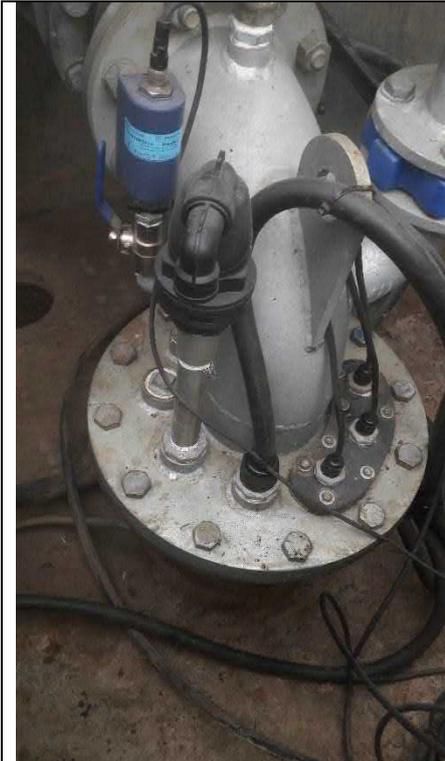
Cable glands sealed

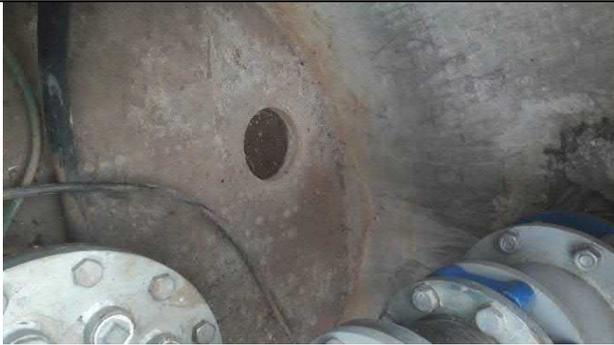
Sump without a sump pump installed

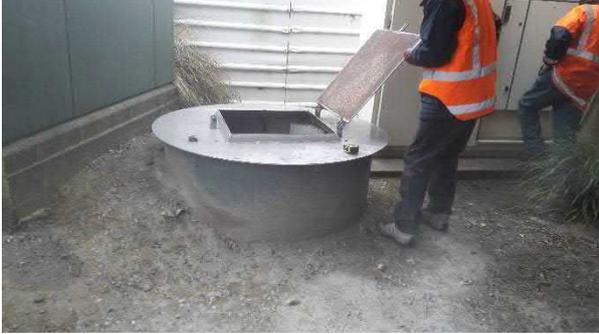
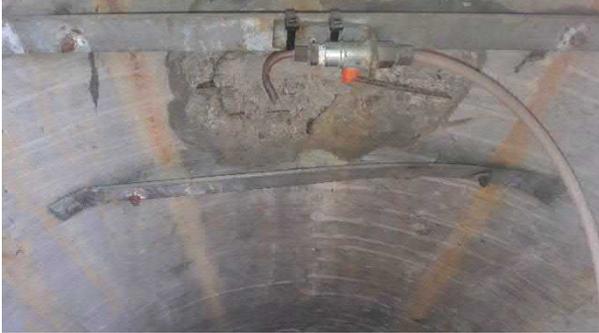
Sample tap drains into chamber. Some chamber corrosion behind sample tap.

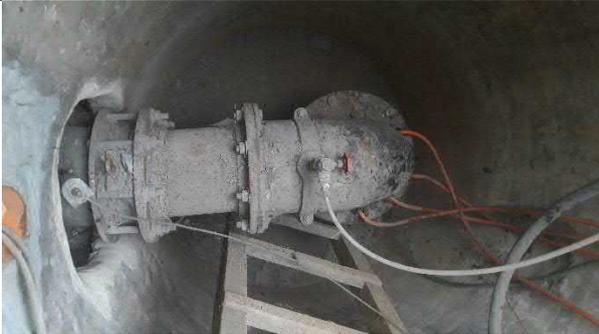
Pipe penetration through chamber wall not sealed. Dirt floor, not sealed

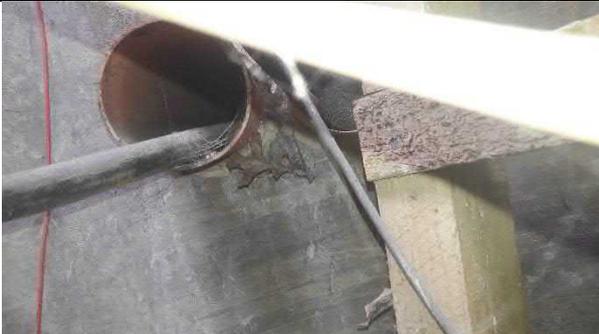
Cable penetration through chamber wall not sealed

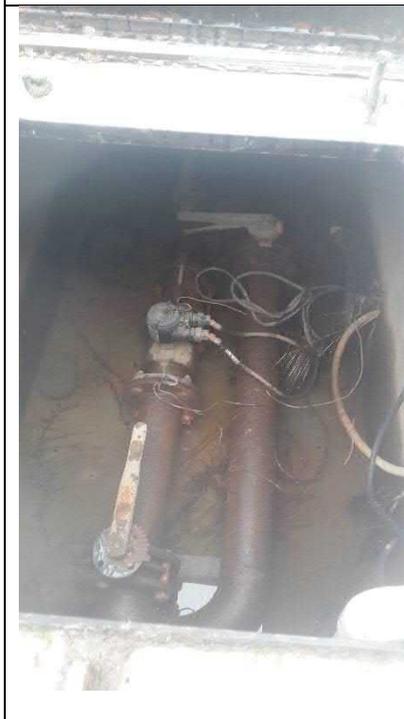
Flow meter in underground chamber with stagnant water and a sump pump.

About 50mm of water at the time of inspection. There has been up to 250-300mm in the past.

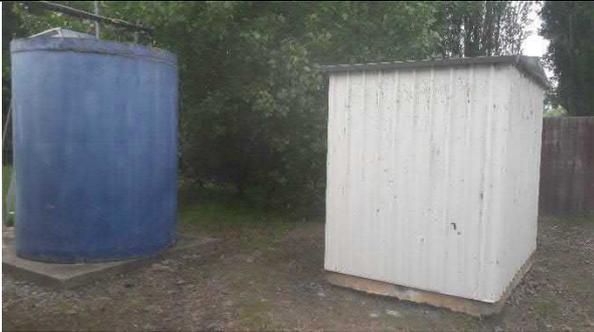
Above ground diesel storage tank adjacent to well shed

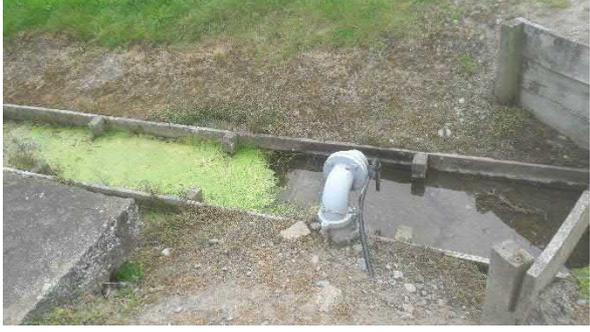
Stormwater collection drain with stagnant water			
5. Risks from Surrounding Environment				
a) Within the site:				
Diesel/Chemical Storage	2m from well	<input type="checkbox"/> Underground <input checked="" type="checkbox"/> Aboveground	Fuel lines	<input type="checkbox"/> Underground <input checked="" type="checkbox"/> Aboveground
Access by Animals	Locked site but low fence at road frontage Pump station door has an alarm			
Protection from vandalism, signs of vandalism	As above, no signs of vandalism			
Other Activities	N/A

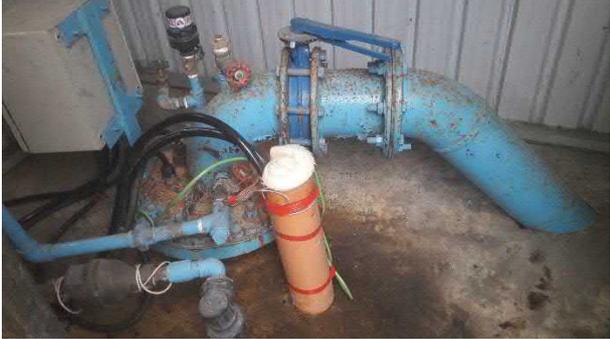
Concrete floor is flat and does not slope away from the casing. Water can be seen on the floor surrounding the casing

7. Actions Arising	
Identify issues and rank them in terms of whether they require:	
First Priority	<ul style="list-style-type: none"> ■ Seal casing and concrete in well shed ■ Regrade the land around the well-house to promote draining away from the well. ■ Regrade the concrete floor within the well-house to promote draining away from the casing ■ Tighten the connection on the cooling tube as this is likely causing a leak in the well-shed ■ Install a downward facing air vent 0.5 m above 100 year flood level (unless the well is not located in a flood prone area)
Second Priority	<ul style="list-style-type: none"> ■ Pipe and casing tidy ups including removing rust and peeling paint and resealing ■ Install backflow prevention device ■ Grout seals must be retrofitted. Requirements will be based on how soon the well will be replaced (i.e. if the well is due for replacement within the next two years, then undertake grout sealing as part of new well construction), and the contamination risks in the immediate vicinity of the well. ■ Ensure that the WSP addresses contaminant sources and contaminant migration pathways.

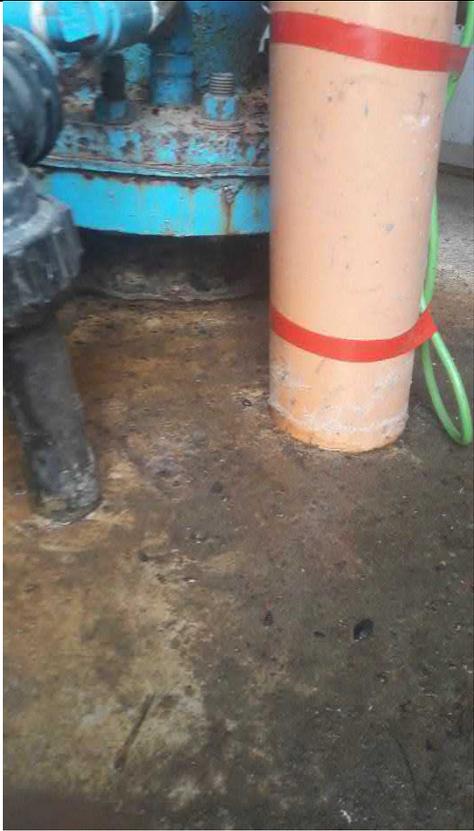
Well casing not sealed to concrete floor
5. Diagram with Well Measurements

a) Water Ingress:		
Condition of seals (see NZS:4411 2.5.5.3 & 2.5.5.4)	Cabling	Good seal
	Pipework	Good seal
	Well casing	Not sealed – 1-2mm gap around casing
Any history of E. coli transgressions? Historical and current levels of total coliforms?		No E. coli transgressions recorded in the data received (dating back to 2012-13 FY). Total coliform levels are unknown
Sanitary well seal watertight or elevated 0.5m above 100 year flood level		No – casing to floor not sealed Site is above the 100 year flood level and so flooding potential is low
Downward facing air vent 0.5m above 100 year flood level		Not installed
Type and condition of borehead pipework (above ground)		Some rust, peeling paint
Raw Water sample port?		Yes, on opposite side of building and on the wellhead
Concrete apron sloped to drain away from well?		No, floor flat and not sloped away from wellhead
100mm step above ground level?		Yes, ground has been dug away and directed to drain

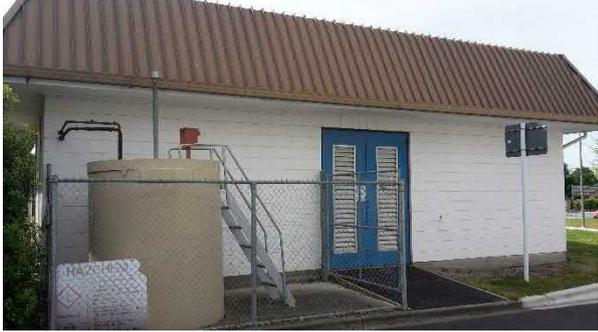
Above ground diesel storage tank outside the pump station

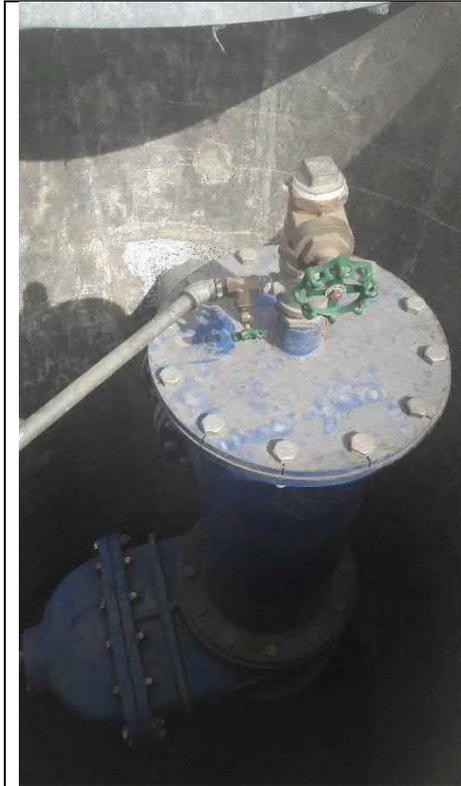
Pipework in reasonable condition

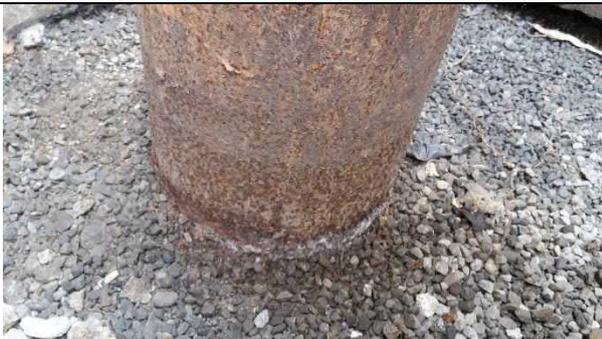
Surface rust on casing and pitting at the gravel level

Floor is gravel rather than concrete

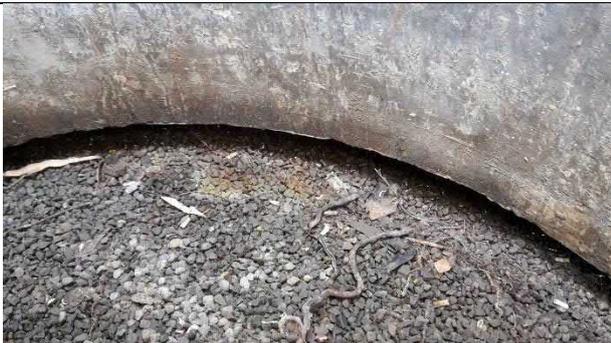
Chamber floor not sealed

a) Water Ingress:		
Condition of seals (see NZS:4411 2.5.5.3 & 2.5.5.4)	Cabling	None
	Pipework	May not be sealed
	Well casing	No concrete seal
Any history of E. coli transgressions?		No E. coli transgressions recorded in the data received (dating back to 2012-13 FY).

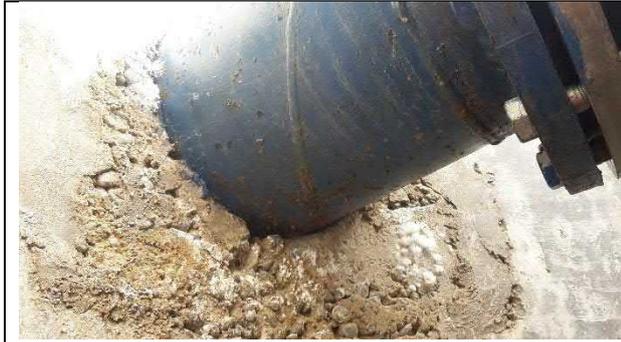
Chamber side wall may not be sealed

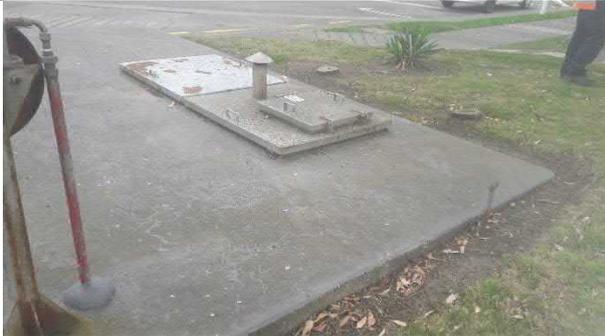
Old suction tank now disconnected

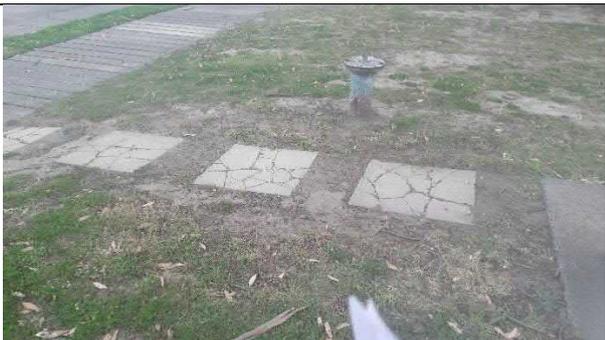
Old well nearby

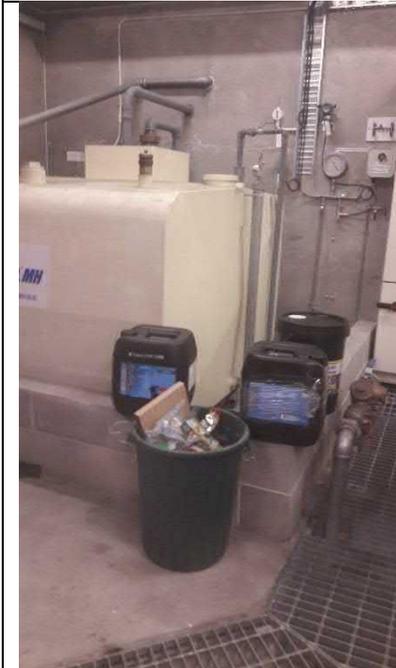
Diesel storage tank within a bunded area

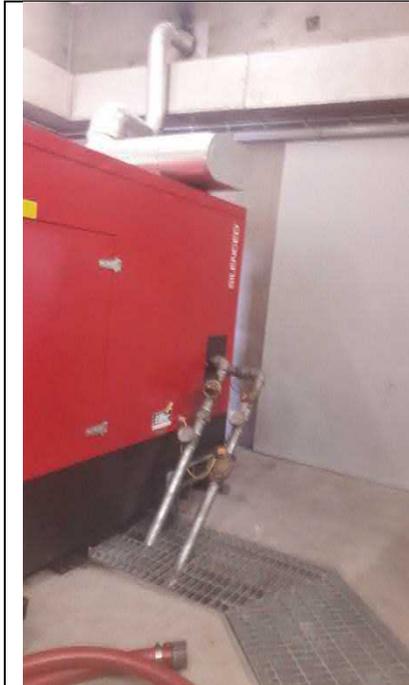
Diesel lines within bunded concrete channel with sump pump installed

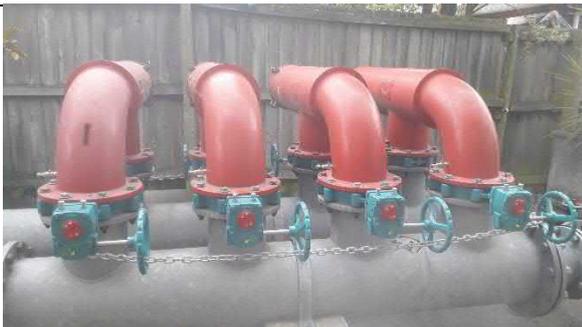
Four filters installed

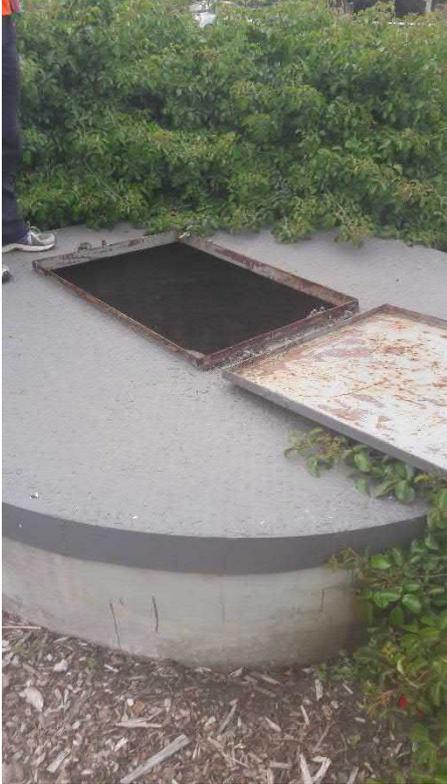
<p>Chamber is within a park and partially covered by vegetation</p>

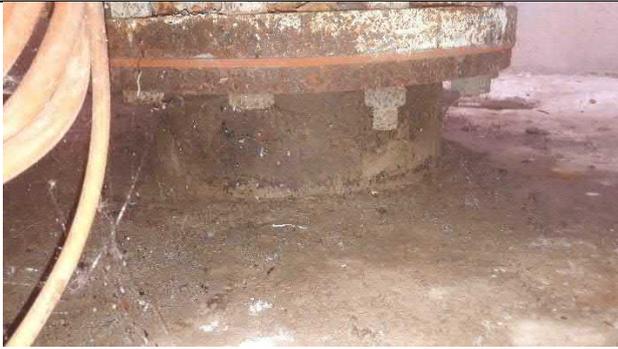
Casing appears to be sealed to chamber floor from photo.
