From: Official Information
Sent: Friday, 9 March 2018 4:54 p.m.
To: '██████████@fairfaxmedia.co.nz'
Subject: LGOIMA 18/029 response - wellheads material

- o Correspondence between the engineers who carried out the assessments of the wellheads, and Council staff members.
- **CityCare report** dated 22 December, concerning the assessment of the below ground wellheads, and the works undertaken as part of the project to repair the wellheads.

Christchurch City Council (CCC) commissioned CH2M Beca Ltd (CH2M Beca) to carry out a review of 25 water supply wells at 9 primary water supply pump stations against *Bore Water Security Criterion 2 (bore head must provide satisfactory protection)* of the Drinking Water Standards New Zealand 2005 (revised 2008) (DWSNZ). The scope of works included inspecting the bores and determining their compliance with Criterion 2, recommending upgrades to improve bore head protection and DWSNZ compliance, and summarising the findings with one report per water scheme. This report summarises the findings for the wells supplying Dunbars Pumping Station.

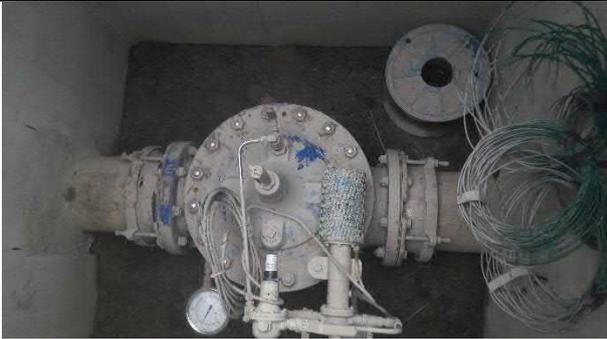
Valve chamber without a sealed floor

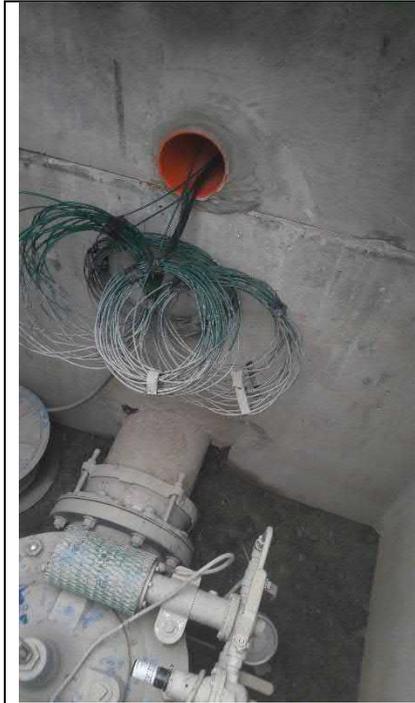
Cable penetration in valve chamber appear to be unsealed from photos. Chamber could not be accessed

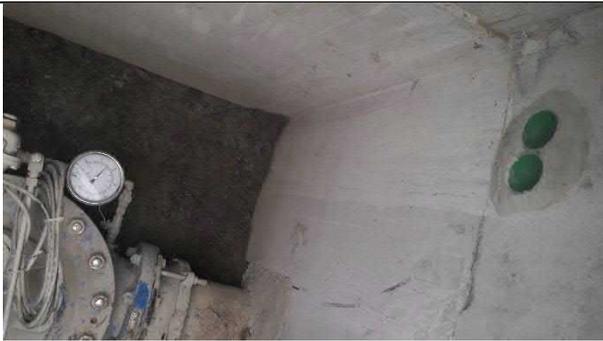
Unsealed holes in valve chamber

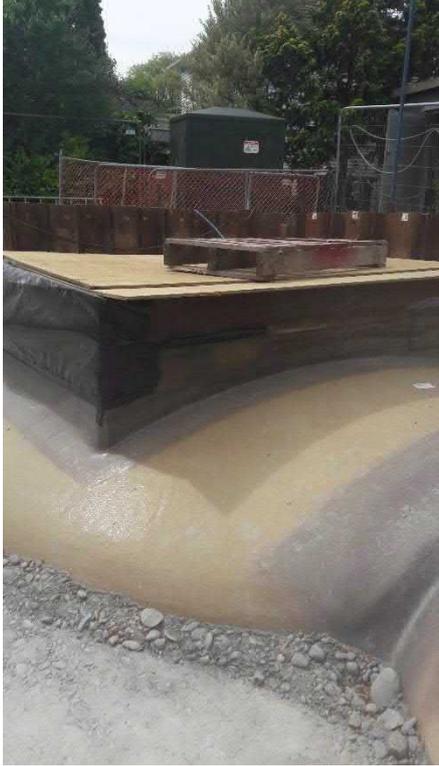
New wastewater wet well being installed within the park		
5. Risks from Surrounding Environment			
a) Within the site:			
Diesel/Chemical Storage	None	<input type="checkbox"/> Underground <input type="checkbox"/> Aboveground	Fuel lines <input type="checkbox"/> Underground <input type="checkbox"/> Aboveground
Access by Animals	Usually not a fenced site, within a park. However at the time of inspection the park was closed and the area was fenced off for construction works. Locked building.		
Protection from vandalism, signs of vandalism	As above, no signs of vandalism		
Other Activities	N/A		
b) Immediate Neighbouring Land Use:			
Current Neighbouring Land Use	Park		
Significant Changes Since Previous Inspection	None identified		
Zoning of Neighbouring Land	Open Space Community Parks Zone, Residential Suburban Density Transition Zone		
c) Wider Environment:

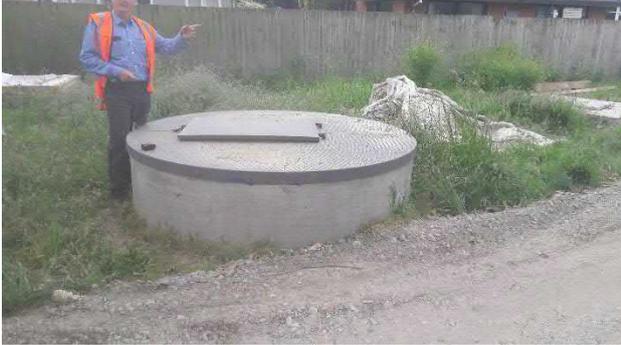
Well chamber is located on the side of the road within a park. Park was closed due to construction works at the time of inspection. Site grading does not promote the flow of water away from the chamber.

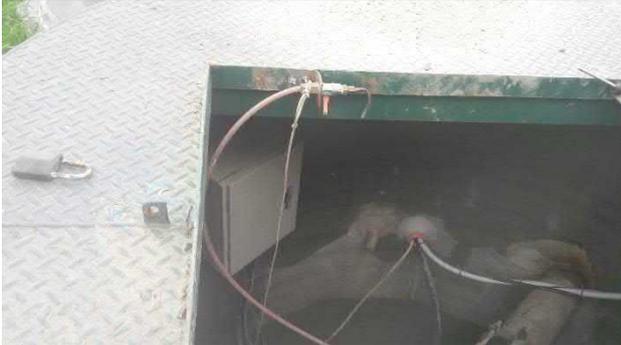
Sample tap drains into chamber.

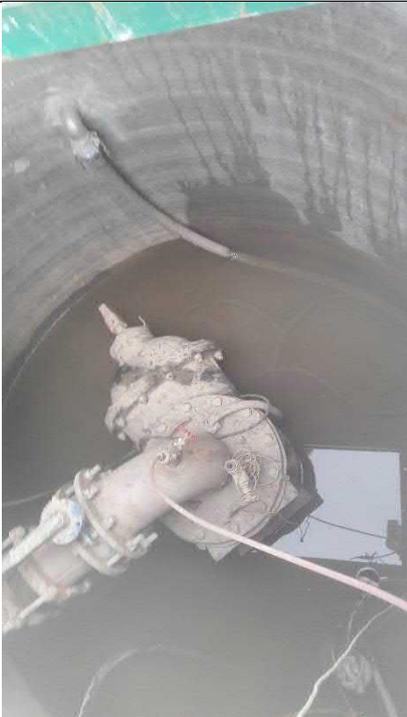
Water in the bottom of the chamber (~170mm) which may be from the sample tap, the ducts, from a hole behind the electrical cable, lid or chamber floor. It is possible that the nearby construction work has had an effect on this.

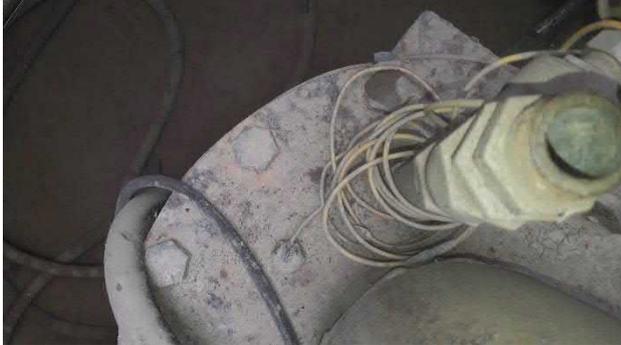
<p>Cable glands may not be sealed</p>
--	---------------------------------------

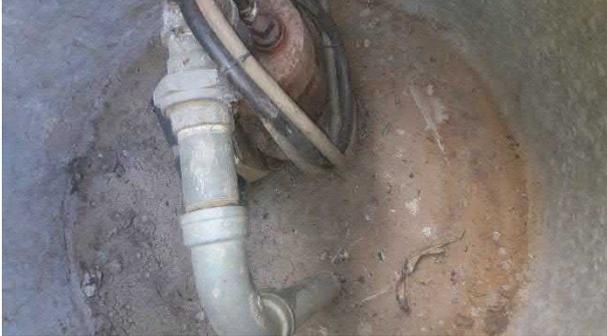
200mm casing and bore head. Headworks is rusty (especially cap)

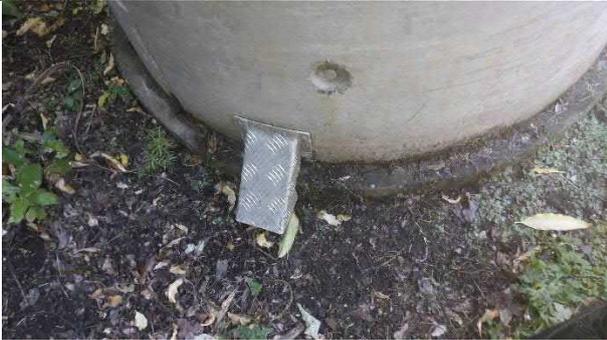
Drain on chamber, no mesh for vermin control

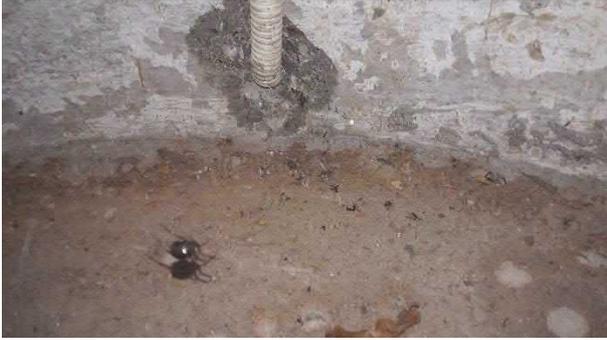
Cable penetration through wall not sealed

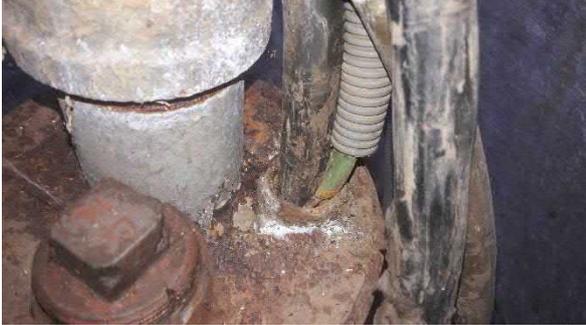
Cable gland not sealed

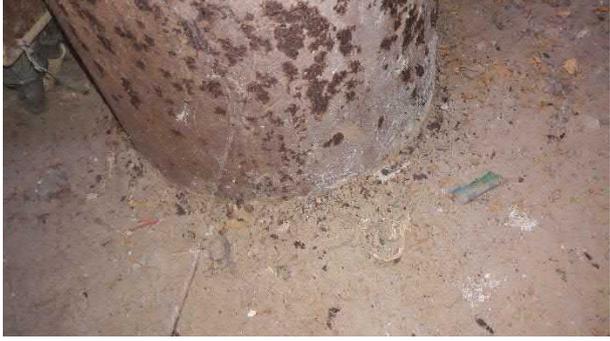
<p>Well casing has some surface rust. Appears to be sealed with chamber floor</p>

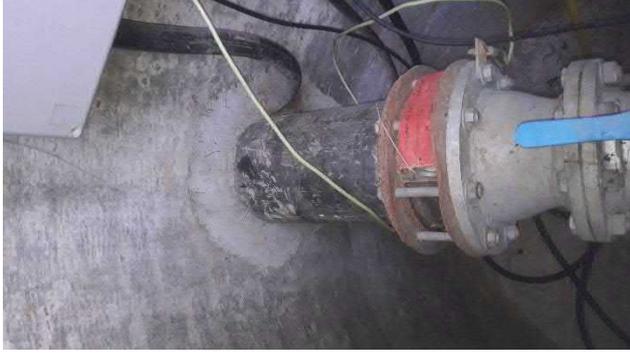
<p>Pipe penetration through chamber wall is sealed</p>

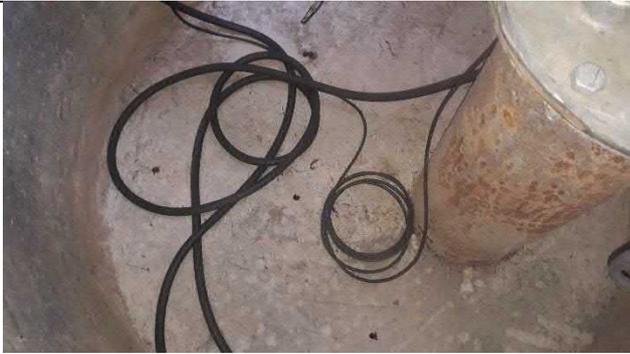
<p>Casing approximately 1m above the chamber floor. Casing appears to be sealed to chamber from photos taken. Chamber could not be entered</p>

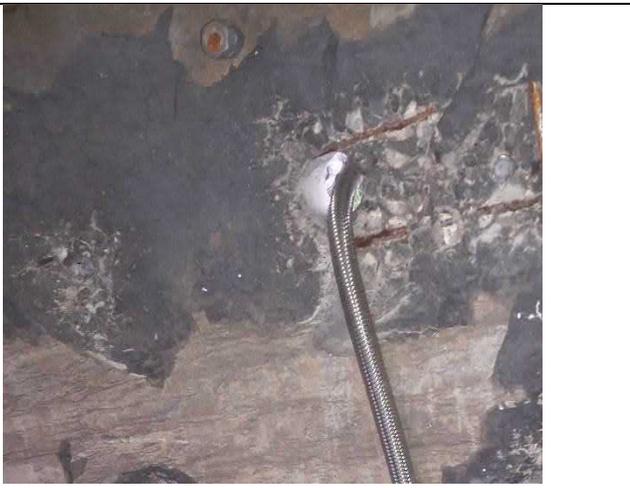
<p>Cable entry to chamber not sealed</p>
<p>5. Diagram with Well Measurements</p>

a) Water Ingress:		
Condition of seals (see NZS:4411 2.5.5.3 & 2.5.5.4)	Cabling	Sealed at casing entry but not at chamber wall
	Pipework	Sealed with chamber wall
	Well casing	Sealed with chamber floor
Any history of E. coli transgressions? Historical and current levels of total coliforms?	Only distribution system E. coli transgressions have been recorded in the data received (dating back to 2012-13 FY). No transgressions have been recorded at the well in this data Total coliform levels are unknown	
Sanitary well seal watertight or elevated 0.5m above 100 year flood level	No – cabling entry at chamber wall not sealed Some of the site is below the 50 year flood level and so there is the potential for flooding	
Downward facing air vent 0.5m above 100 year flood level	Not installed	
Type and condition of borehead pipework (above ground)	Good condition	
Raw Water sample port?	Yes, in cabinet next to chamber

First Priority	Second Priority	Third Priority	Ongoing
Well 1	<ul style="list-style-type: none"> ■ Seal cable penetration through chamber 			
Well 2	<ul style="list-style-type: none"> ■ Check that the cable entries are sealed and seal if required ■ Seal side entry points to chamber 	<ul style="list-style-type: none"> ■ Modify sample tap so that it is either outside the chamber, or so that it contains a length of flexible hose that can be pulled outside the chamber when samples are collected ■ Tidy up well casing including removing rust from above ground area 		
Well 3	<ul style="list-style-type: none"> ■ Locate source of leak and seal. ■ Seal cable entry points ■ Seal water supply pipe and sample tap pipe entry points to chamber 			
Well 4	<ul style="list-style-type: none"> ■ Seal pipework with side chamber wall. ■ Seal cable entry points 	<ul style="list-style-type: none"> ■ Modify sample tap so that it is either outside the chamber, or so that it contains a length of flexible hose that can be pulled outside the chamber when samples are collected

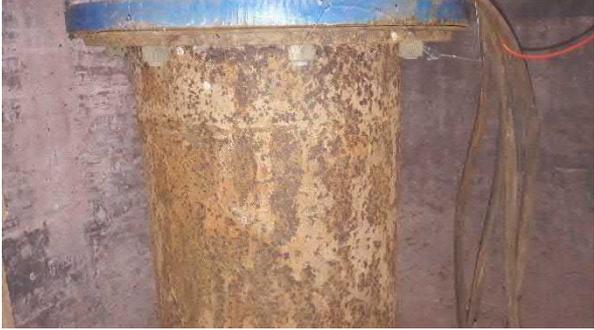
<p>Casing condition – some surface rust</p>

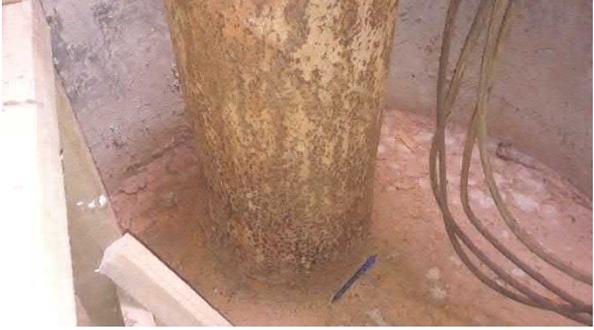
<p>Casing and chamber connection appears to be sealed from photos although the chamber could not be entered.</p>

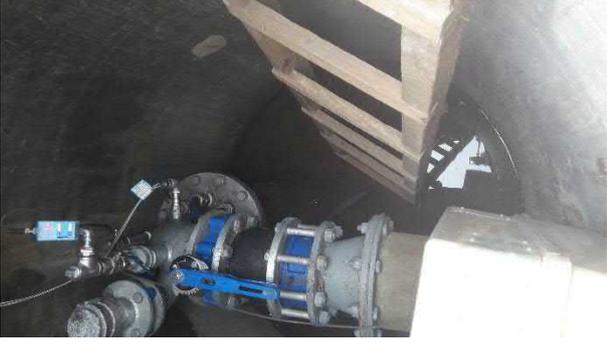
<p>Approximately 20 mm of water in the bottom of the chamber</p>

7. Actions Arising		
Identify issues and rank them in terms of whether they require:		
First Priority	<ul style="list-style-type: none"> ■ Locate source of leak and seal. ■ Seal cable entry points ■ Seal water supply pipe and sample tap pipe entry points to chamber

<ul style="list-style-type: none"> ■ Install a sump pump (with a level sensor that alarms to an operator) ■ Install a downward facing air vent 0.5 m above 100 year flood level (unless the well is not located in a flood prone area)
Second Priority	<ul style="list-style-type: none"> ■ We consider a single check valve at the headworks meets the backflow prevention requirements. This should be confirmed with the DWA. ■ Grout seals must be retrofitted. Requirements will be based on how soon the well will be replaced (i.e. if the well is due for replacement within the next two years, then undertake grout sealing as part of new well construction), and the contamination risks in the immediate vicinity of the well. ■ Address the risks associated with the below ground bore in the WSP. This includes treatment and raising above ground where practicable. ■ Ensure that the WSP addresses contaminant sources and contaminant migration pathways.

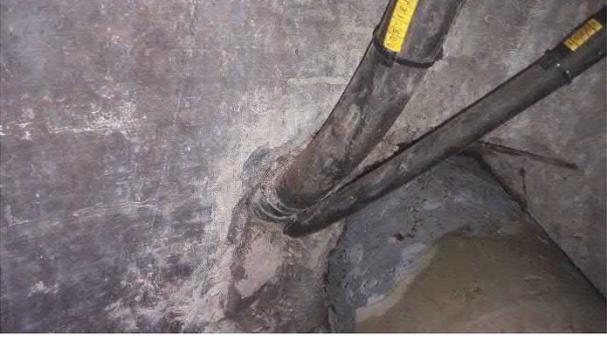
<p>Chamber penetrations appear to be sealed</p>

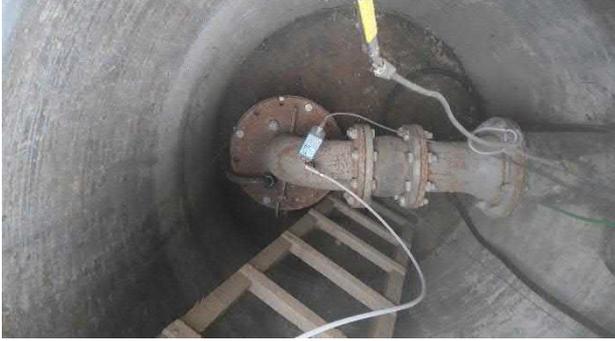
<p>Bore head – pipe glands not sealed</p>

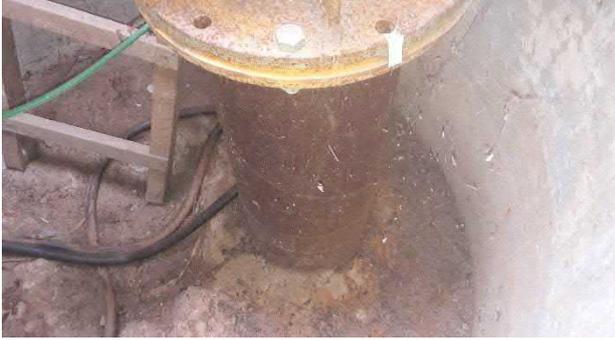
<p>Casing in reasonable condition with some rust</p>

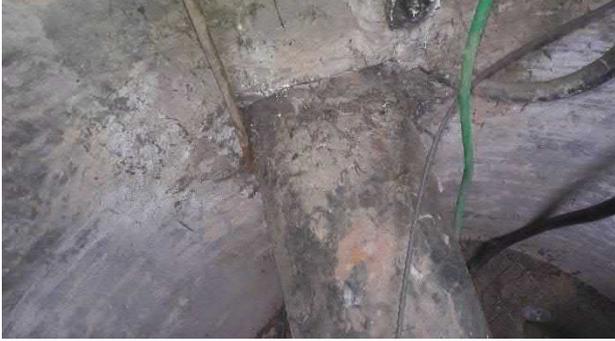
<p>Pipe to wall entry not sealed</p>

a) Water Ingress:		
Condition of seals (see NZS:4411 2.5.5.3 & 2.5.5.4)	Cabling	Power cable joint not sealed
	Pipework	Not sealed with sidewall of chamber
	Well casing	Sealed
Any history of E. coli transgressions? Historical and current levels of total coliforms?	Only distribution system E. coli transgressions have been recorded in the data received (dating back to 2012-13 FY). No transgressions have been recorded at the well in this data Total coliform levels are unknown	
Sanitary well seal watertight or elevated 0.5m above 100 year flood level	No Site is above the 50 year flood level and so flooding potential is low	
Downward facing air vent 0.5m above 100 year flood level	Not installed	
Type and condition of borehead pipework (above ground)	Steel, reasonable condition	
Raw Water sample port?	Yes, in chamber	
Concrete apron sloped to drain away from well?	No

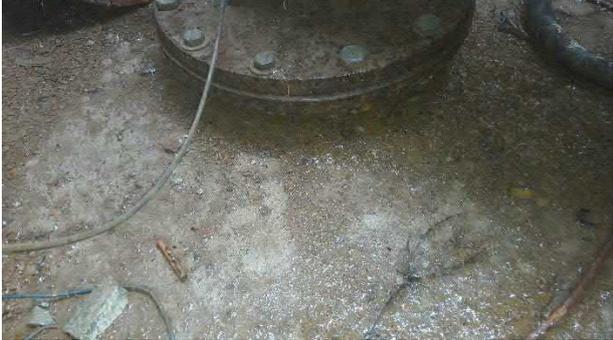
<p>Well chamber floor. Casing to floor connection could not be viewed as the chamber could not be accessed.</p>

Well 5	<ul style="list-style-type: none"> ■ Seal casing to chamber floor if required (could not be accessed during visit) ■ Seal cable entry points to the bore and at the chamber wall ■ Install backflow prevention device 	<ul style="list-style-type: none"> ■ Modify sample tap so that it is either outside the chamber, or so that it contains a length of flexible hose that can be pulled outside the chamber when samples are collected ■ Rust removal and prevention for the pipework and casing

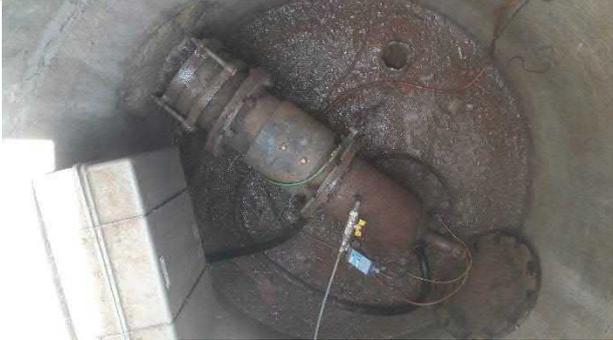
<p>Pipework is rusty Chamber floor appears to be damp but on closer inspection it was found that sparkling spider webs cause the damp look.</p>

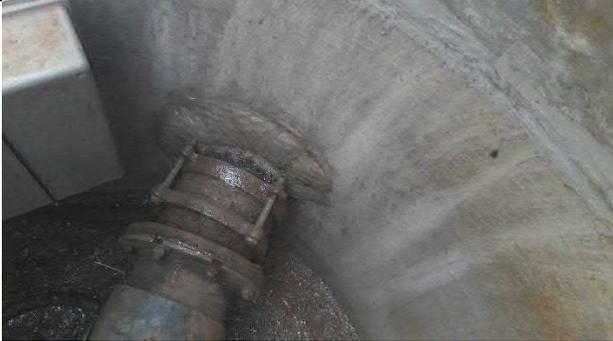
<p>Pipework to chamber sidewall connection appears to be sealed.</p>

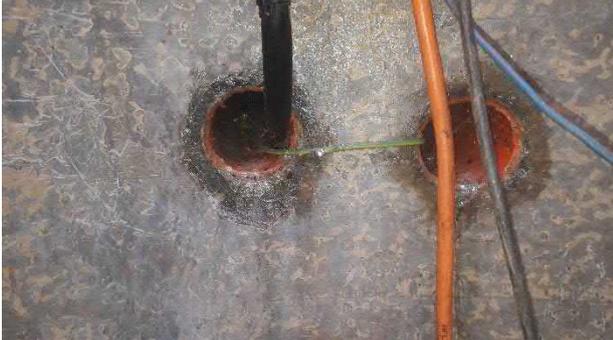
<p>Cable penetrations through the chamber sidewall are not sealed</p>

a) Water Ingress:		
Condition of seals (see NZS:4411 2.5.5.3 & 2.5.5.4)	Cabling	Cable entry not sealed
	Pipework	Sealed with sidewall of chamber
	Well casing	Cannot be seen as the chamber cannot be accessed
Any history of E. coli transgressions? Historical and current levels of total coliforms?		Only distribution system E. coli transgressions have been recorded in the data received (dating back to 2012-13 FY). No transgressions have been recorded at the well in this data Total coliform levels are unknown
Sanitary well seal watertight or elevated 0.5m above 100 year flood level		No
Downward facing air vent 0.5m above 100 year flood level		Not installed
Type and condition of borehead pipework (above ground)		Rusty pipework
Raw Water sample port?		Yes, in chamber
Concrete apron sloped to drain away from well?		No
100mm step above ground level?		Yes
Signs of ponding?		Yes
