HARLEY CHAMBERS

**137 CAMBRIDGE TERRACE
CHRISTCHURCH**

HERITAGE IMPACT ASSESSMENT

Report Prepared by
SMART ALLIANCES LTD
for
LEE PEE LTD

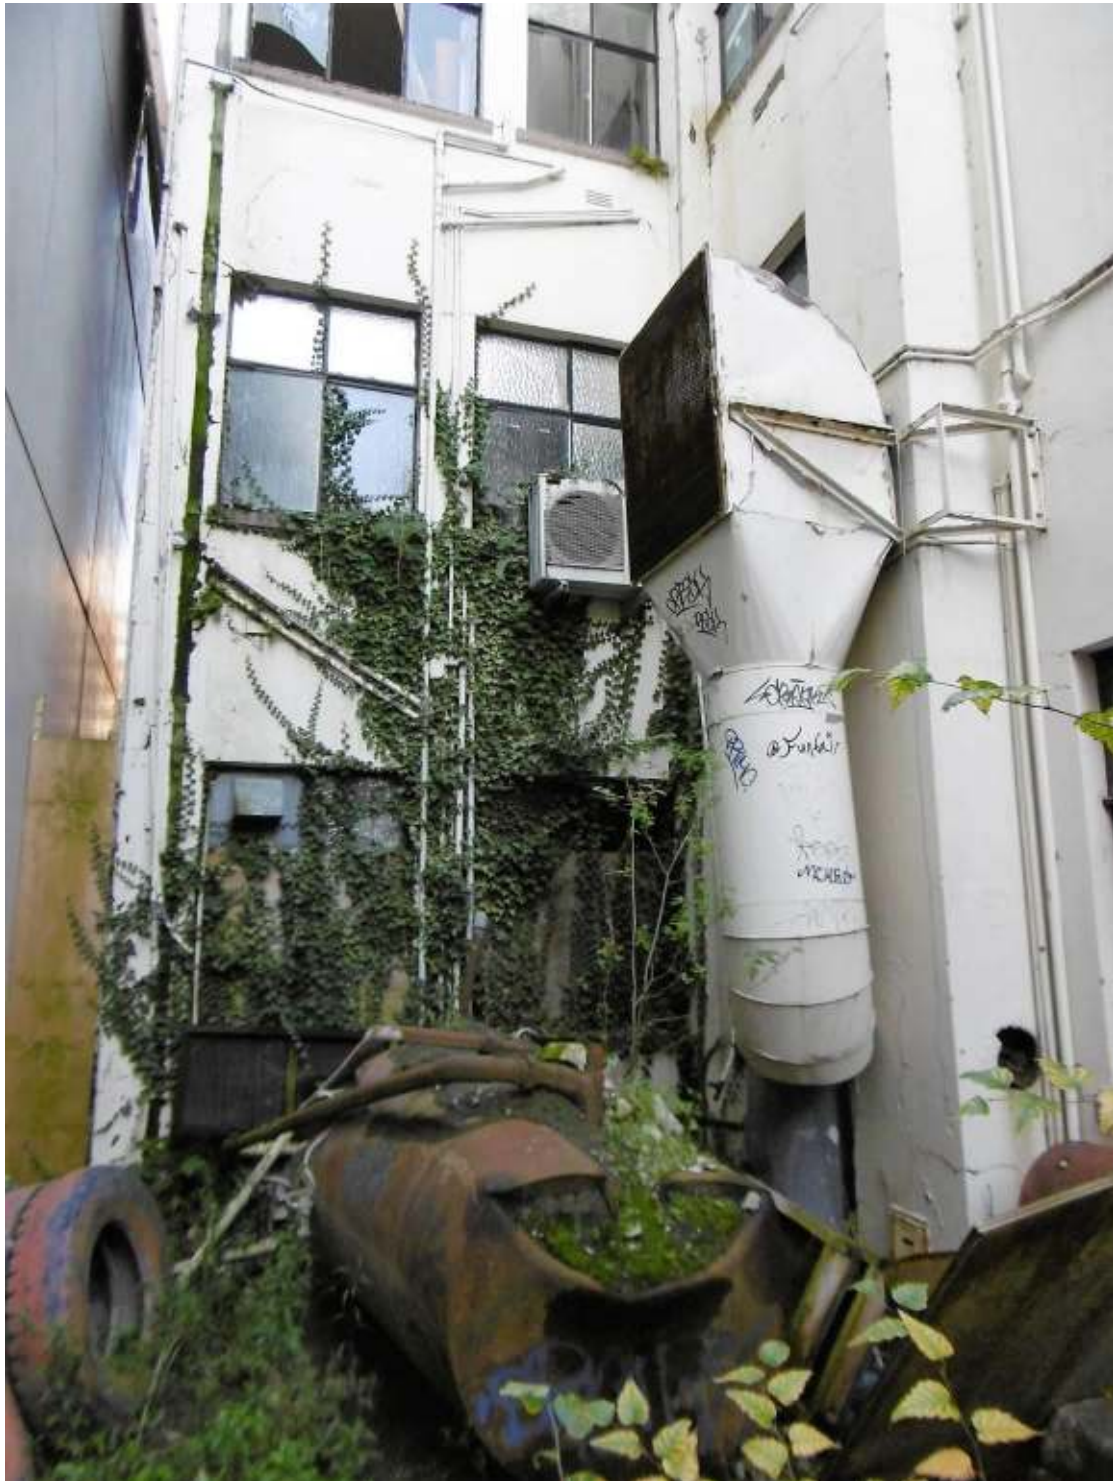
END OF NORTH ELEVATION, SHOWING REDUNDANT MECHANICAL EQUIPMENT WHICH WAS PROBABLY PART OF THE INOVATIVE PLANT ORIGINALLY FITTED TO THIS BUILDING

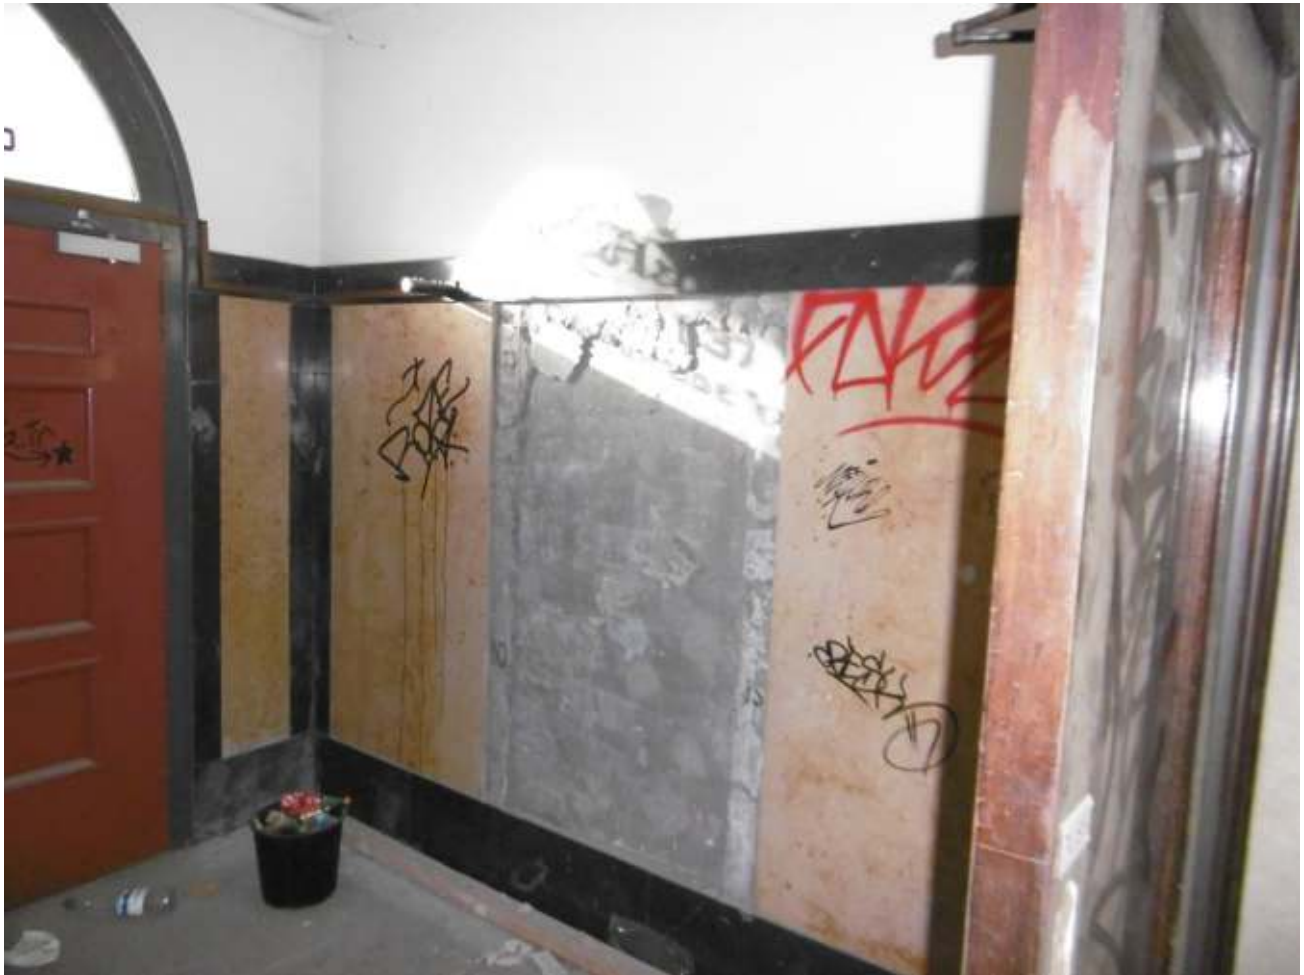
THE MISSING MARBLE PANEL FROM THE FOYER WALL IS STILL WITHIN THE BUILDING

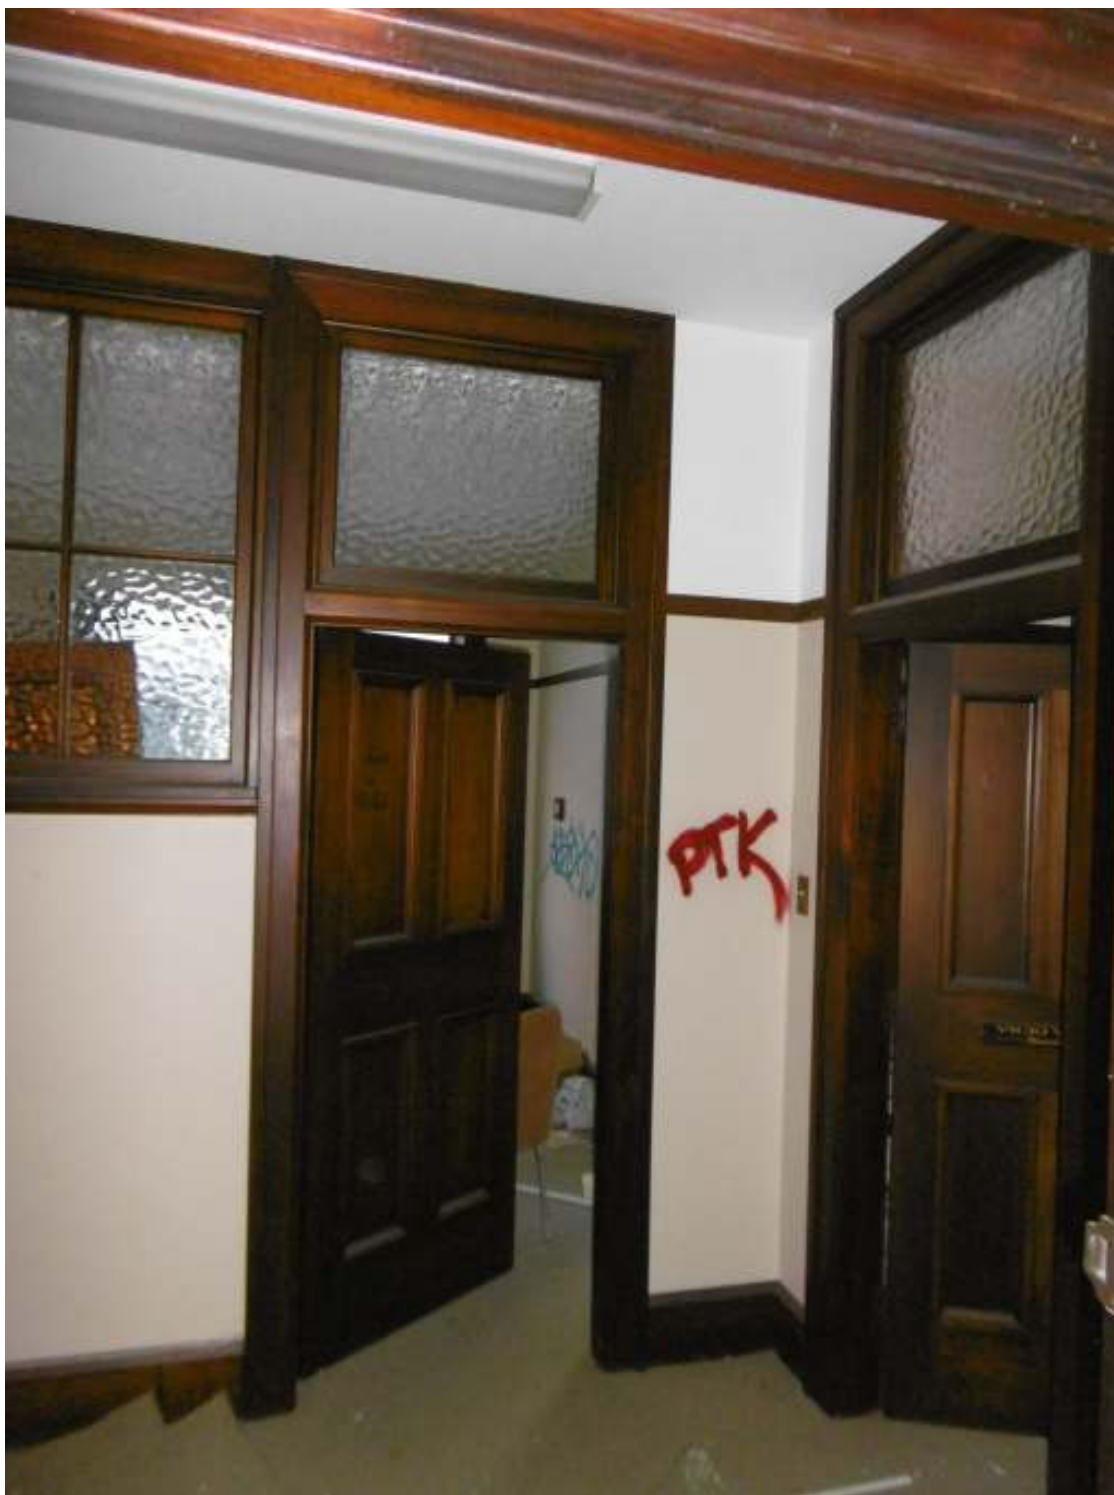
ORIGINAL FIRST FLOOR DOORS, FRAMES AND BORROWED LIGHTS WHICH REMAIN IN GOOD CONDITION

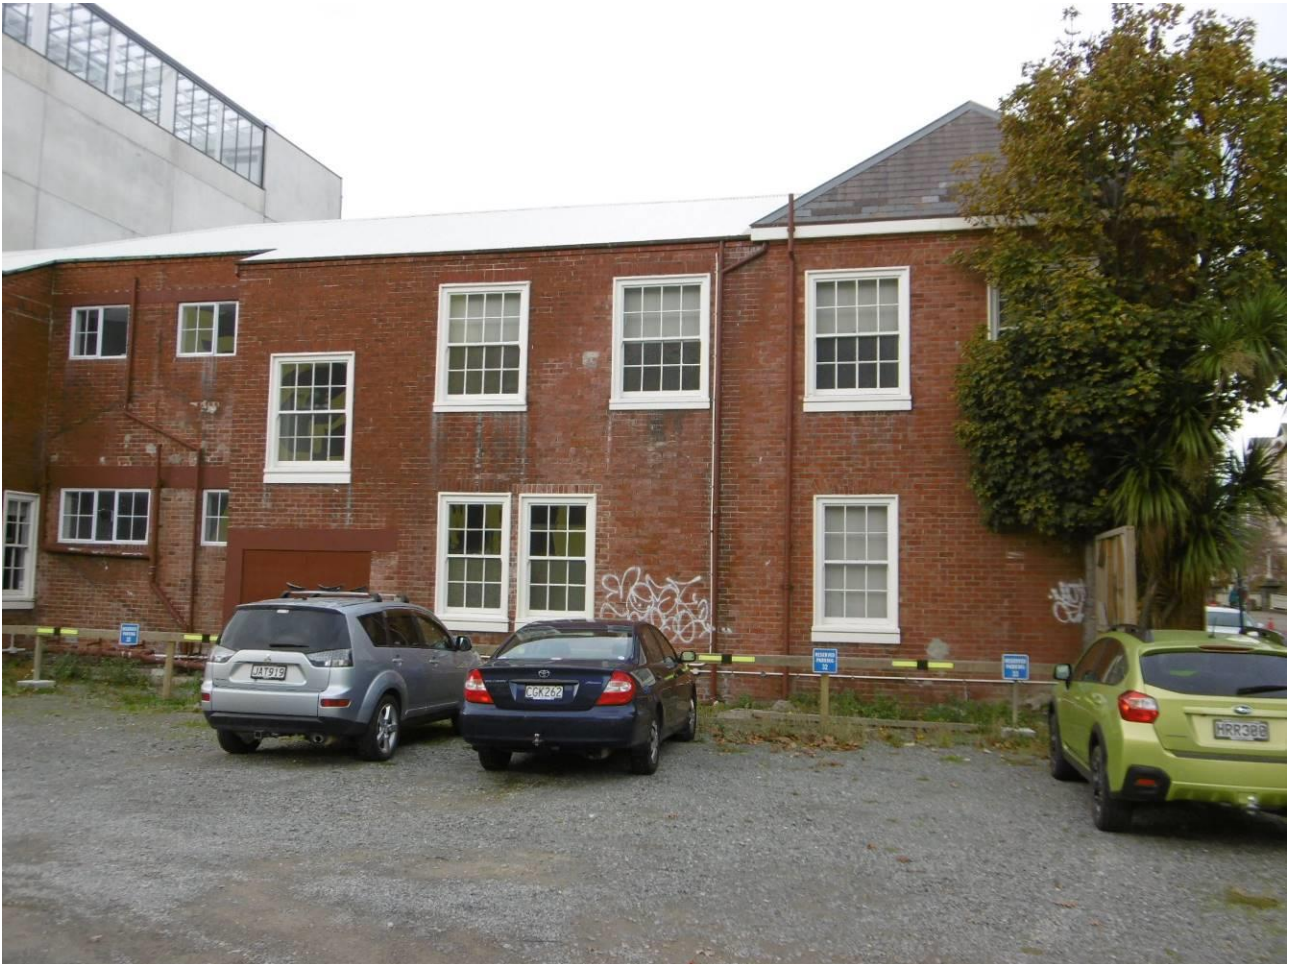
FRONT SECTION, WEST ELEVATION. OPTION A RETENTION IS FROM THE FRONT BACK TO THE LEFT HAND SIDE OF THE SLATE ROOF; AND OPTION B RETENTION IS FROM THE FRONT BACK TO THE LEFT HAND SIDE OF THE SILVER CAR.

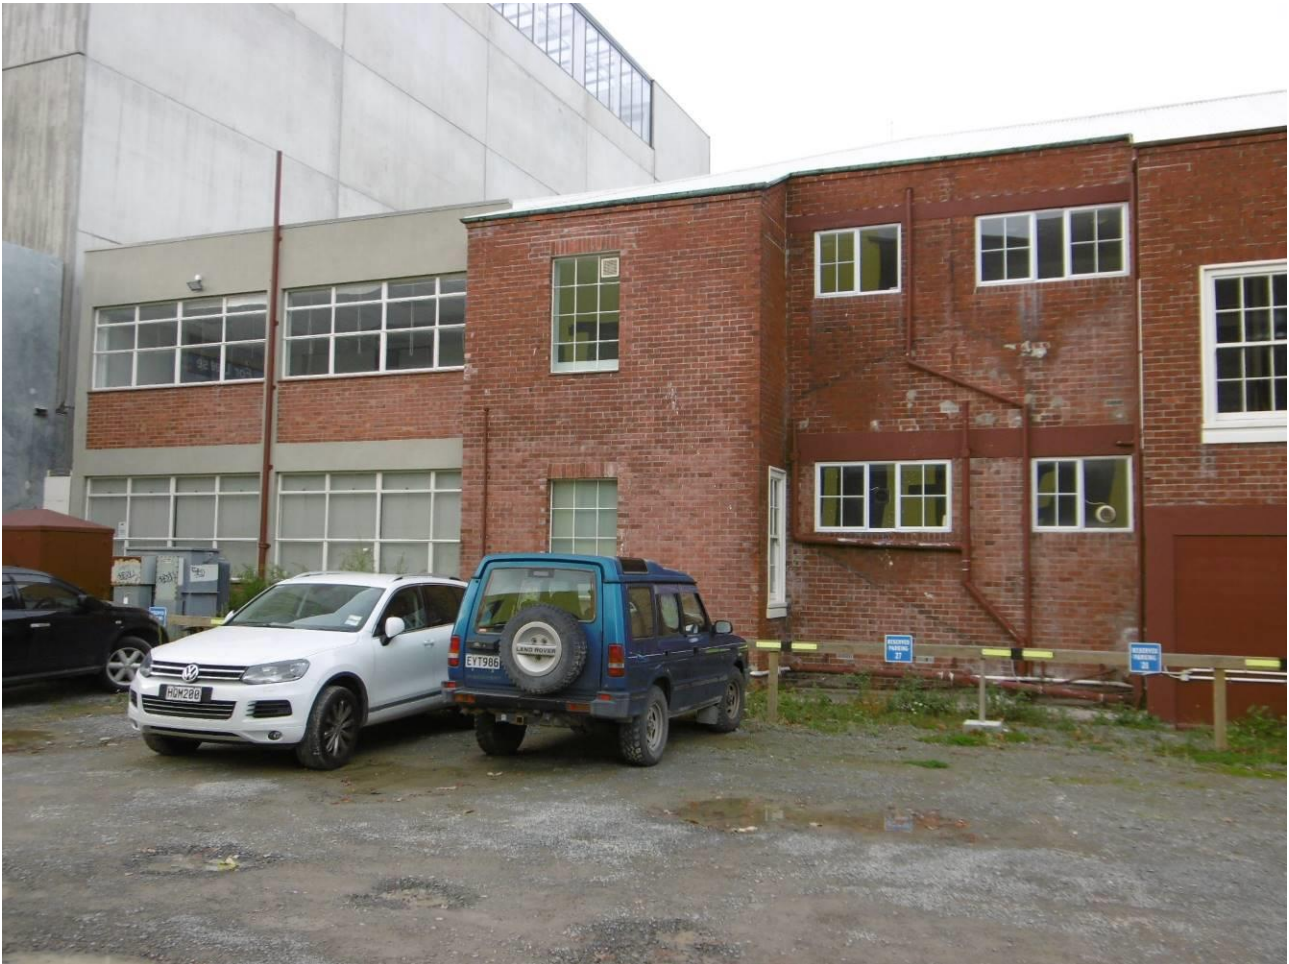
MID AND REAR SECTIONS, WEST ELEVATION. IT IS PROPOSED TO DEMOLISH THE 1958 ADDITION TO THE LEFT, ALONG WITH THE PROJECTED AND RECESSED MID SECTIONS OF THE ORIGINAL WORCESTER CHAMBERS BUILDING.

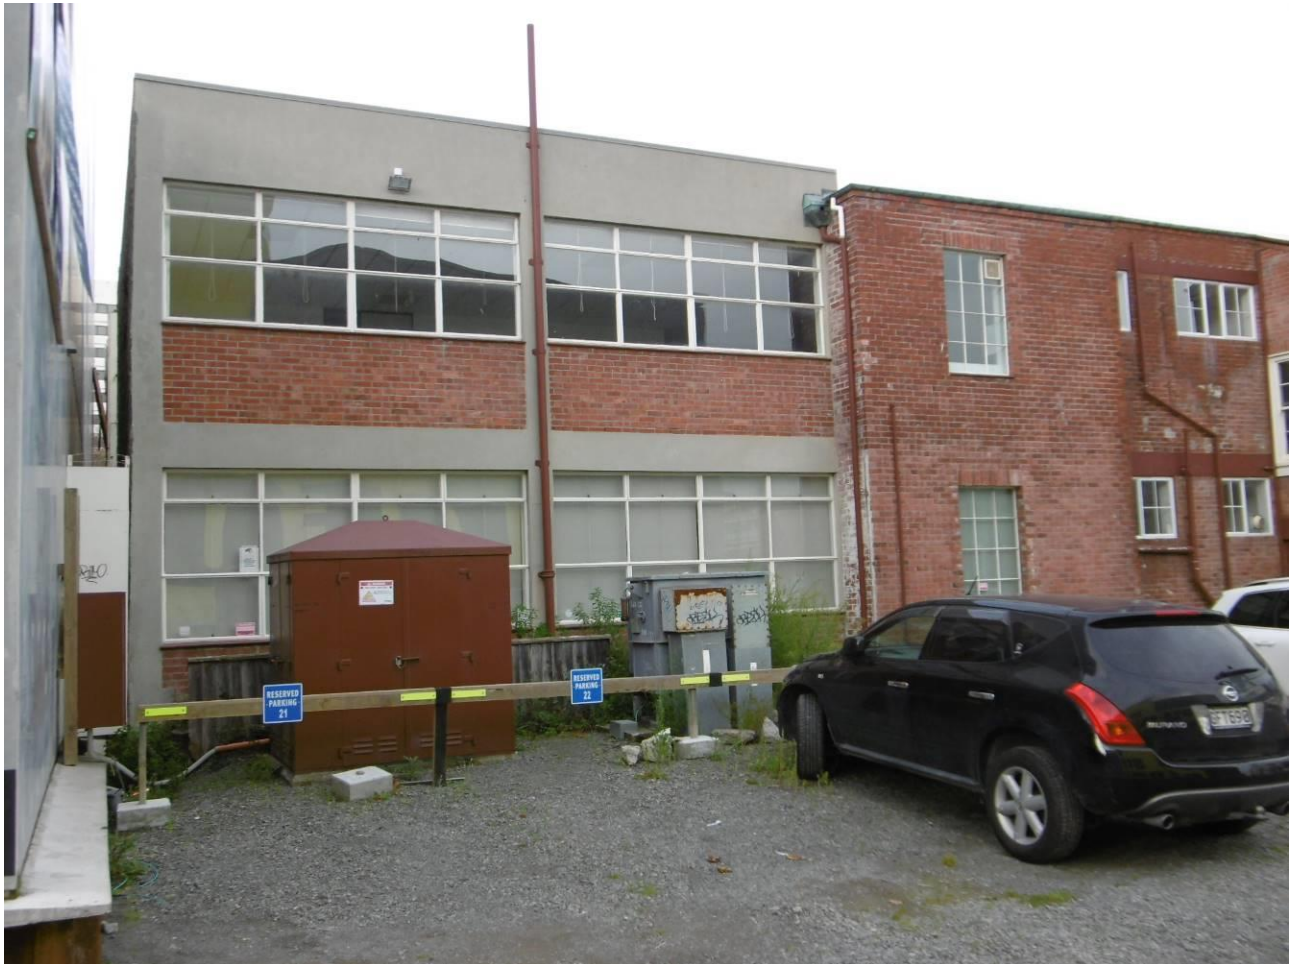
ANOTHER VIEW OF THE REAR AND MID SECTIONS OF THE WEST ELEVATION. IT IS NECESSARY TO DEMOLISH THESE SECTIONS OF THE BUILDING TO GAIN ACCESS INTO THE CENTRE OF THE SITE TO SAFELY DEMOLISH THE HARLEY CHAMBERS BUILDING.

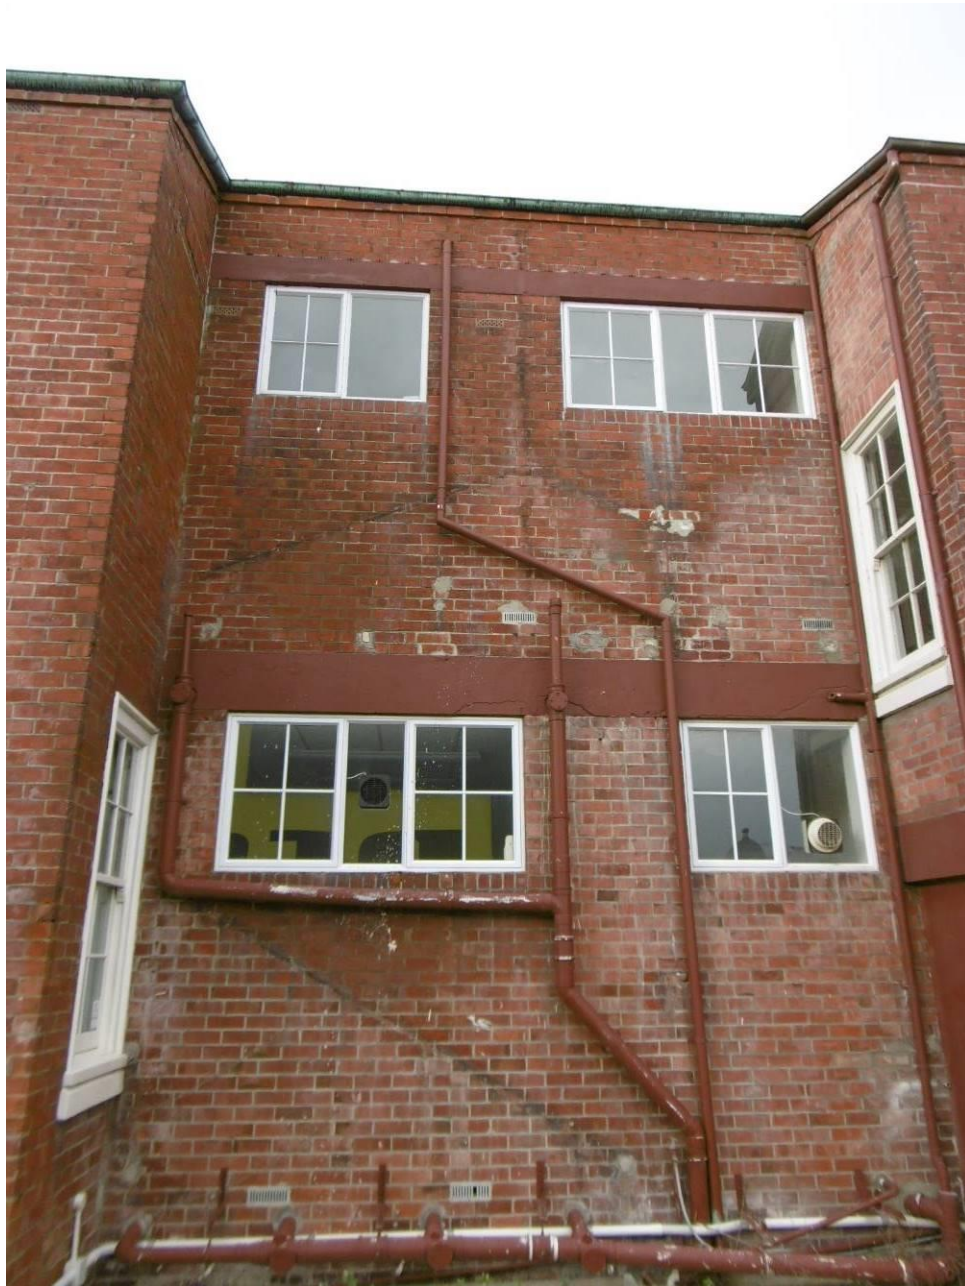
RECESSED SECTION WEST ELEVATION, SHOWING ALUMINIUM WINDOWS TO TOILETS AND EXPOSED PIPEWORK

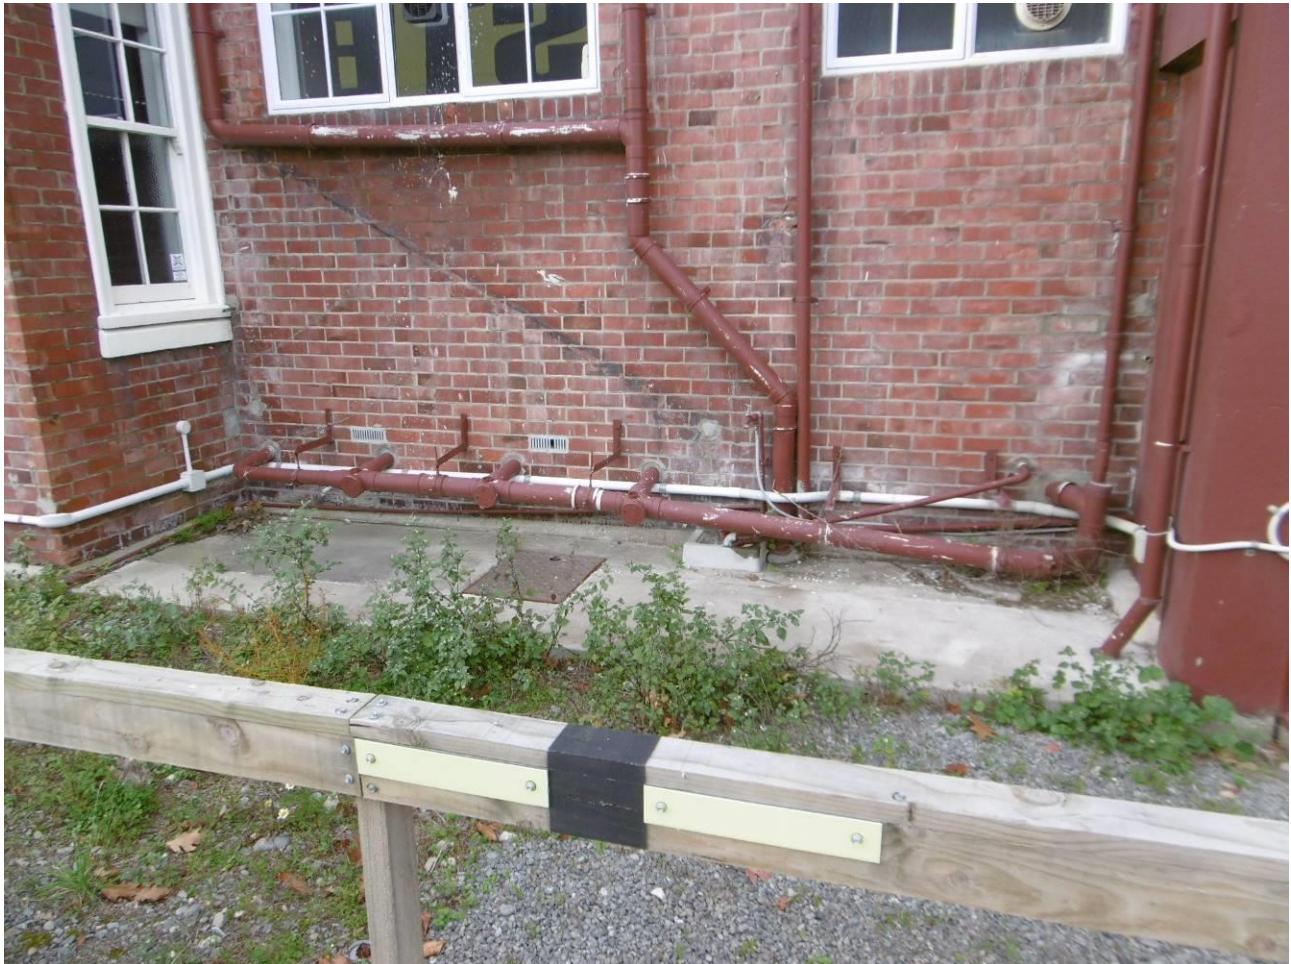
PIPES AND CABLES ON WALL AT BASE OF RECESSED SECTION

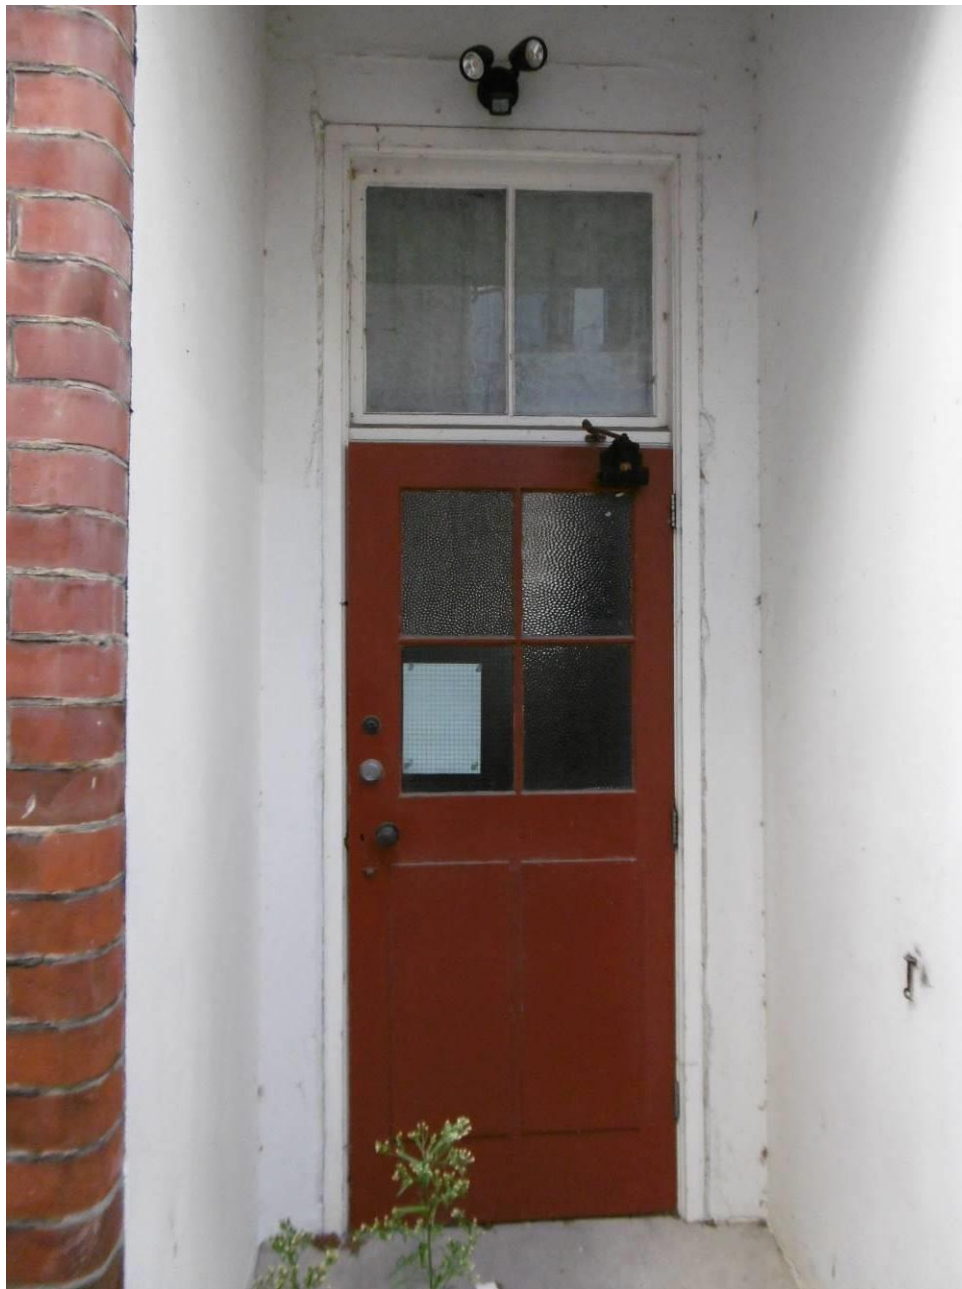
FIRE EGRESS DOOR ON THE EAST ELEVATION. THE OPTION B TRUNCATION OF THE BUILDING, WOULD BE TO THE BRICKWORK ON THE LEFT HAND SIDE OF THIS ENTRANCE WAY.

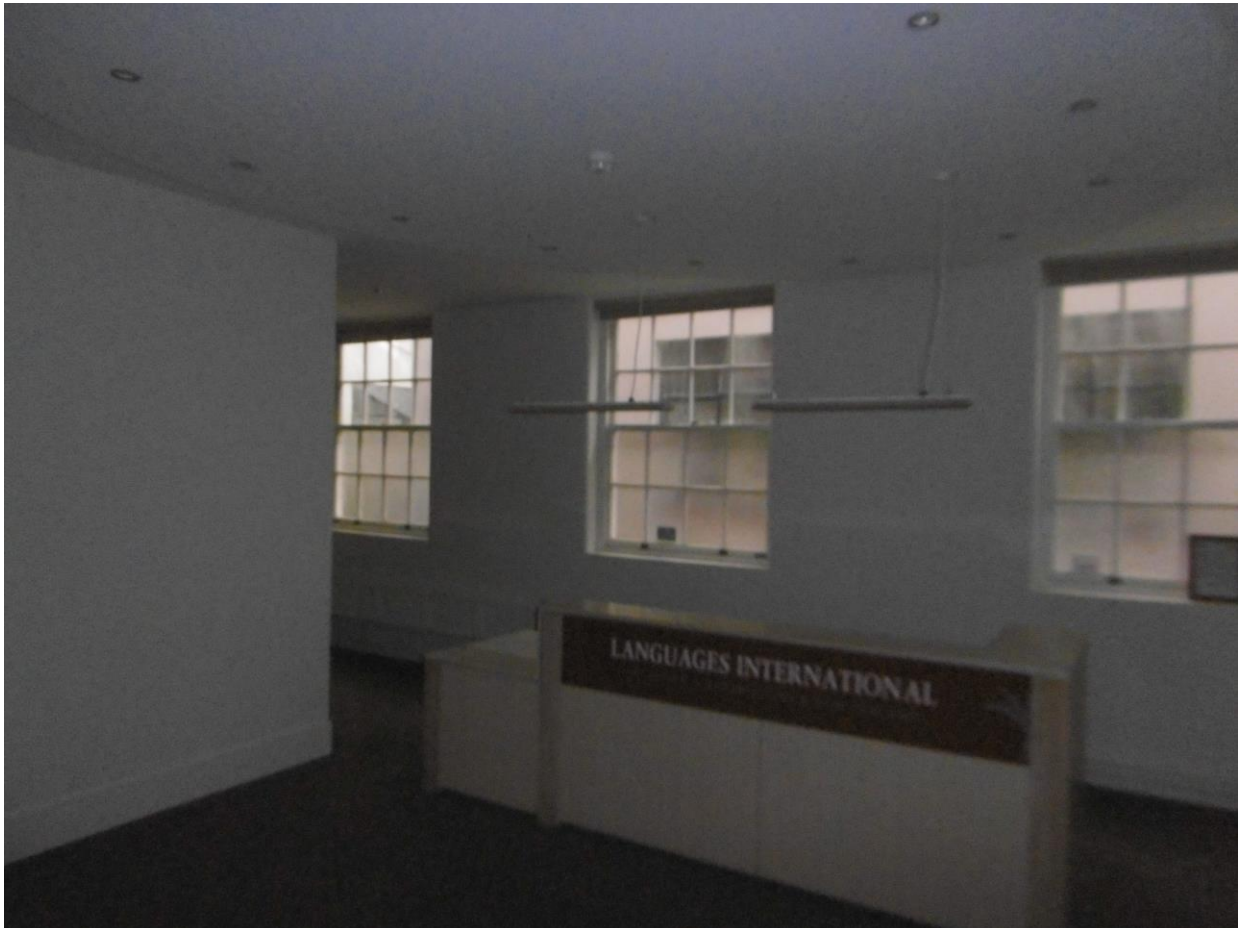
MAIN GROUND FLOOR OFFICE, WITH TIMBER DOUBLE HUNG WINDOWS ON THE EAST SIDE. THERE HAS BEEN CONSIDERABLE MODERNISATION OF THE OFFICE AREAS, INCLUDING CEILINGS, DOORS ETC.

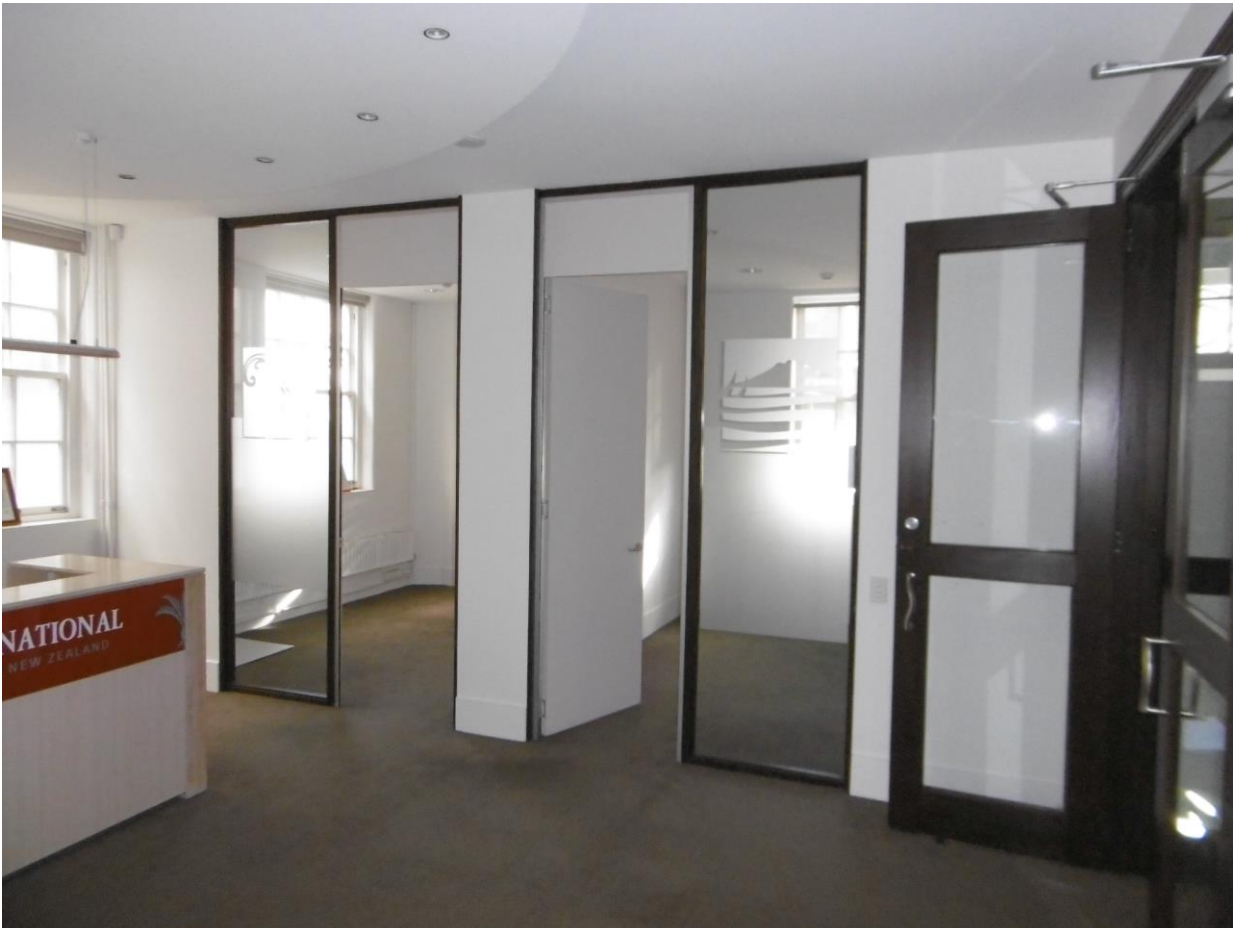
MODERN OFFICE PARTITIONS AT THE SOUTH END OF MAIN GROUND FLOOR OFFICE.

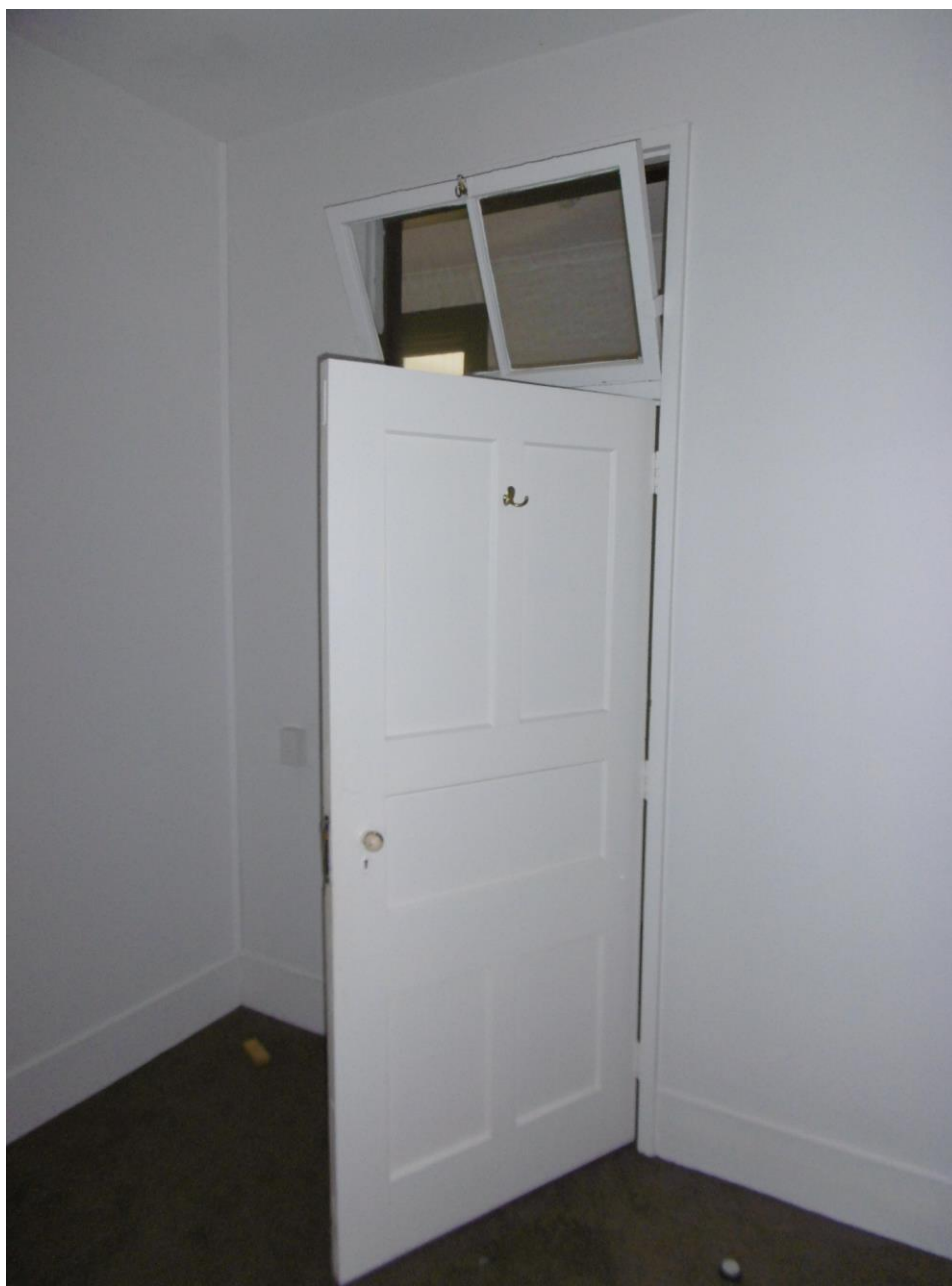
TYPICAL GROUND FLOOR ORIGINAL PANELED TIMBER DOOR AND OVERLIGHT

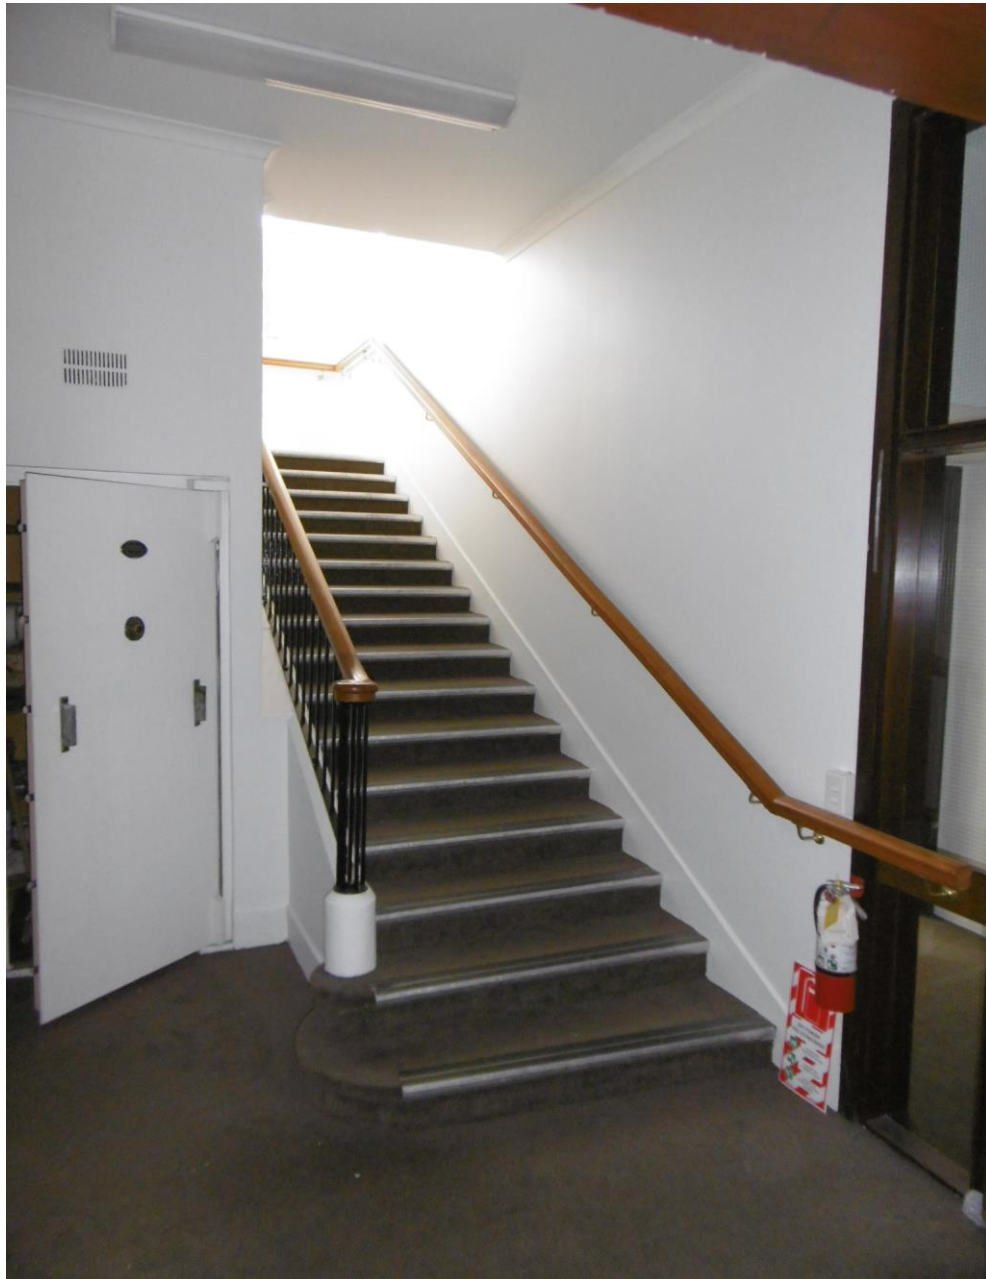
CENTRAL STAIRWAY WITH ORIGINAL STEEL BALUSTRADE AND TIMBER HANDRAIL ON THE LEFT HAND SIDE.

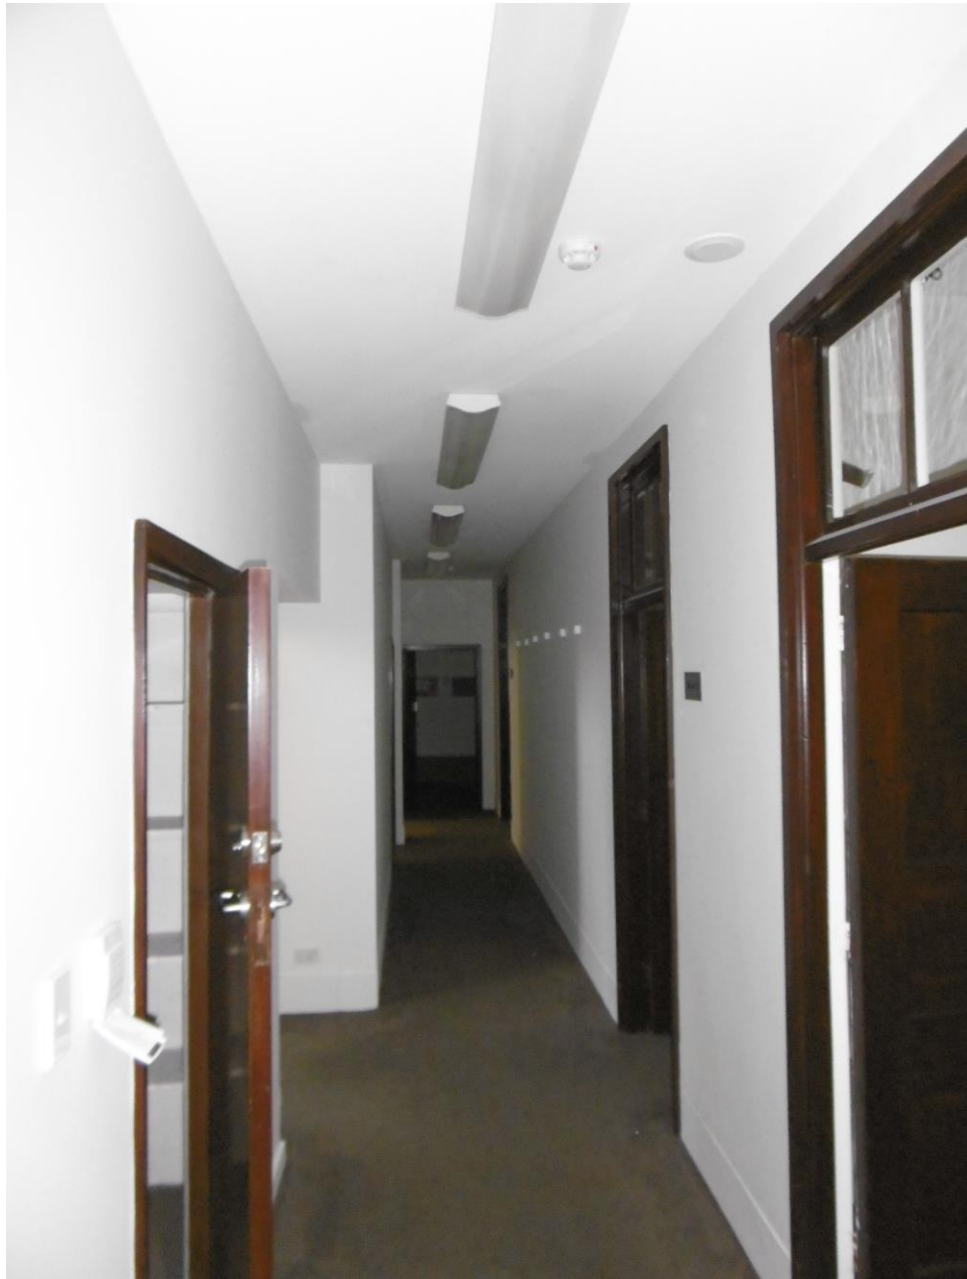
GROUND FLOOR CORRIDOR, NORTH SIDE LOOKING NORTH

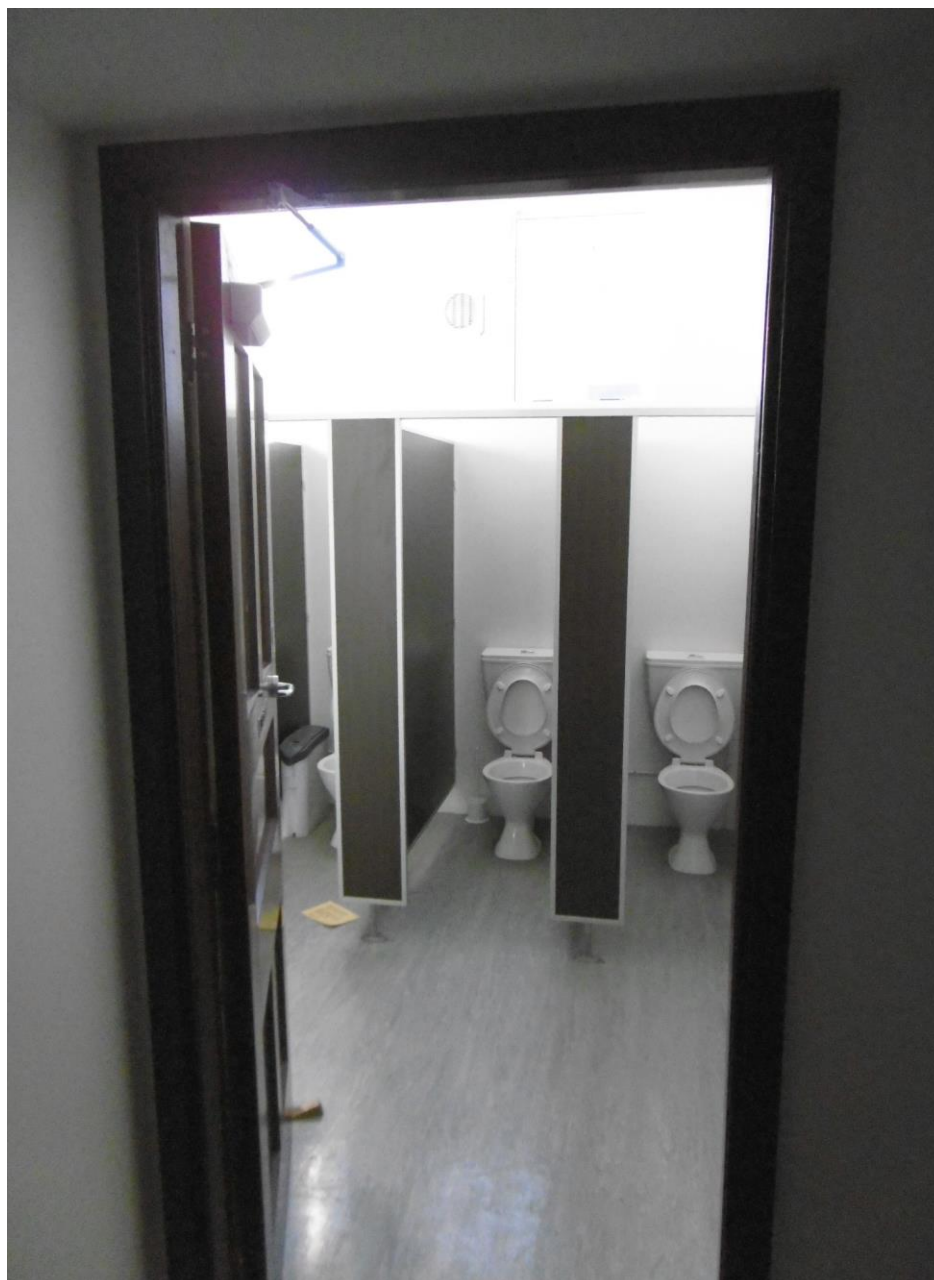
TYPICAL GROUND FLOOR WITH MODERN FITTINGS

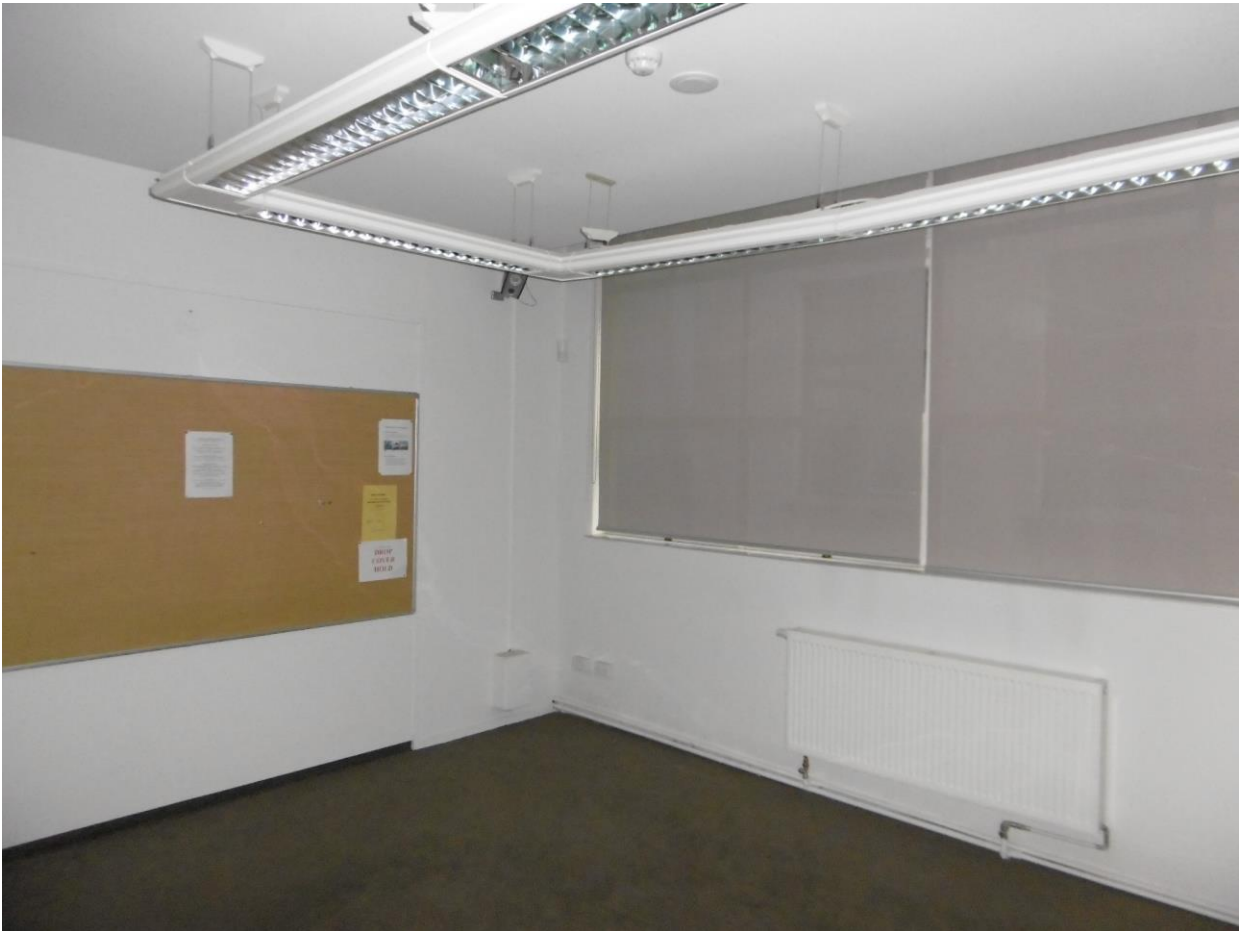
GROUND FLOOR OFFICE IN 1958 ADDITION. THERE HAS BEEN CONSIDERABLE MODERNISATION OF THE INTERIORS.

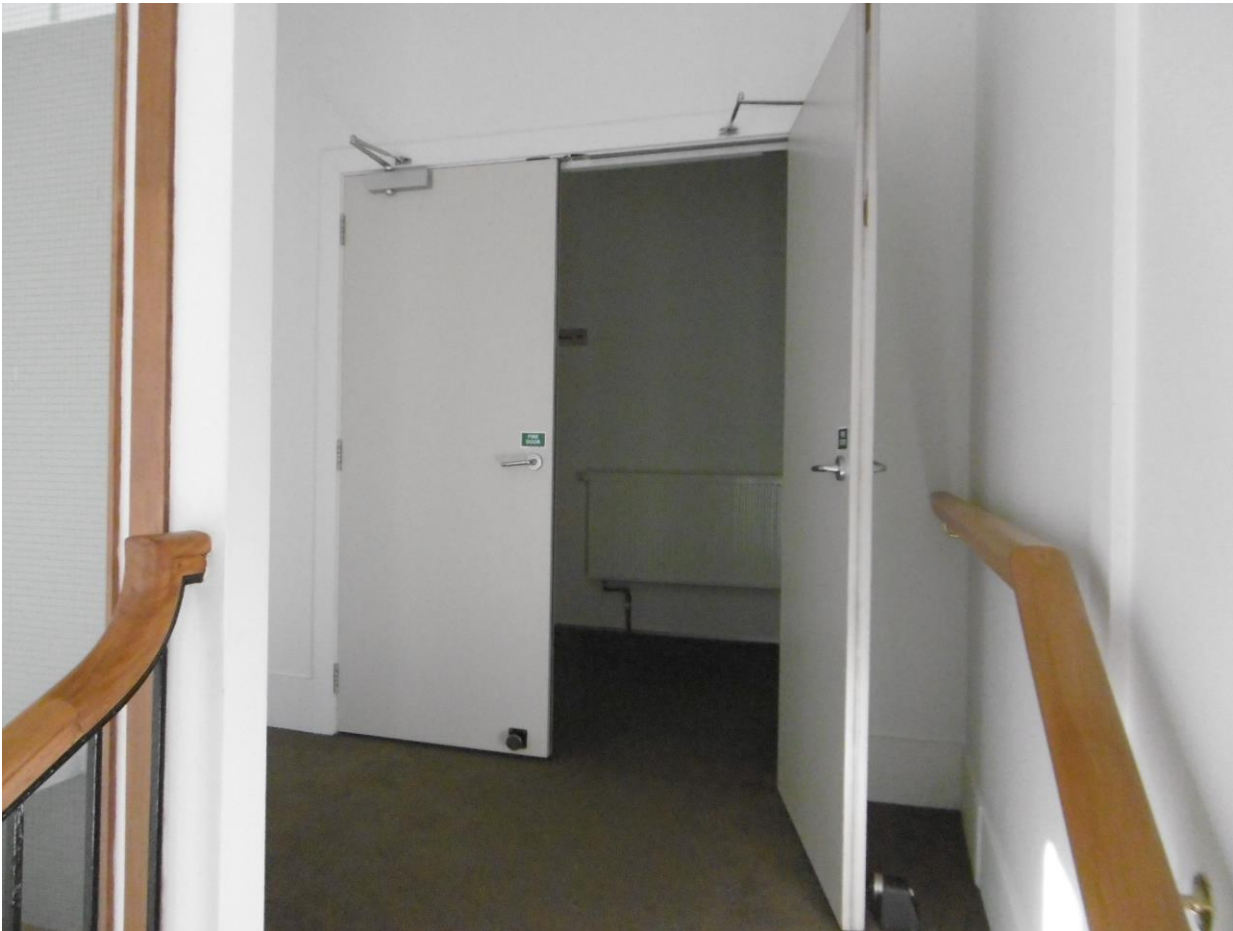
UPPER FLOOR STAIR FOYER FROM THE STAIRS. NOTE THE MODERN SMOKE STOP DOORS. THE ORIGINAL TIMBER HANDRAIL IS ON THE LEFT, WITH A MODERN ONE ON THE RIGHT.

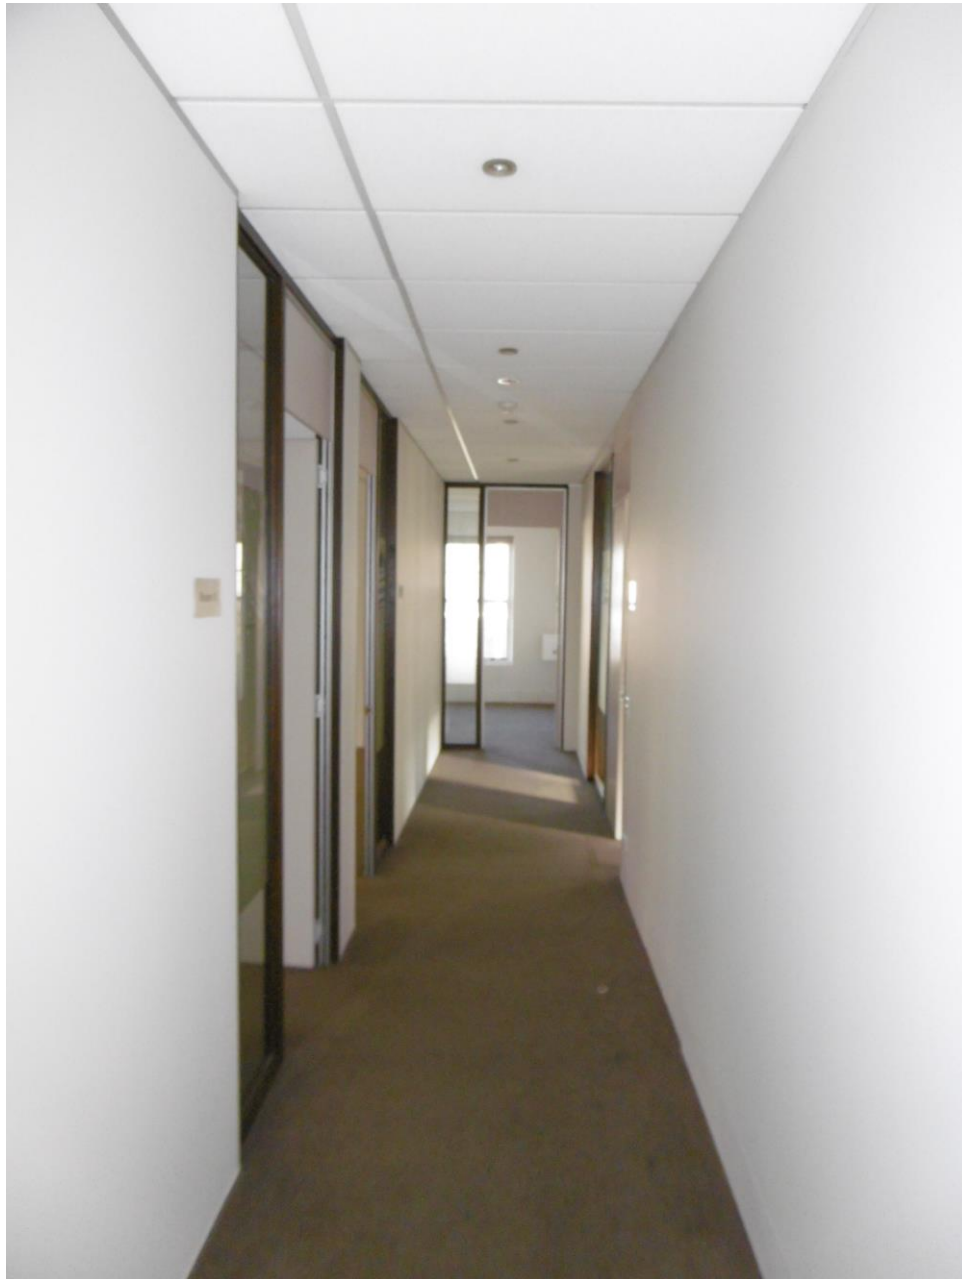
FIRST FLOOR CORRIDOR, LOOKING TOWARDS THE SOUTH (WORCESTER BOULEVARD)
