HARLEY CHAMBERS

**137 CAMBRIDGE TERRACE
CHRISTCHURCH**

HERITAGE IMPACT ASSESSMENT

Report Prepared by
SMART ALLIANCES LTD
for
LEE PEE LTD

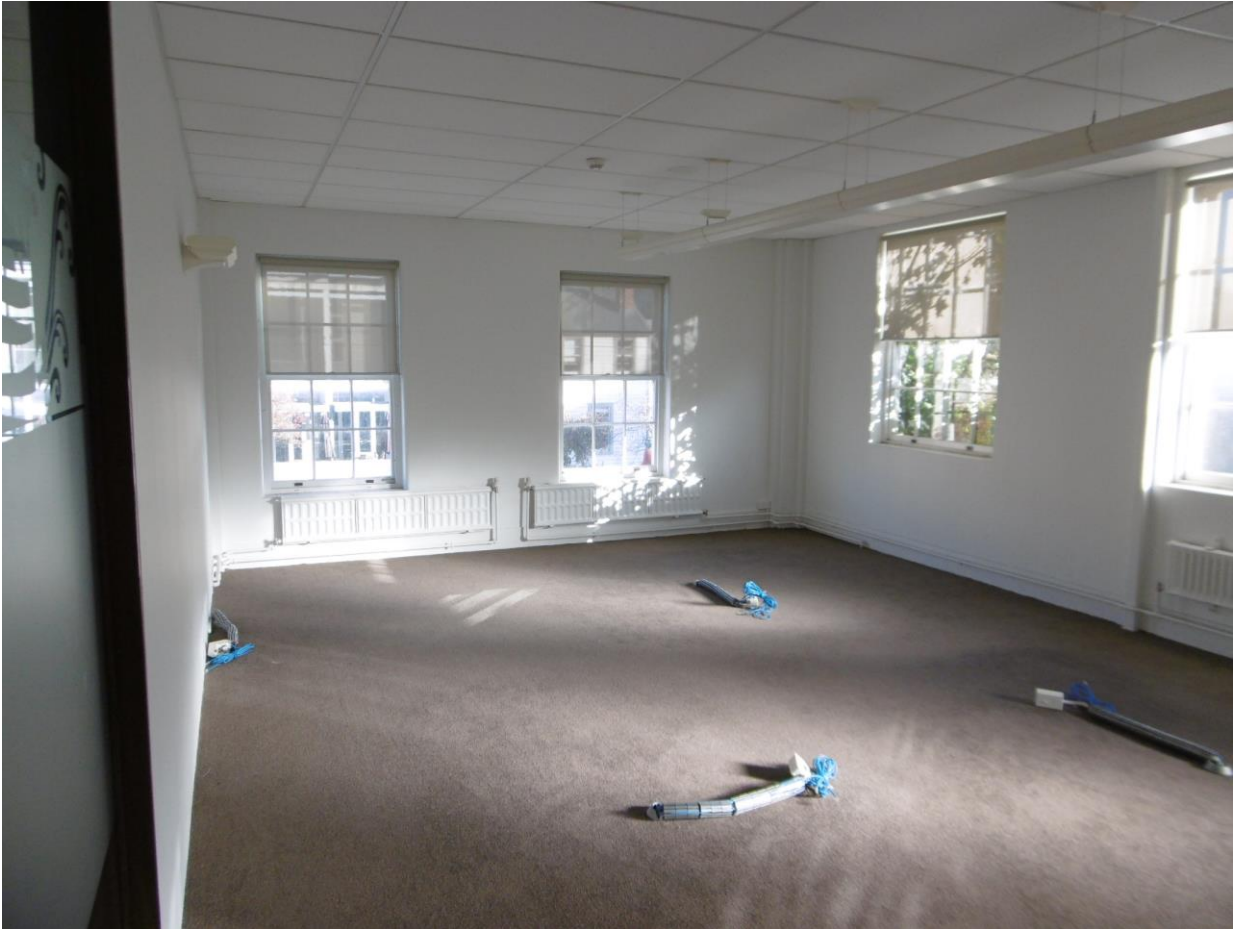
FIRST FLOOR FRONT OFFICE, WEST SIDE. THERE HAS BEEN CONSIDERABLE ALTERATION AND MODERNISATION IN THIS AREA. PLEASE NOTE THE STEEL STRUCTURAL STRENGTHENING MEMBERS IN THE CORNER AND TO THE LEFT OF THE SECOND WINDOW ON THE RIGHT.

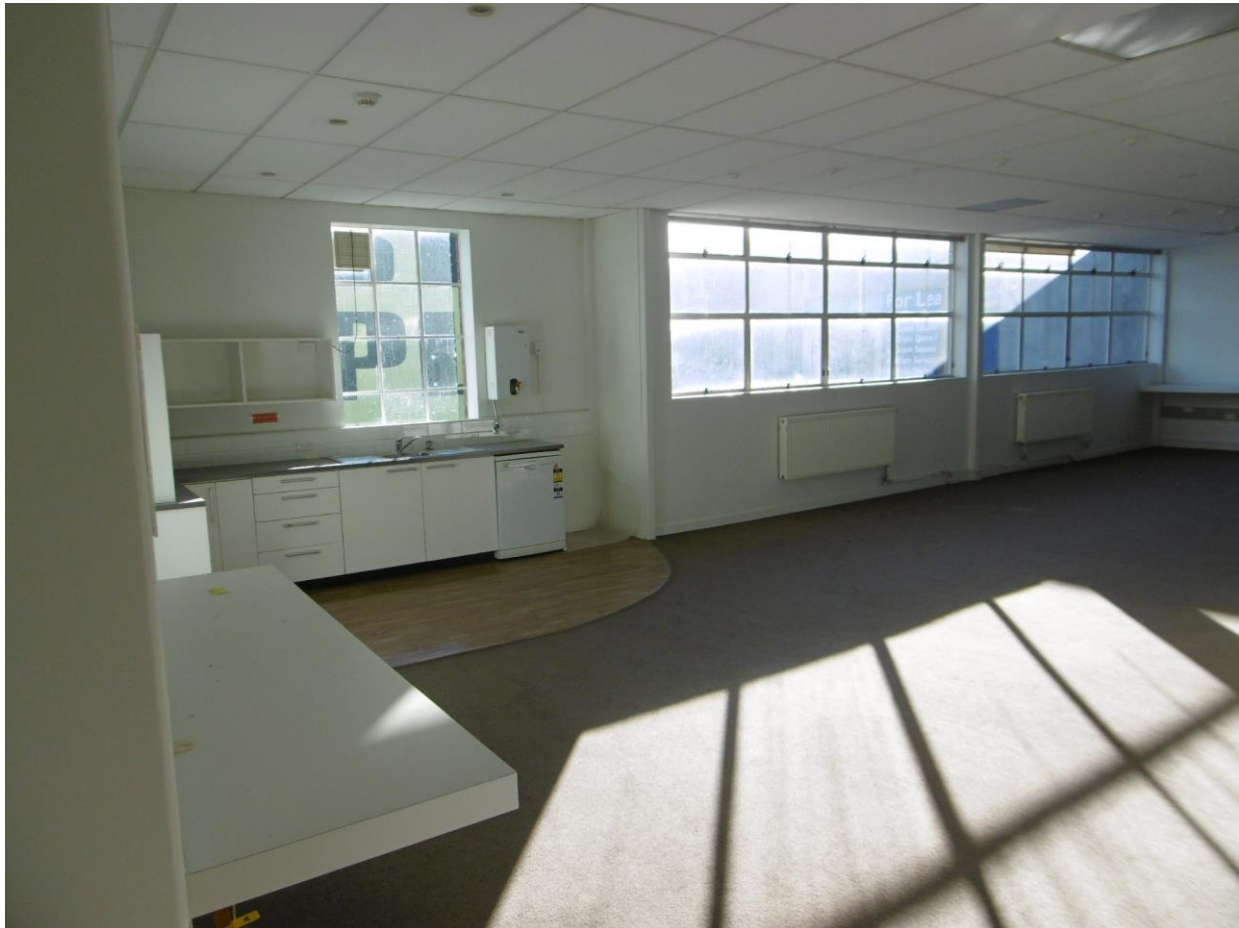
LUNCH ROOM AREA, FIRST FLOOR WEST SIDE. THE AREA TO THE LEFT WITH THE MULTI PANED WINDOW IS IN THE ORIGINAL BUILDING; AND THE LARGER OPEN WINDOW AREA, IS THE 1958 ADDITION

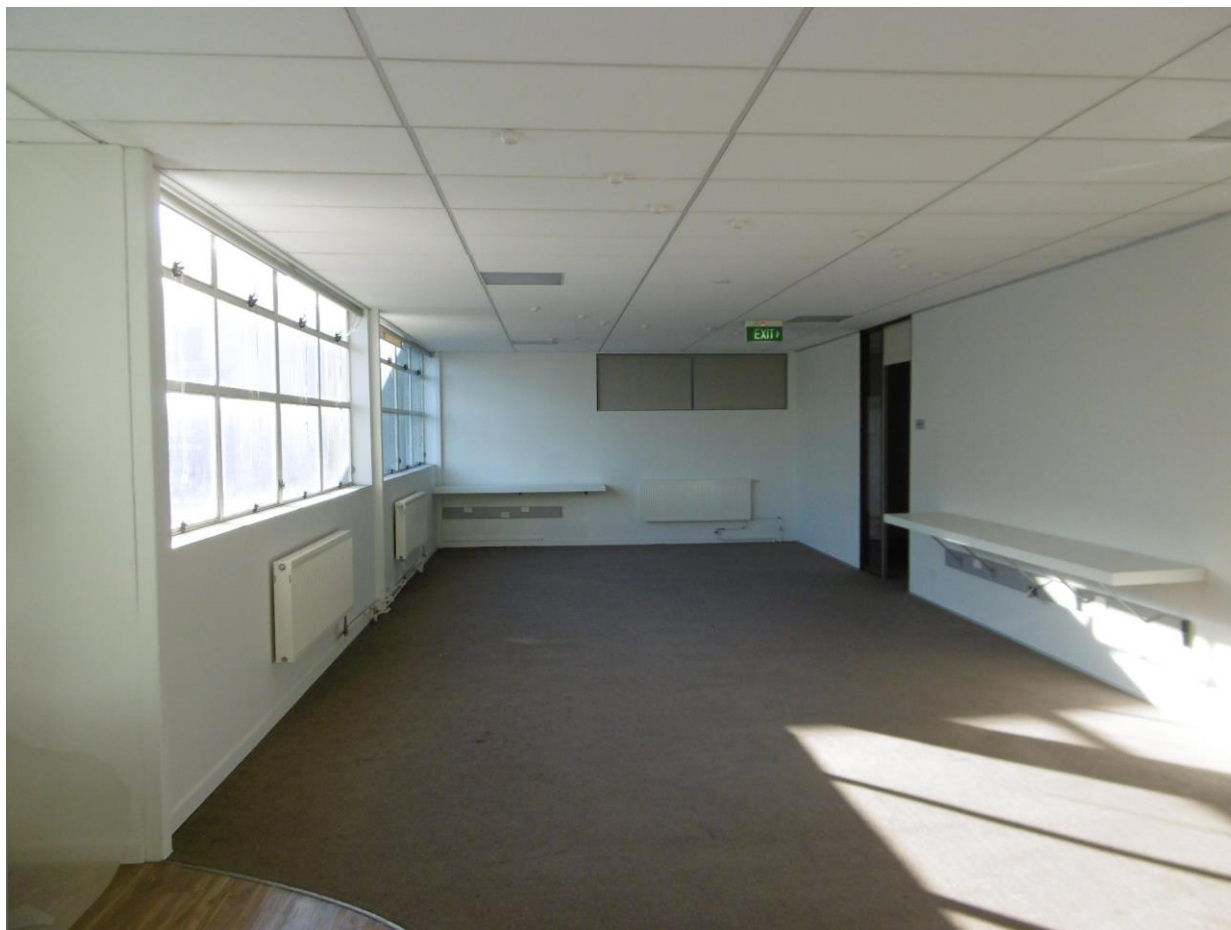
THE 1958 ADDITION AREA, AT THE NORTH END, FIRST FLOOR

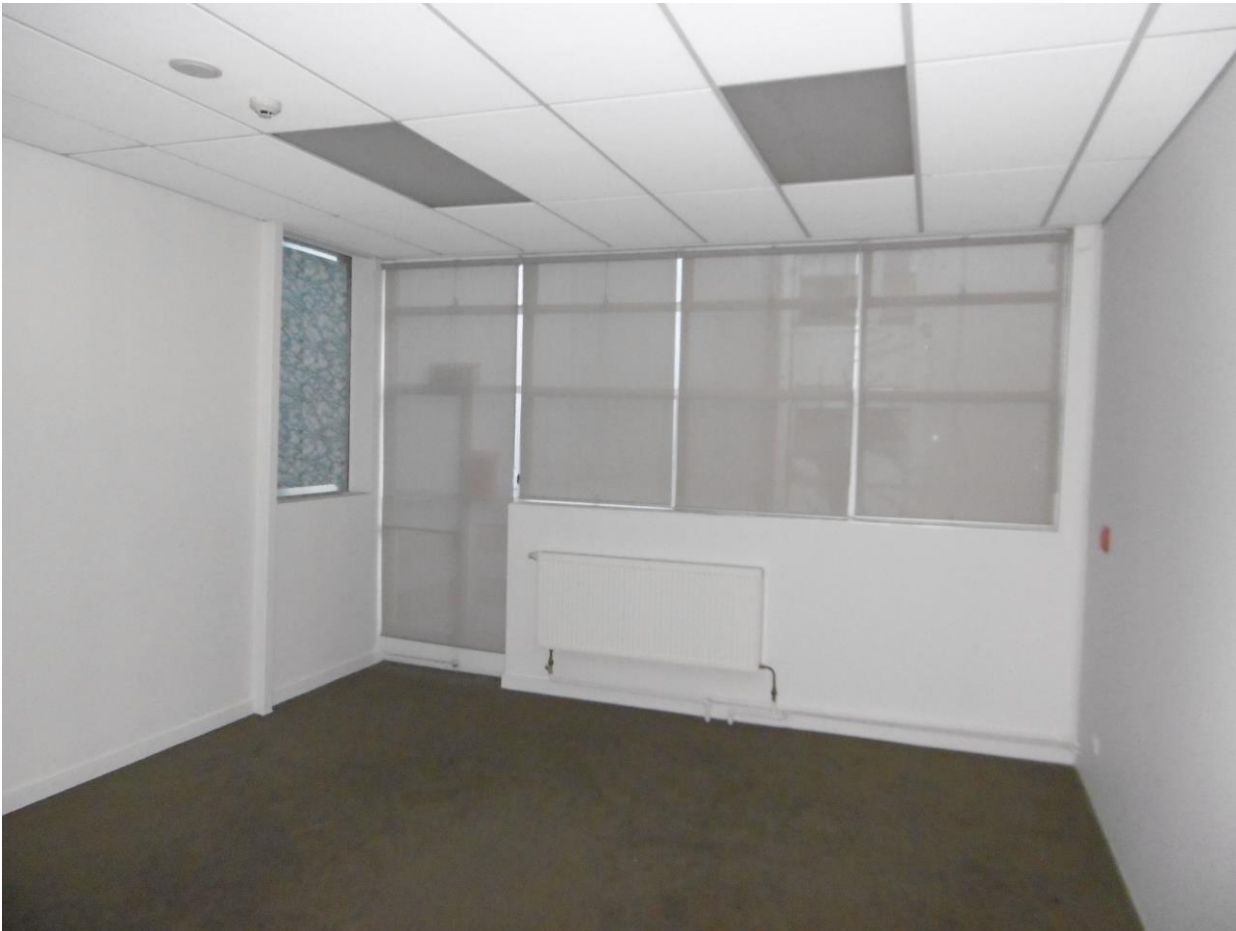
FIRST FLOOR OFFICE, NORTH END WEST SIDE. THE DOOR LEADS TO THE COUNTERBALANCED FIRE ESCAPE STAIR SHOWN IN THE EXTERIOR ELEVATION PHOTOS.

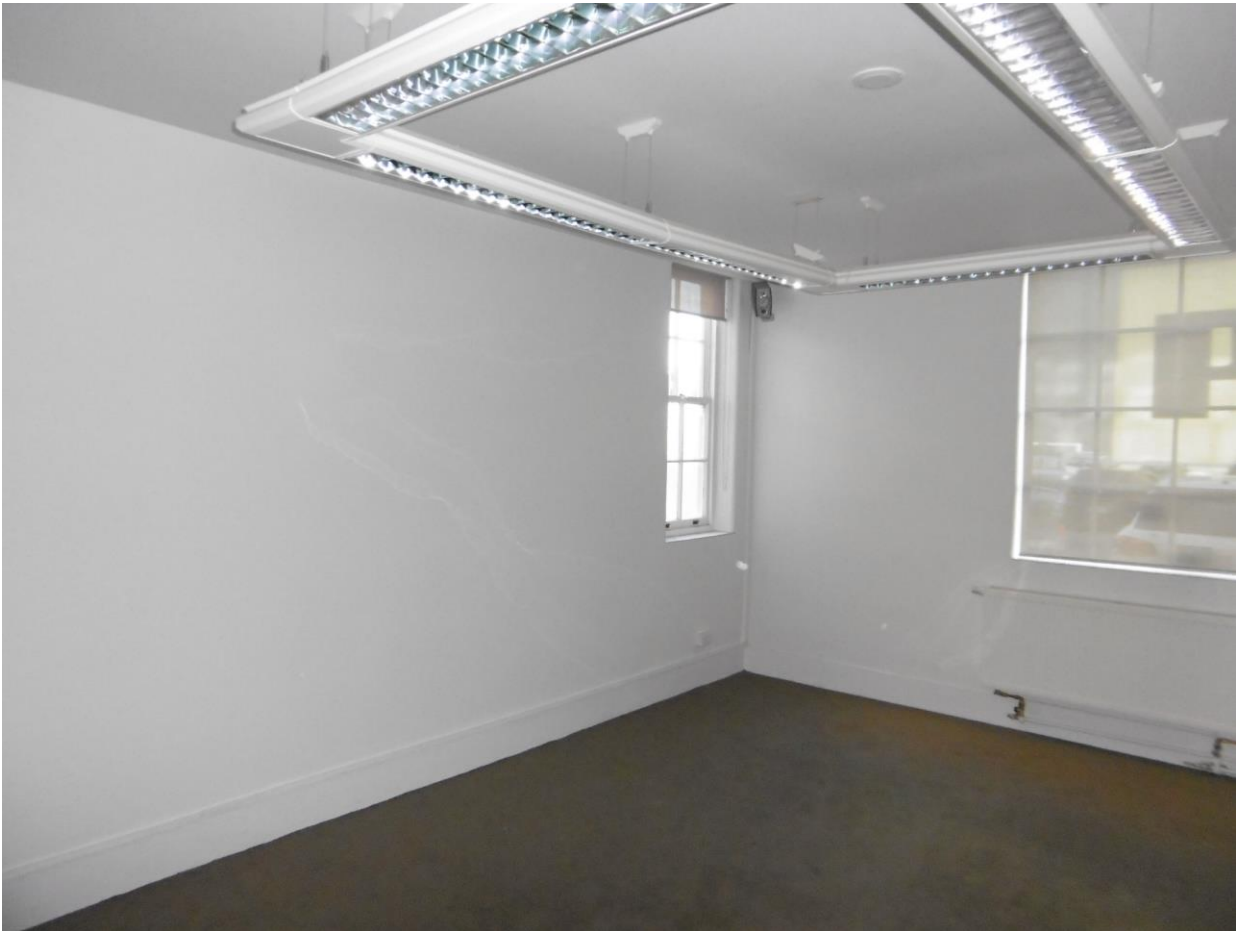
TYPICAL FIRST FLOOR OFFICE SHOWING THE HIGHLY MODERNISED INTERIOR WHICH HAS LOST THE MAJORITY OF ITS HERITAGE SIGNIFICANCE.
