Damage Assessment Report

Grand National (Public) Stand

Client: Canterbury Jockey Club

Job No.: 60332326

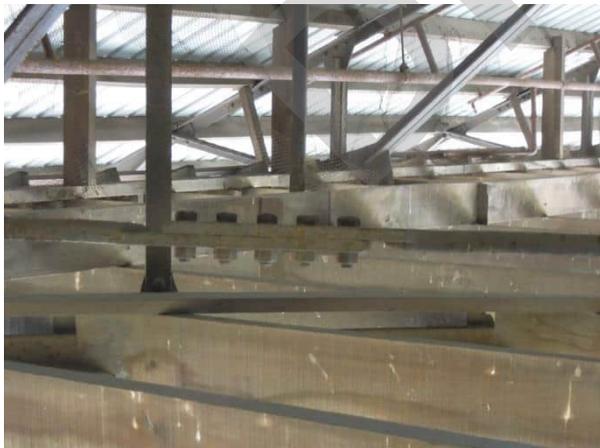
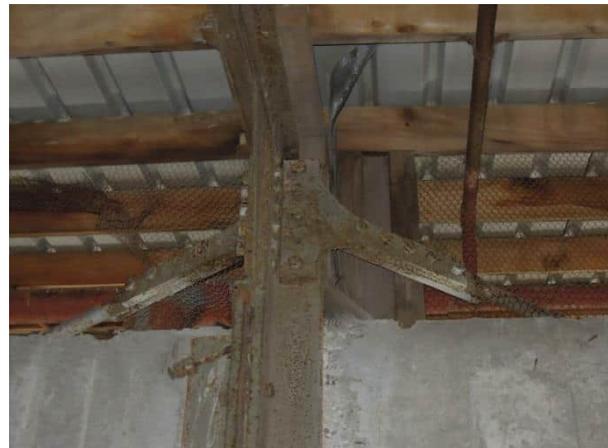
Figure 43: Bracing connections

The primary steel bracing in the roof consists of three bays of cross bracing as shown in drawing A-440. The bracing consists of round bars that appear to have been flattened at their ends to form splice connections. There are three types of brace bolted connections, splice at mid span, to the shear wall and to the truss. Typical connection details are shown in Figure 43.

The bracing rods run above the trusses and are supported on timber blocking. A number of the timber blocks have moved and fallen on to the netting as shown in photo F.2 and F.3 on drawing A-442. This indicates that the braces have displaced during the earthquake sequence or wind but there does not appear to be any sagging or yielding of the braces.

It should be noted that the inspection of the roof was visual in nature and mostly carried out from a relatively significant distance (upper stand level, level 4 slab). A detailed inspection of roof structure is recommended in the course of repair works to ensure that no loose timber blocks exist and that all connections are adequate.

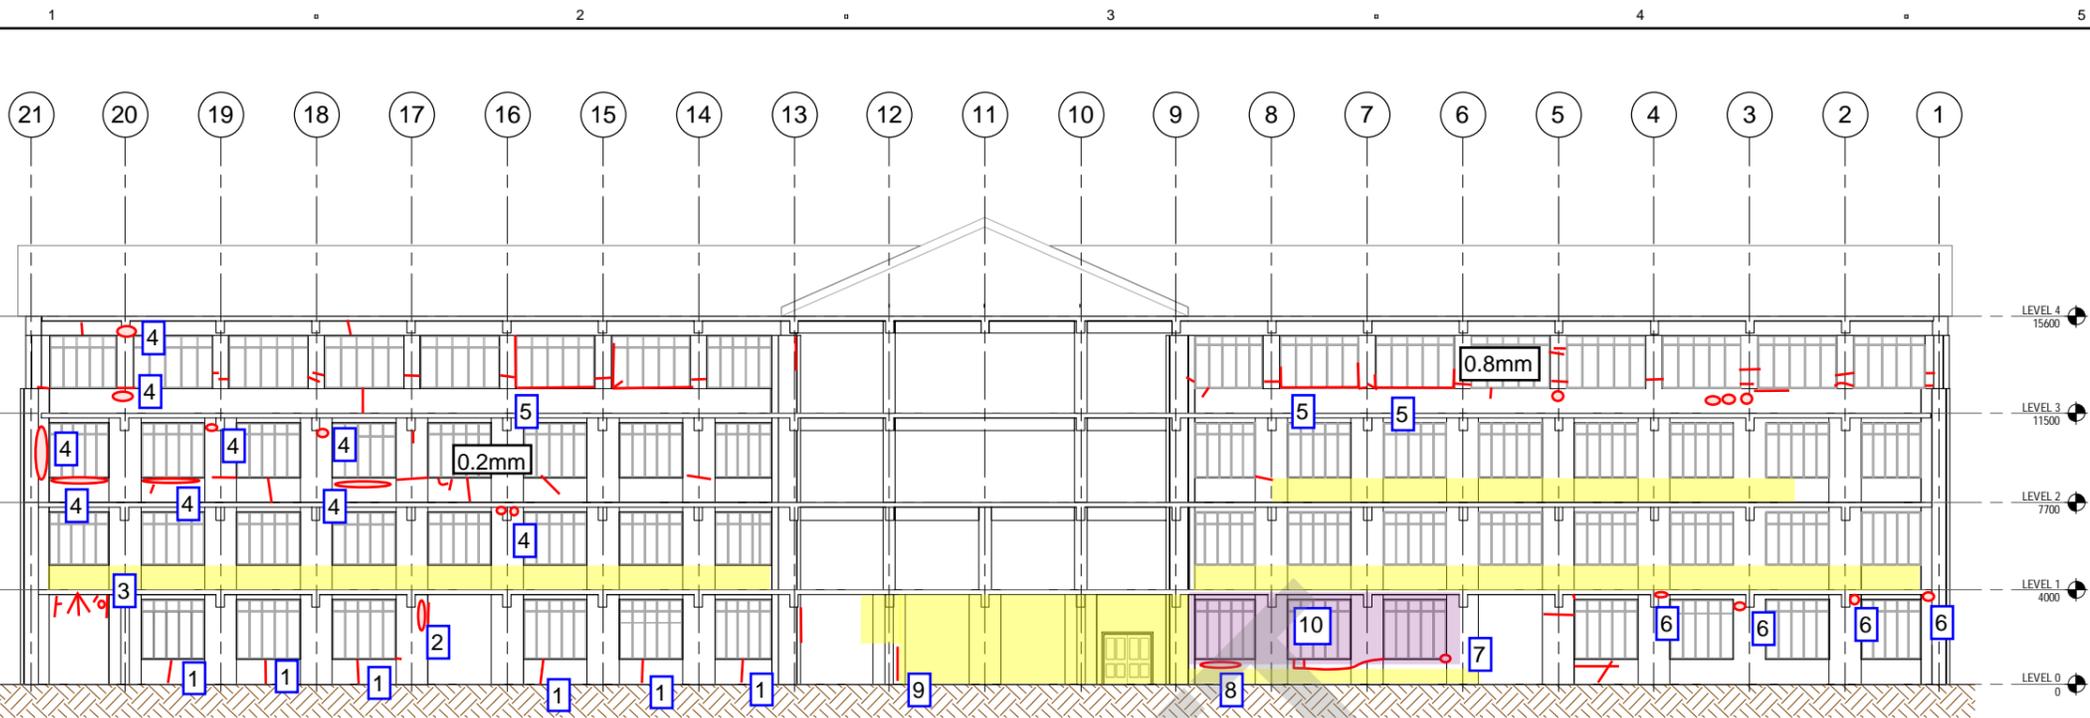
8 | DAMAGE SURVEY - SECTION ON GRID D FROM INTERIOR

1. Panels have separated
2. Bubbling paint
3. Separation and WD
4. WD
5. Separation between window and wall
6. Poor quality concrete
7. Broken out
8. Spalling
9. Separation between wall and column
10. Paint peeling off visual inspection limited

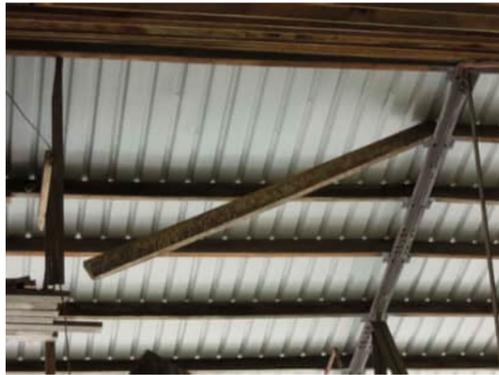
F.1
A.441 | TIMBER PURLIN END CONNECTION FAILED

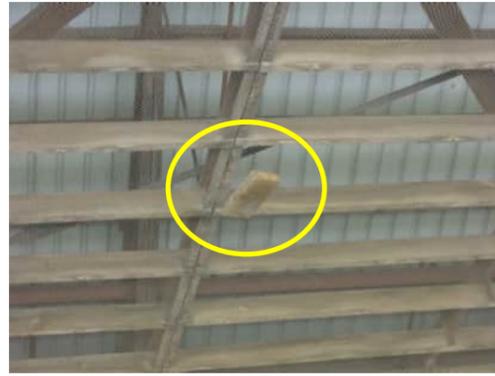
F.2
A.441 | TIMBER BLOCKING SUPPORTING BRACE FALLEN ONTO NET

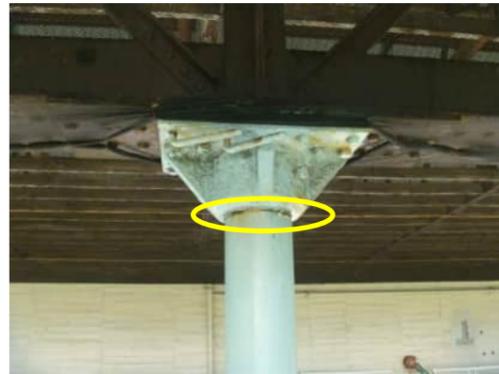
F.4
A.441 | COLUMN COLLAR CONNECTION GRID 2, PAINT SPLIT WITH RUST

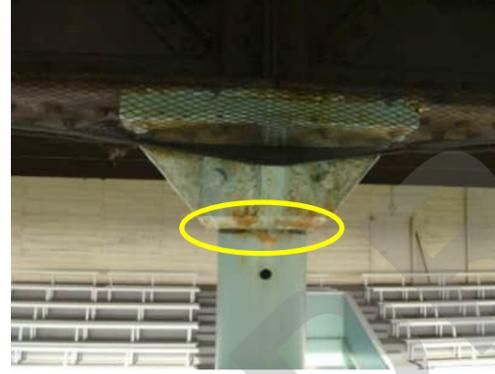
F.5
A.441 | COLUMN COLLAR CONNECTION GRID 8, PAINT SPLIT WITH RUST

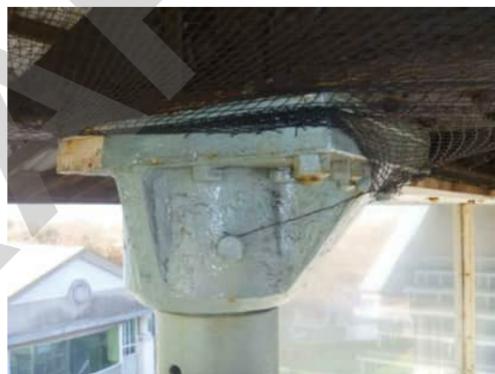
F.6
A.441 | COLUMN COLLAR CONNECTION GRID 14, PAINT SPLIT WITH RUST

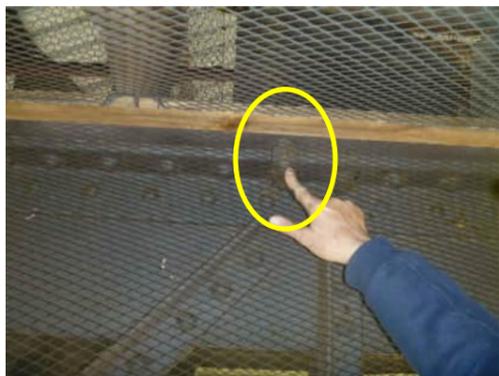
F.8
A.441 | SIGNIFICANT RUSTING TO GRID 20 TO 21 CORNER TRUSS

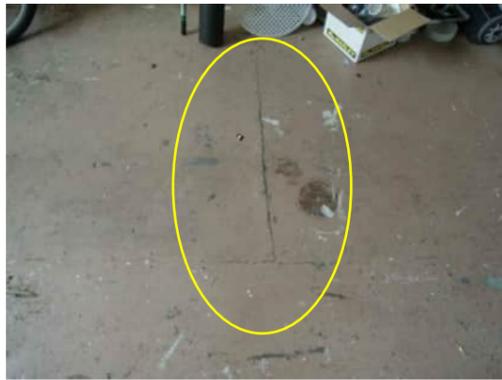
0.1
A-500 | 1.5mm WIDE CRACK

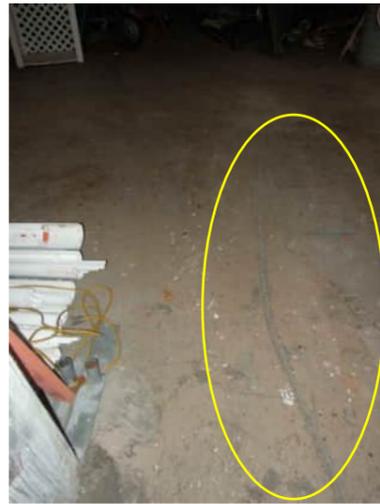
0.2
A-500 | DAMAGE TO FLOOR, 10mm WIDE ON SURFACE ONLY

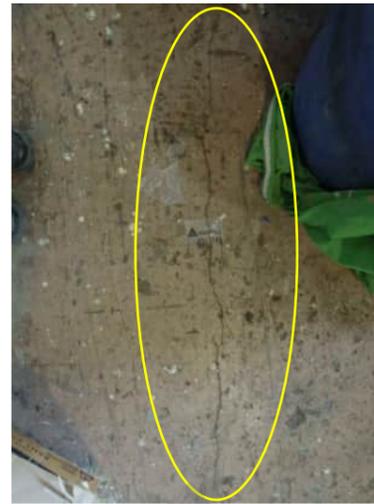
0.3
A-500 | CRACK IN SLAB, UP TO 2mm WIDE

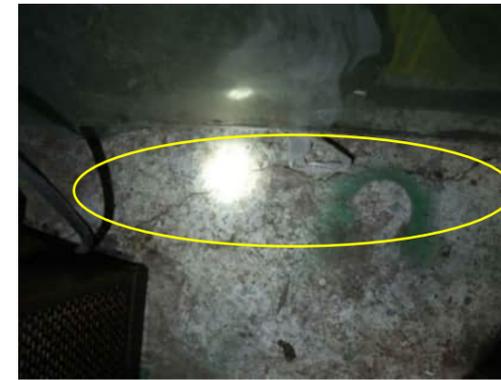
0.4
A-500 | MINOR CRACK IN SLAB

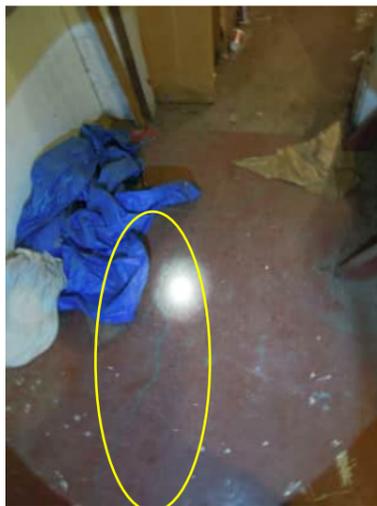
0.5
A-500 | MINOR CRACK TO SURFACE COATING ONLY

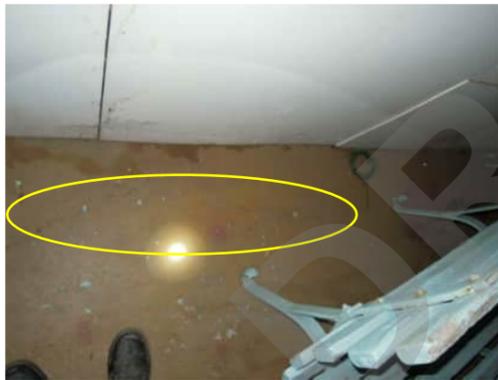
0.6
A-500 | MINOR CRACK TO SURFACE COATING ONLY

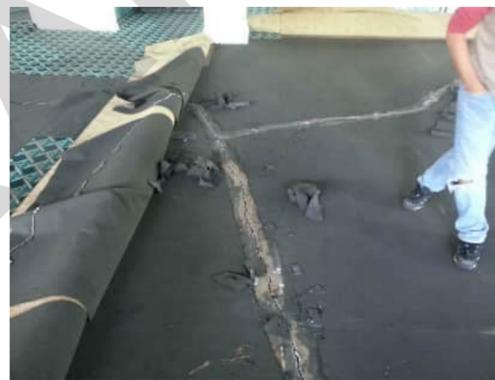
0.7
A-500 | SIGNIFICANT CRACKS IN SLAB WHERE CARPET HAS BEEN PULLED UP

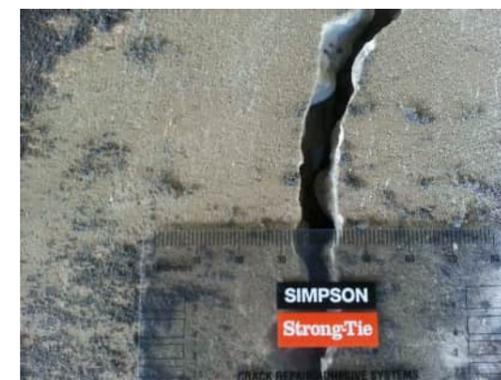
0.8
A-500 | CRACK UP TO 15mm

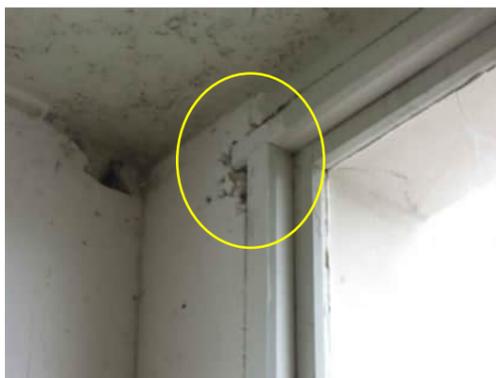
0.9
A-500 | POORLY COMPACTED CONCRETE AROUND WINDOW FRAME AT TOP OF GRID D COLUMN

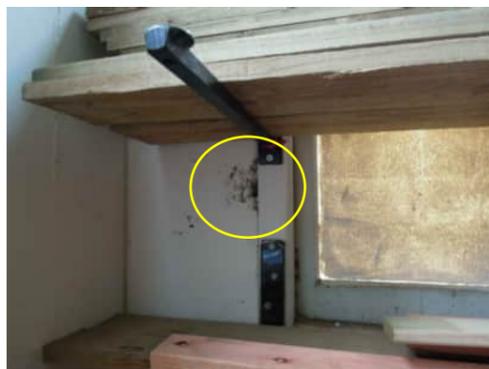
0.10
A-500 | POORLY COMPACTED CONCRETE AROUND WINDOW FRAME AT MID-HEIGHT OF GRID D COLUMN

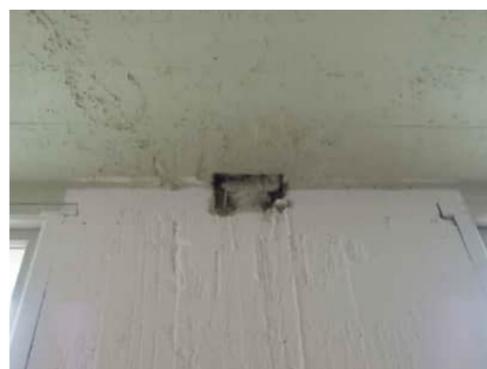
0.11
A-500 | HISTORICAL HOLE IN TOP OF COLUMN BETWEEN GRID C AND D

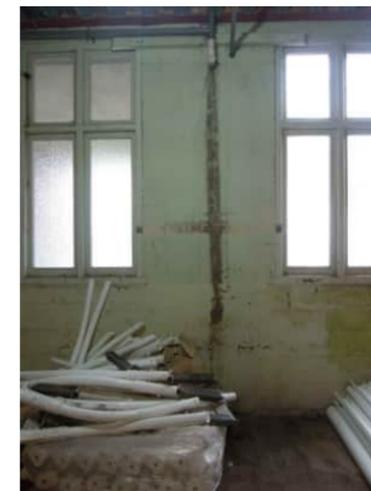
0.12
A-500 | PIPE AT TOP OF COLUMN BETWEEN GRID B AND C, WITH WATER DAMAGE BELOW

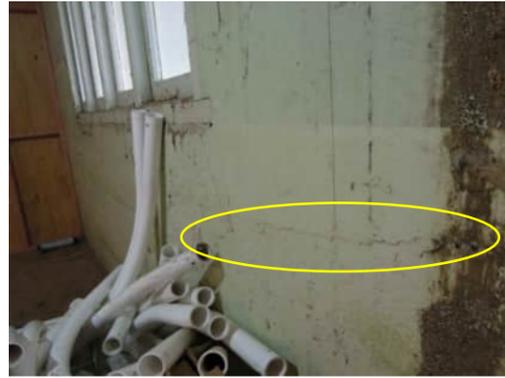
0.13 HORIZONTAL CRACK IN WALL BETWEEN GRID B AND C
A-500

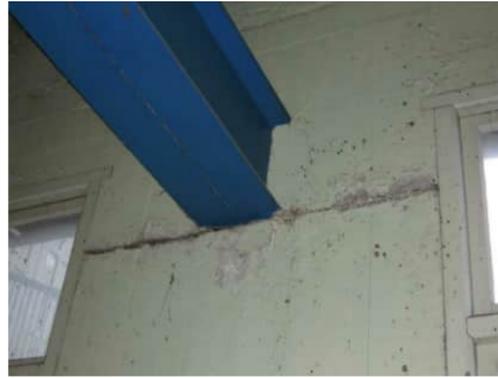
0.14 HORIZONTAL CRACK AT TOP OF WALL AT GRID B IN CONSTRUCTION JOINT, BELOW CAST-IN STEEL BEAM.
A-500

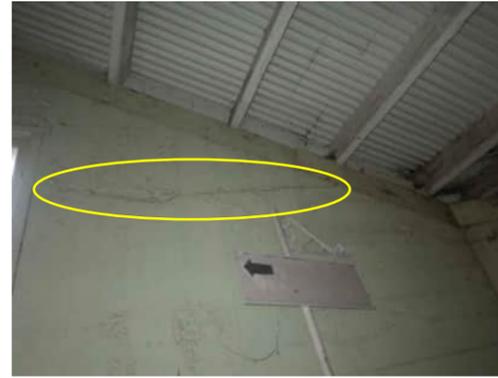
0.15 HORIZONTAL CRACK TO TOP OF WALL AT GRID A
A-500

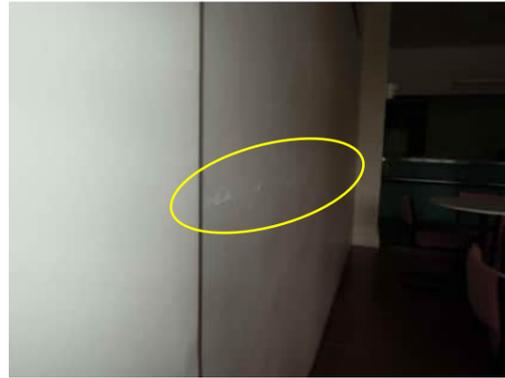
0.17 CRACK TO THE PLASTER
A-500

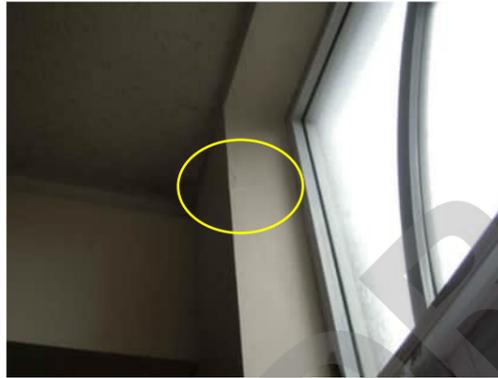
0.18 CRACKS IN DOOR FRAME BETWEEN GRID A AND B
A-500

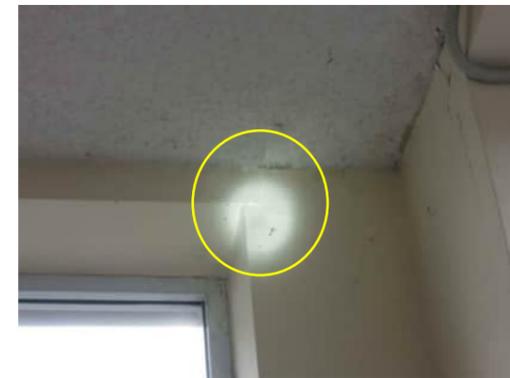
0.20 CRACK ABOVE DOOR FRAME AT GRID D
A-500

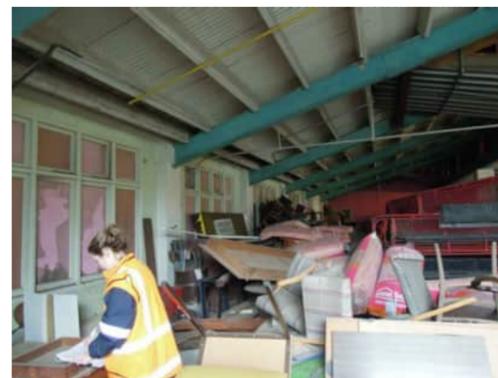
0.22 VIEW OF GRID 3 TO 9, LIMITED ACCESS DUE TO STORED GOODS BLOCKING WALL
A-500

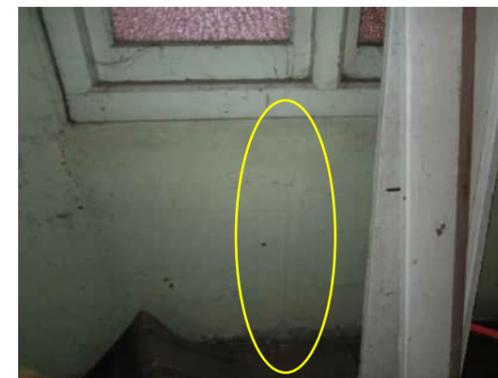
0.23 0.2mm VERTICAL CRACK BELOW WINDOW BETWEEN GRID 2 AND 3
A-500

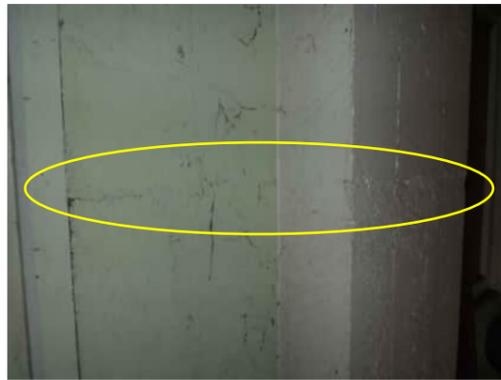
0.24
A-500 | HAIRLINE HORIZONTAL CRACK AT LOCATION OF CONSTRUCTION JOINT ON GRID 3

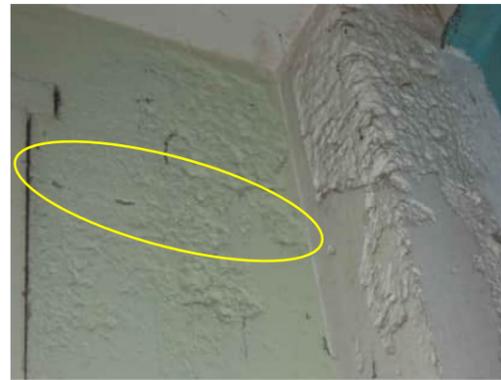
0.25
A-500 | HAIRLINE HORIZONTAL CRACK NEAR TOP OF WINDOW AT GRID 3

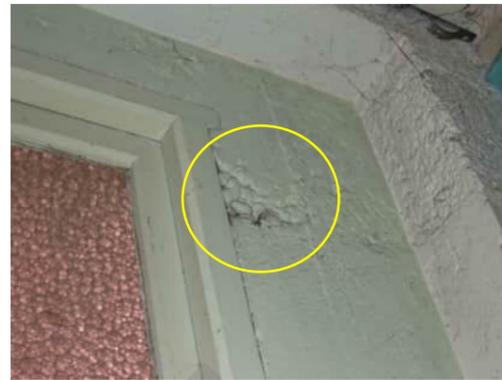
0.26
A-500 | TYPICAL POORLY COMPACTED CONCRETE WITH EXPOSED AGGREGATE NEAR TOP OF COLUMNS

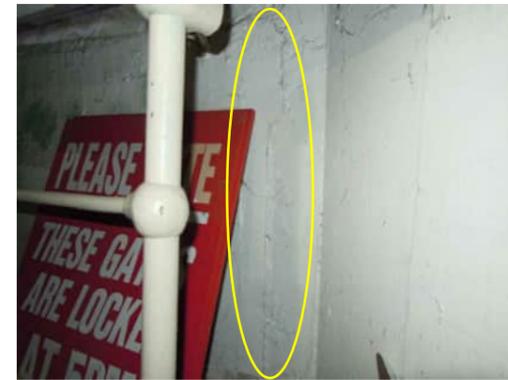
0.27
A-500 | VERTICAL CRACKS BELOW WINDOW BETWEEN GRID 13 AND 14

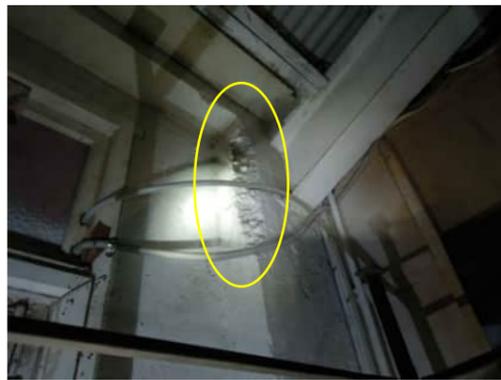
0.28
A-500 | POORLY COMPACTED CONCRETE ON EDGE OF GRID 16 COLUMN

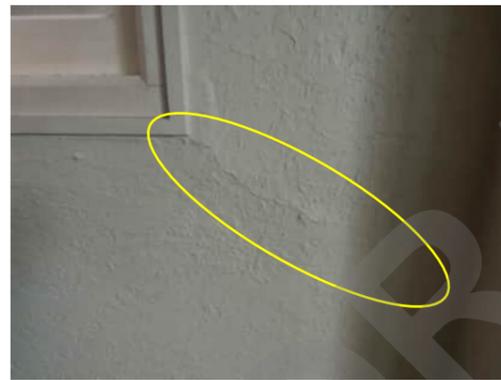
0.29
A-500 | HAIRLINE DIAGONAL CRACK FROM CORNER OF WINDOW BETWEEN GRID 18 AND 19

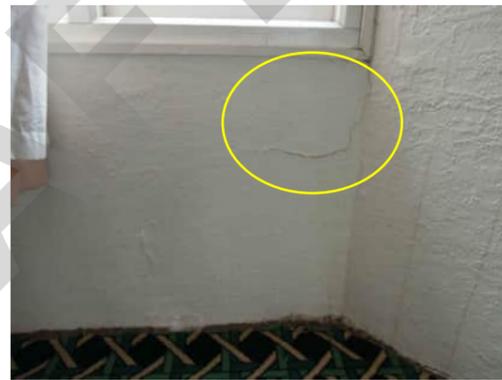
0.30
A-500 | CRACK UP TO 2.5mm BELOW WINDOW ON GRID 20

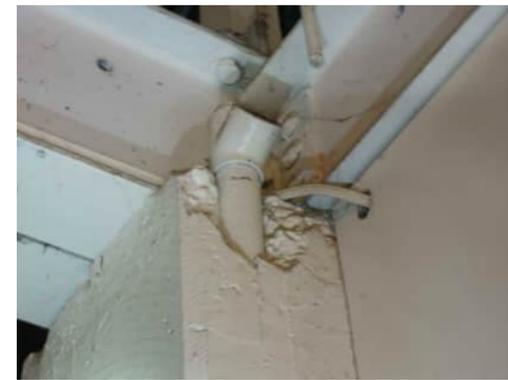
0.31
A-500 | DAMAGE AROUND PIPE CAST INTO COLUMN ON GRID 10

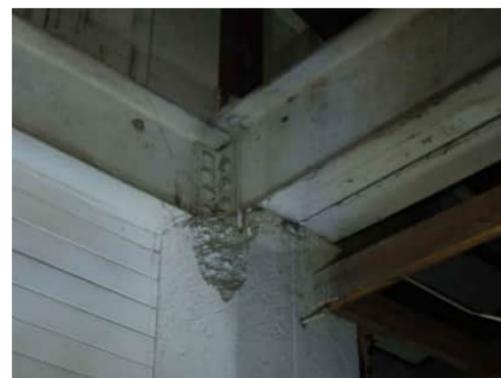
0.32
A-500 | DAMAGE TO TOP OF GRID 12 COLUMN

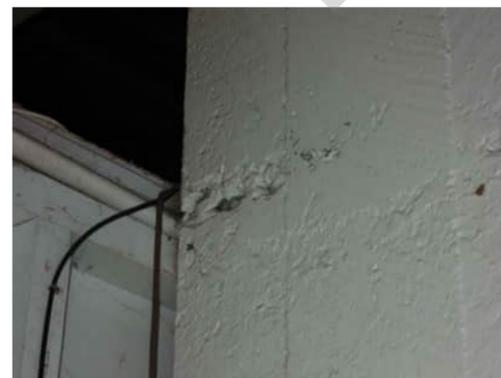
0.33
A-500 | POORLY COMPACTED CONCRETE ON GRID 14 COLUMN

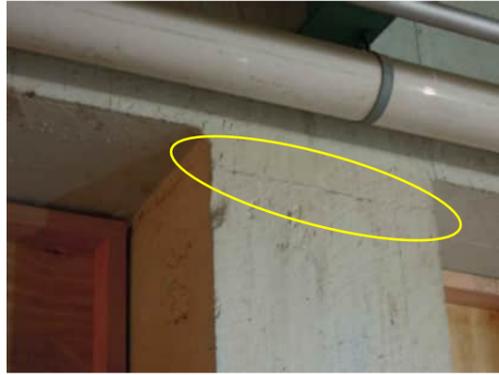
0.36 TYPICAL CRACK NEAR TOP OF COLUMN, ON ALL FACES OF COLUMN
A-500

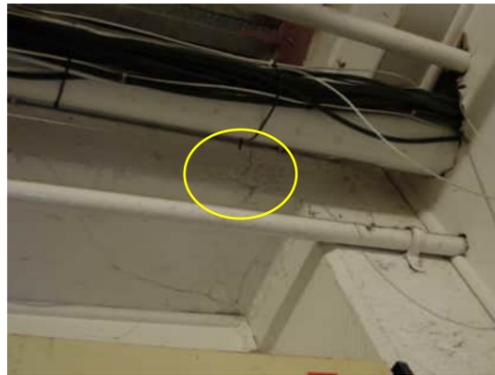
0.37 SIGNIFICANT CRACK TO BEAM NEAR BEAM COLUMN JOINT ON GRID 9
A-500

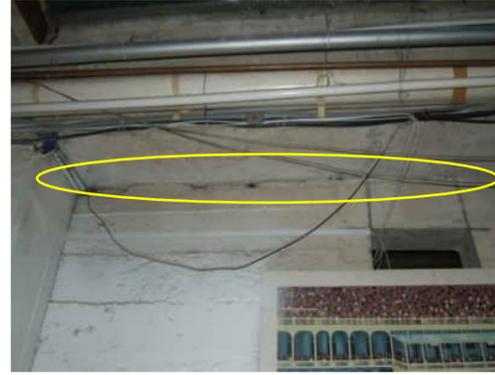
0.38 SEPARATION BETWEEN CONCRETE WALL AND BEAM/COLUMNS BETWEEN GRID 12 AND 13
A-500

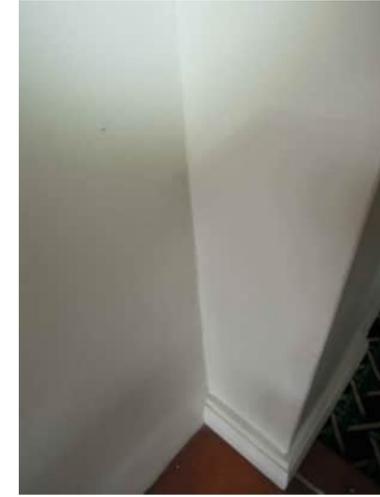
0.39 SEPARATION BETWEEN GRID 13 COLUMN AND GIB LINED WALL
A-500

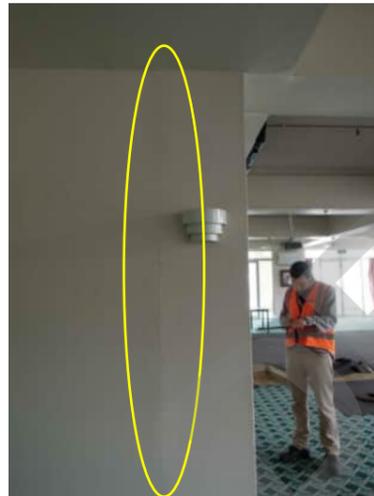
0.41 SEPARATION TO GIB LINING BETWEEN GRID 17 COLUMN AND WALL
A-500

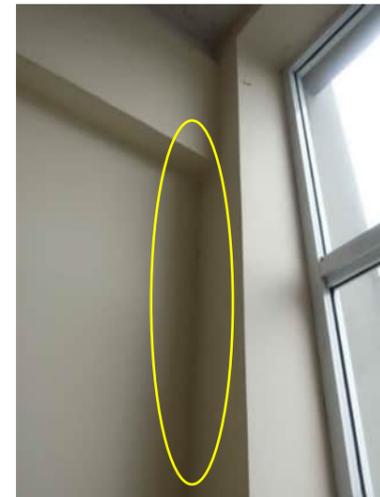
0.43 SEPARATION BETWEEN GRID 21 COLUMN AND WALL
A-500

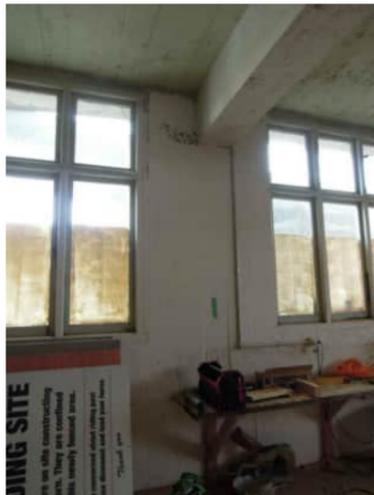
0.44 TYPICAL BEAM COLUMN JOINT ON GRID D
A-500

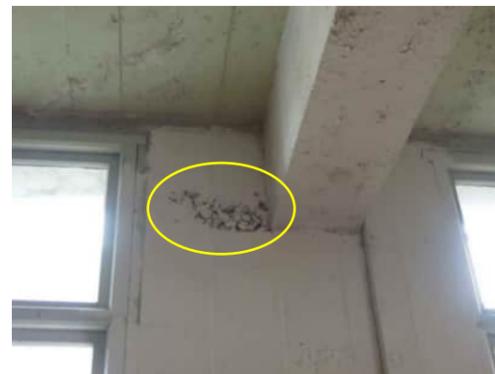
0.45 POORLY COMPACTED CONCRETE AT TOP OF COLUMN, TYPICAL BETWEEN GRID 1 AND GRID 4
A-500

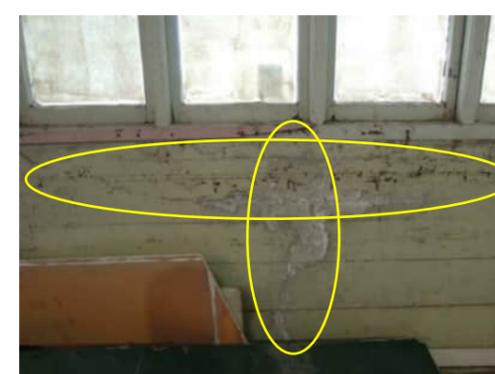
0.46 HORIZONTAL AND VERTICAL CRACK BELOW WINDOW BETWEEN GRID 4 AND 5
A-500

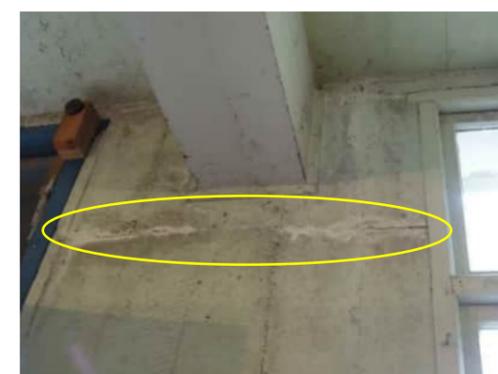
0.47 CRACK IN CONSTRUCTION JOINT ON GRID 5 COLUMN
A-500

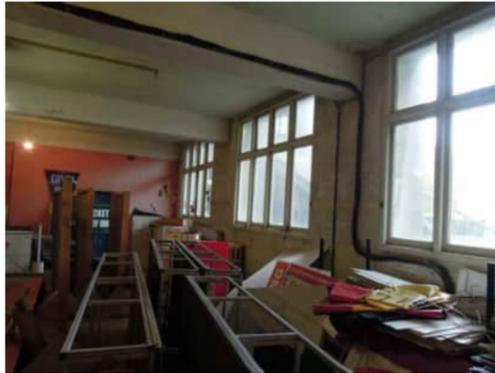
0.48 VIEW OF GRID 6-9, RESTRICTED ACCESS TO LOWER HALF OF WALL DUE TO STORAGE
A-500

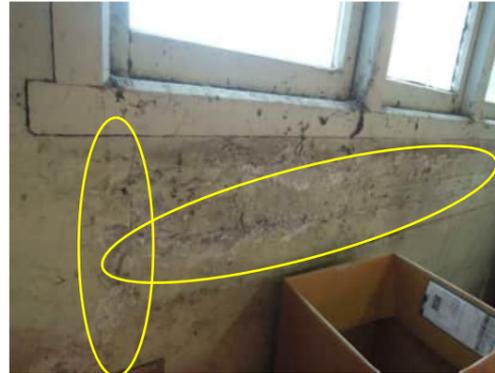
0.49 HORIZONTAL AND VERTICAL CRACK BELOW WINDOW BETWEEN GRID 7 AND 8
A-500

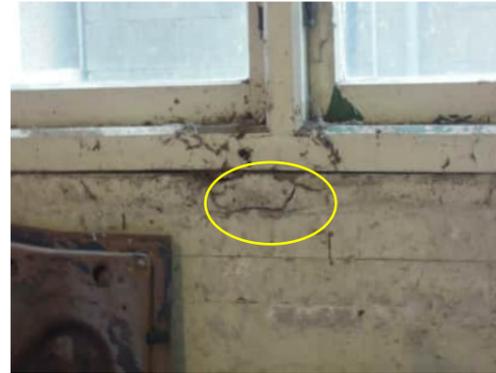
0.50 SIGNIFICANT CRACK BELOW WINDOW BETWEEN GRID 8 AND 9
A-500

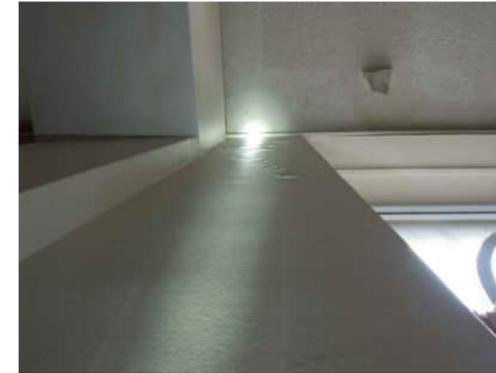
0.51 SIGN OF MOISTURE DAMAGE TO TOP OF COLUMN ON GRID 17, ALSO OCCURS AT GRID 20
A-500

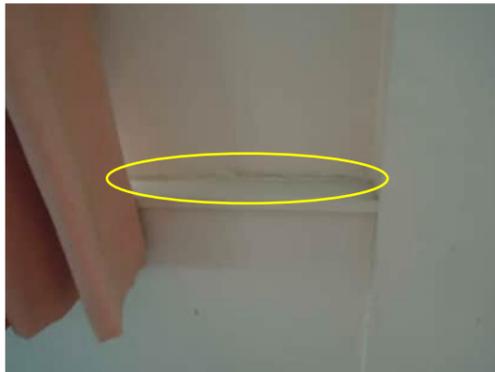
0.52 HORIZONTAL CRACK IN WALL ON GRID 17 IN LINE WITH BOTTOM OF WINDOW
A-500

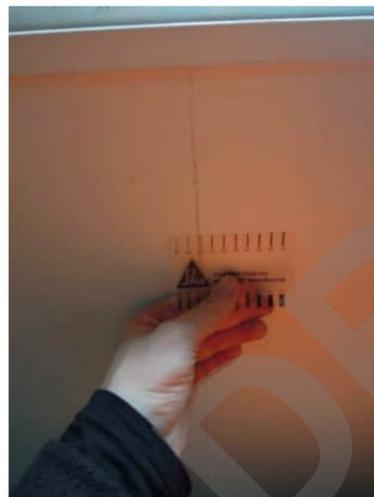
0.53 TYPICAL SEPARATION BETWEEN PLASTER BOARD PANELS, OCCURS FROM GRID 13 TO GRID 20
A-500

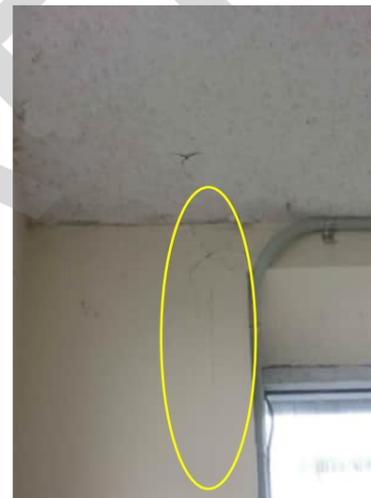
0.54 CRACKS AT TOP OF GRID 21 COLUMN
A-500

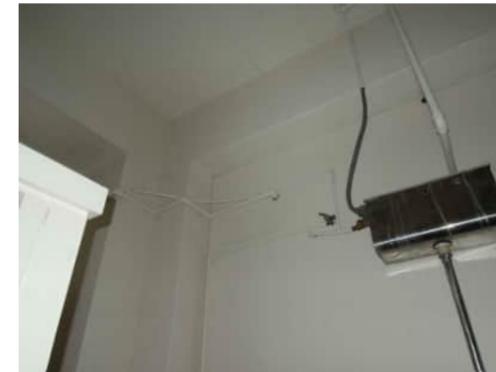
0.55 VIEW OF BEAM COLUMN JOINT AT GRID 13
A-500

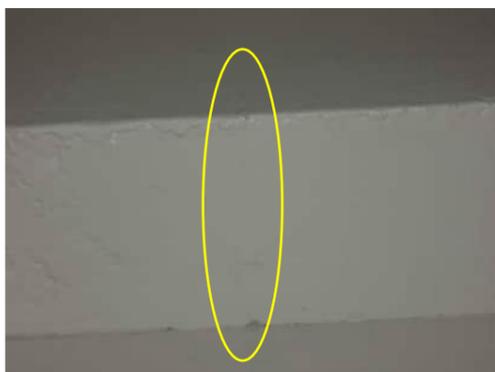
0.56 CRACK TO BEAM BETWEEN GRID 12 AND 13
A-500

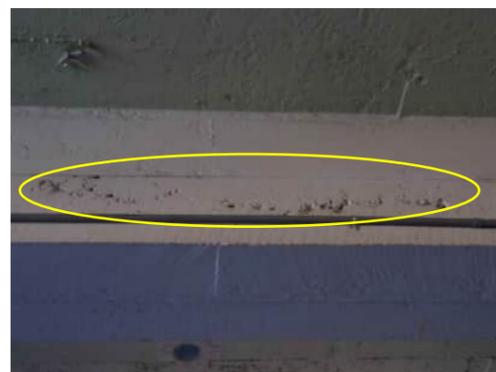
0.58 POORLY COMPACTED CONCRETE ALONG BEAM AT GRID 6 (GRID 8 SIMILAR)
A-500

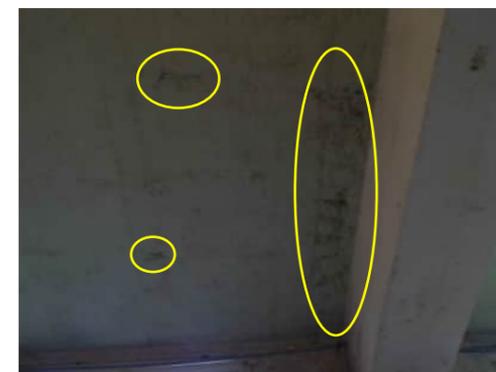
0.59 EXPOSED SLAB BOTTOM REINFORCEMENT, IN THE BAY BETWEEN GRID 8 AND GRID 9
A-500

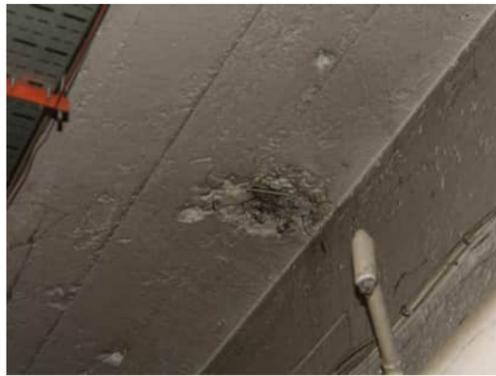
0.60 VOID ON CEILING EXPOSING THE REINFORCING AT GRID 10
A-500

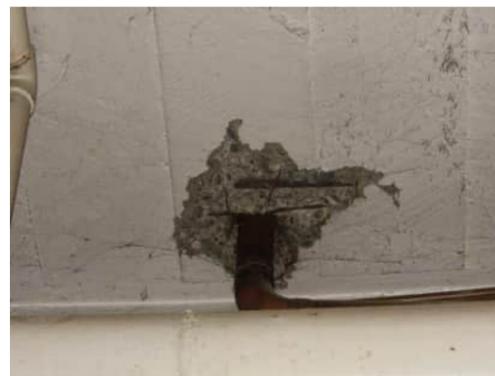
0.61 PIPE THROUGH CEILING WITH SPALLING WHICH HAS EXPOSED REINFORCING
A-500

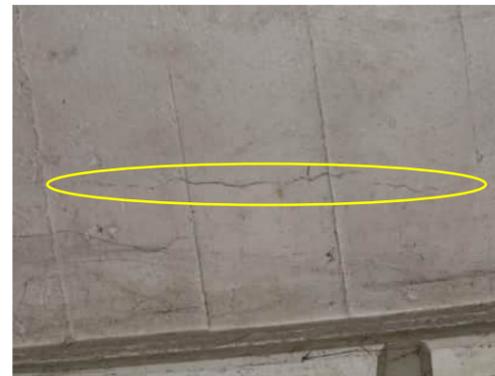
0.62 SIGNIFICANT CRACKS IN THE CEILING NEAR GRID 12/D
A-500

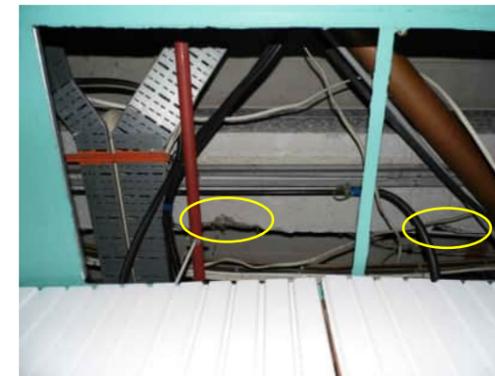
0.63 CORNER OF BEAM ON GRID 10 HAS BROKEN OUT IN TWO LOCATIONS BETWEEN GRID D AND GRID E
A-500

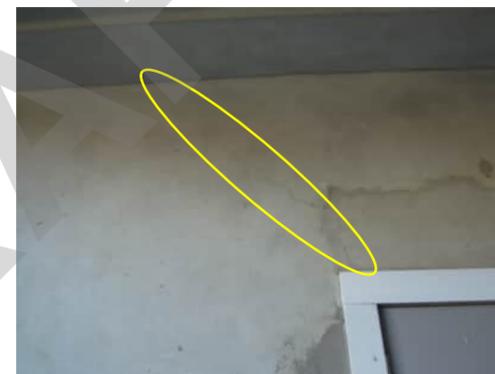
0.66 DIAGONAL CRACK ON EXTERIOR FACE OF CONCRETE WALL
A-500

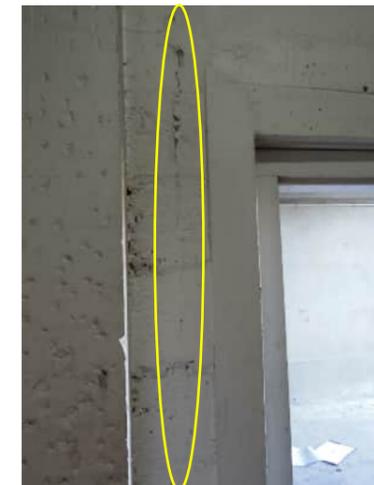
0.67 VERTICAL FULL HEIGHT CRACK IN CONCRETE WALL PANEL ON INTERIOR FACE
A-500

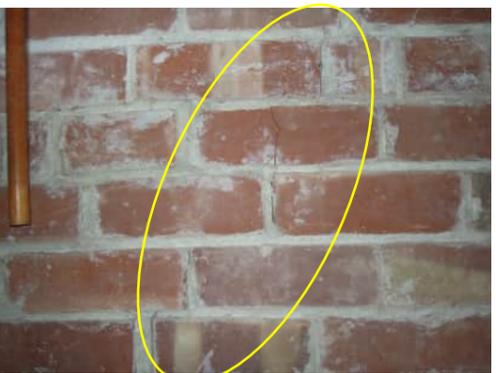
0.68 DIAGONAL STEP CRACKING IN RED BRICK INFILL PANEL
A-500

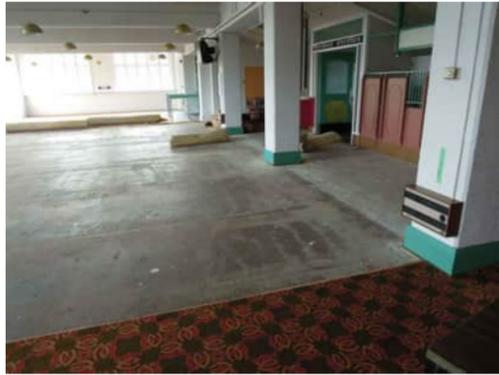
1.1 VIEW OF EXPOSED SLAB
A-510

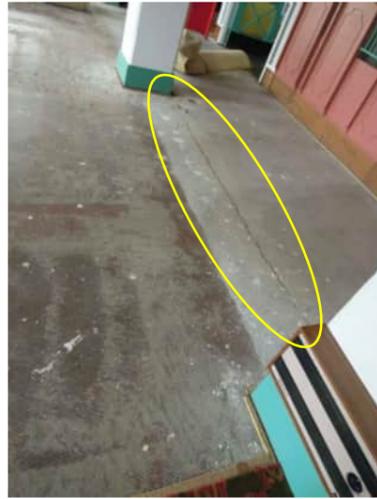
1.2 LOCATION OF CRACK BETWEEN GRID C COLUMNS
A-510

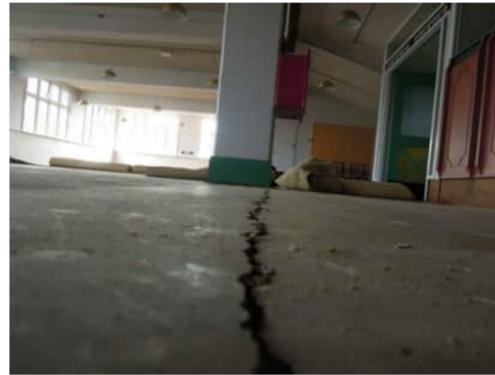
1.3 CRACK BETWEEN GRID C COLUMNS UP TO 10MM WIDE WITH 5MM VERTICAL DISPLACEMENT
A-510

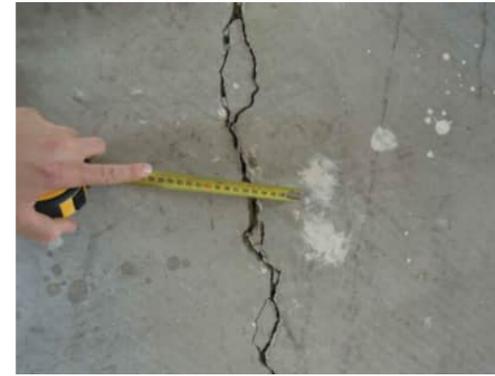
1.4 SPALLING OF CRACK BETWEEN GRID C COLUMNS
A-510

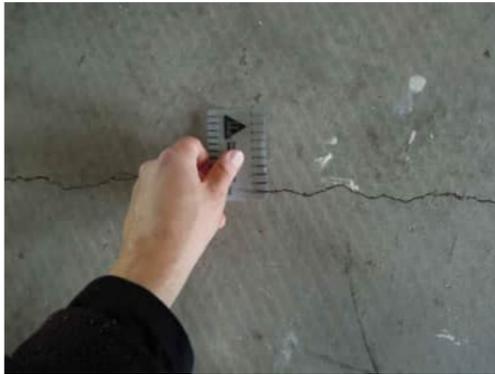
1.5 CRACK UP TO 1MM PERPENDICULAR TO THE CRACKS BETWEEN GRID C COLUMNS
A-510

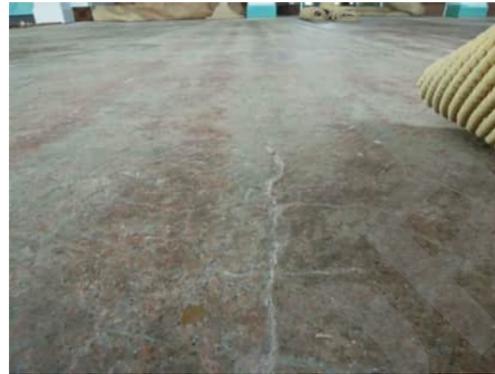
1.6 TYPICAL CRACK OVER THE CENTRE OF BEAMS RUNNING BETWEEN GRID C AND GRID D
A-510

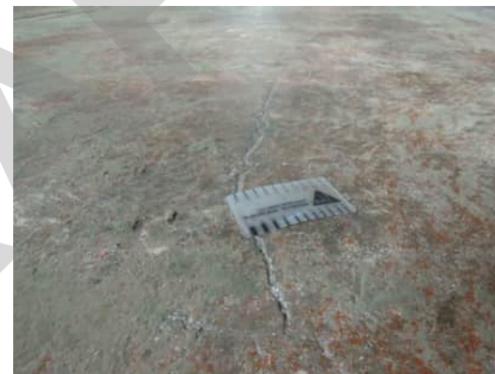
1.7 CRACKS ARE UP TO 5MM ON THE SURFACE
A-510

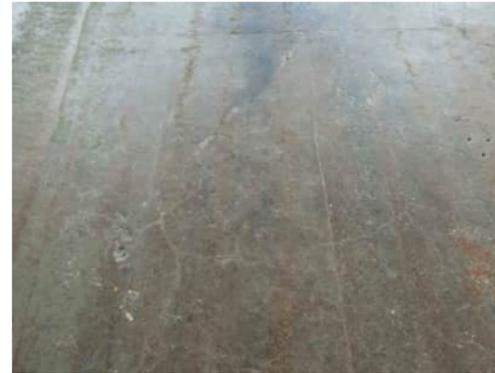
1.8 CRAZED CRACK PATTERN ON SLAB BETWEEN GRID 4 AND 5
A-510

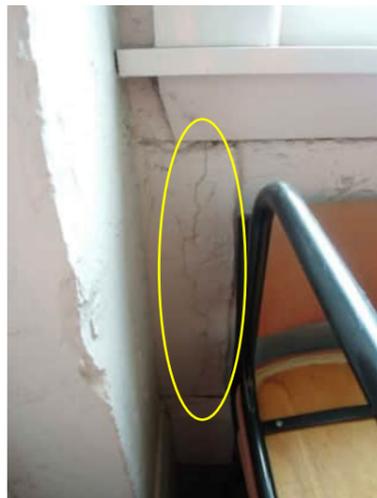
1.9 0.9MM VERTICAL CRACK FROM BOTTOM OF WINDOW IN GRID C COLUMN
A-510

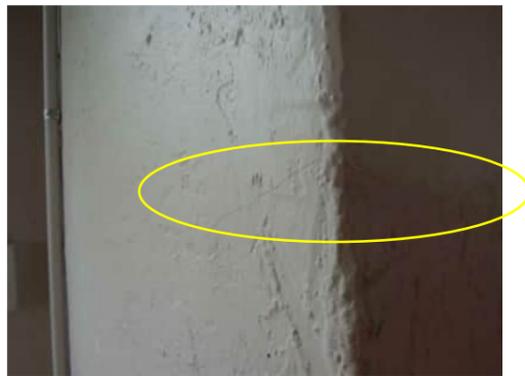
1.10 HAIRLINE HORIZONTAL CRACK AROUND COLUMN AT MID HEIGHT
A-510

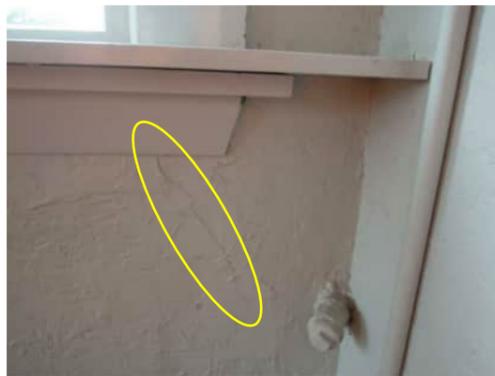
1.11 0.3MM DIAGONAL CRACK FROM BOTTOM OF WINDOW IN GRID C COLUMN
A-510

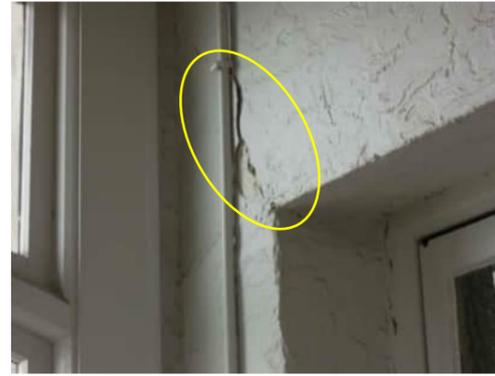
1.12 DIAGONAL CRACK FROM TOP CORNER OF WINDOW IN WALL BETWEEN GRID B AND C
A-510

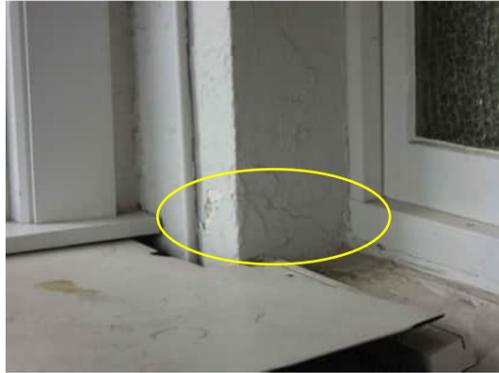
1.13 | CRACK FROM BOTTOM CORNER OF WINDOW IN WALL BETWEEN GRID B AND C
A-510

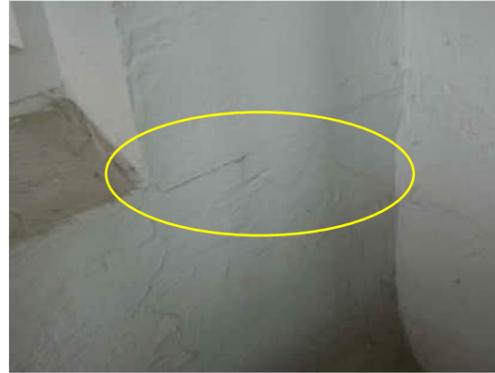
1.14 | CRACK FROM BOTTOM CORNER OF WINDOW IN GRID C COLUMN
A-510

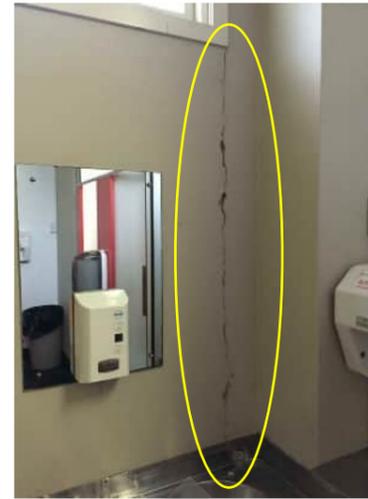
1.15 | CRACK BETWEEN GRID D COLUMN AND WALL 2-3MM WIDE WITH SPALLING UP TO 25MM ON SURFACE
A-510

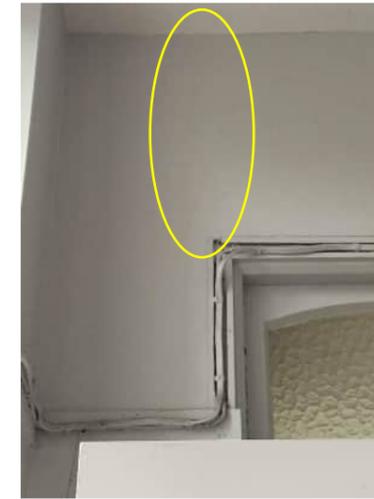
1.16 | CRACK IN GRID E COLUMN ABOVE WINDOW FRAME
A-510

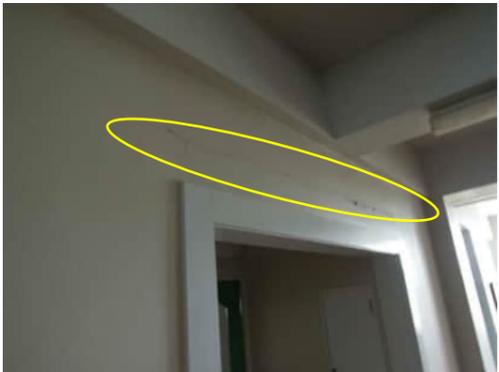
1.17 | HORIZONTAL CRACK ALONG WALL BELOW THE BEAM ABOVE OPENING
A-510

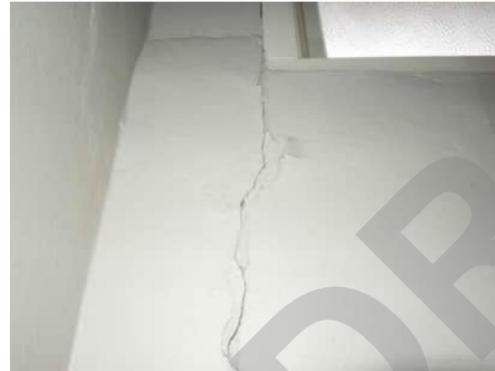
1.18 | 1.6MM VERTICAL CRACK BETWEEN WALL AND COLUMN AT GRID D
A-510

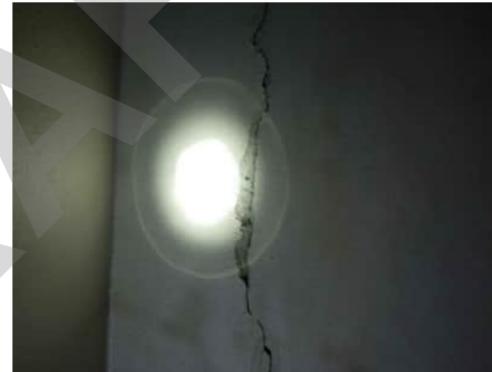
1.19 | SPALLING OF CRACK BETWEEN WALL AND COLUMN AT GRID D
A-510

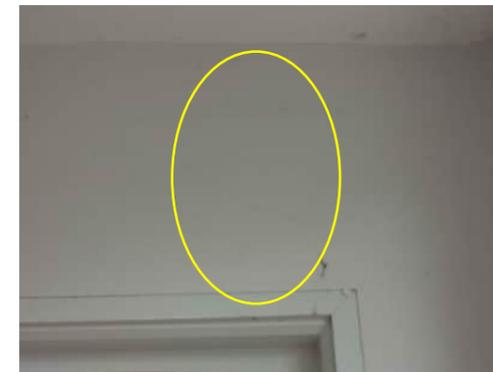
1.20 | CRACK IN WALL NEAR GRID E ABOVE WINDOW FRAME
A-510

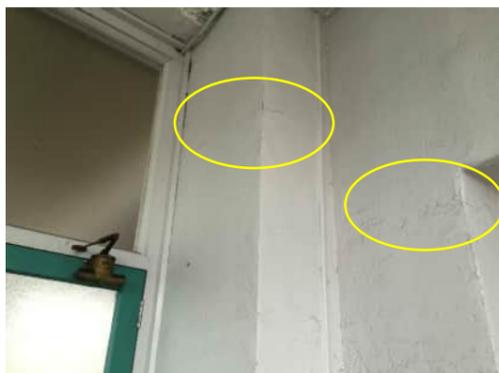
1.21 | HORIZONTAL CRACK IN GRID C COLUMN 0.5m FROM TOP OF COLUMN. CRACK IN WALL NEAR TOP OF WINDOW FRAME
A-510

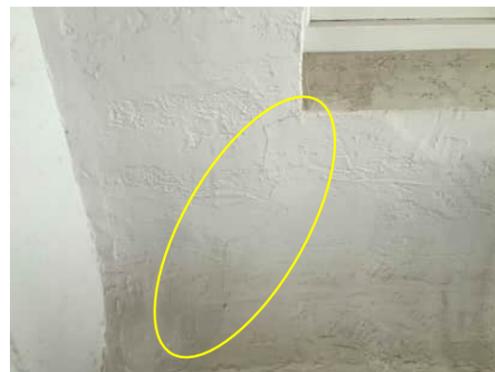
1.22 | DIAGONAL CRACK FROM BOTTOM CORNER OF WINDOW IN GRID C COLUMN
A-510

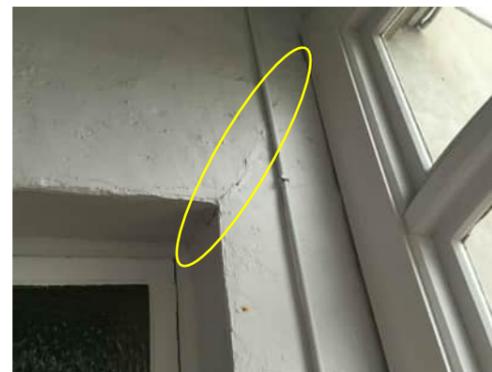
1.23 | DIAGONAL CRACK FROM TOP CORNER OF WINDOW IN WALL BETWEEN GRID B AND C
A-510

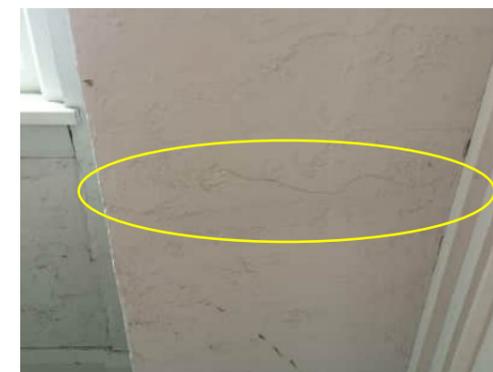
1.24 | HORIZONTAL CRACK AROUND GRID C COLUMN 1m FROM FLOOR
A-510

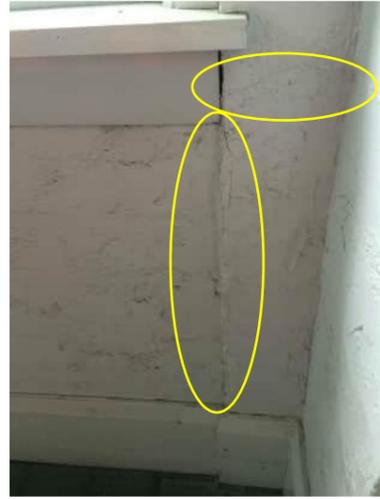
1.25 | CRACK IN CORNER OF GRID C COLUMN BELOW WINDOW
A-510

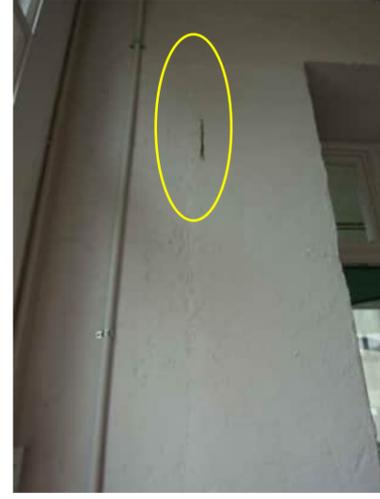
1.26 | DAMAGE TO SURFACE BETWEEN GRID 1 COLUMN AND CONCRETE DOOR FRAME
A-510

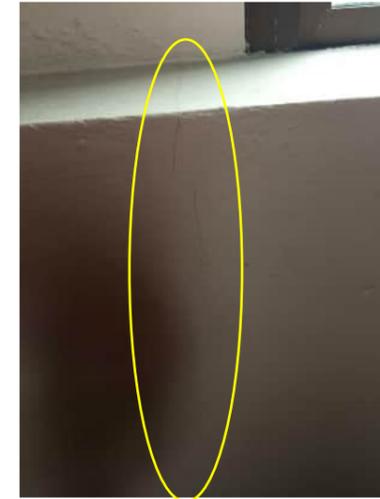
1.28 | VERTICAL CRACK UP TO 0.2mm BELOW WINDOW AT GRID 11 IN LIFT SHAFT EXTENSION
A-510

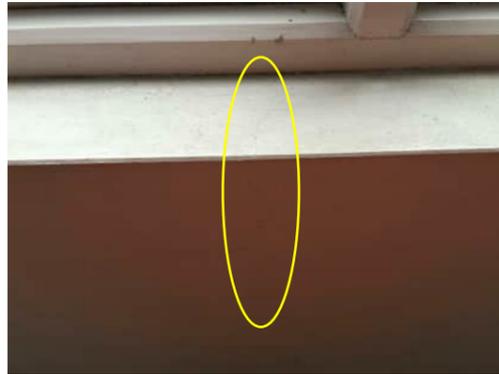
1.29 | HAIRLINE VERTICAL CRACK BELOW WINDOW BETWEEN GRID 12 AND 13
A-510

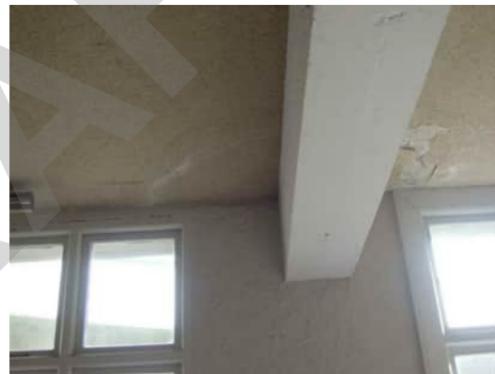
1.31 | TYPICAL MOISTURE DAMAGE TO CEILING AT BEAM COLUMN JOINTS ALONG GRID D
A-510

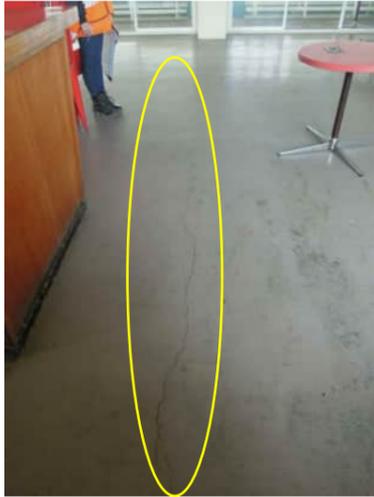
2.1 | TYPICAL CRACK ABOVE BEAM ON GRID 7, UP TO 1.6MM
A-520 | TYPICAL FOR GRIDS 2-12

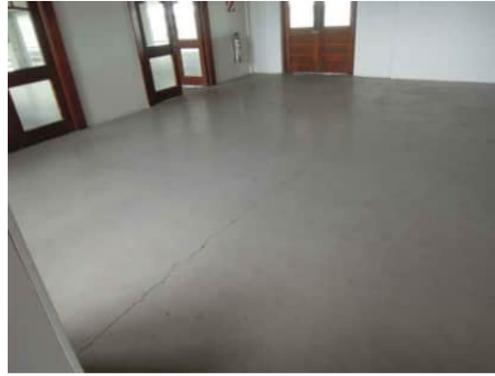
2.2 | CRACK ABOVE BEAM ON GRID 9, UP TO 10MM
A-520

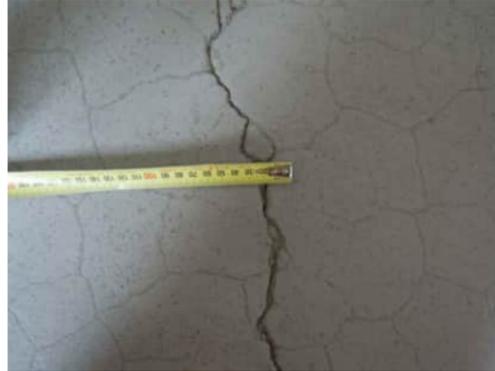
2.3 | CRACK RUNNING DIAGONALLY ACROSS SLAB, UP TO 10MM
A-520

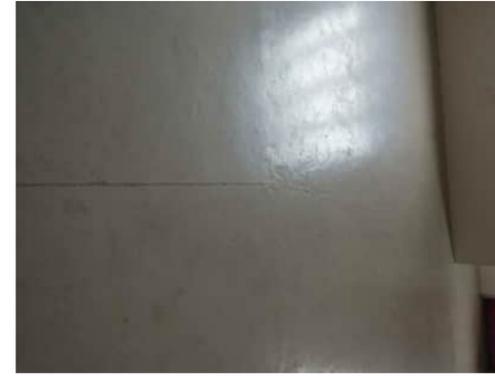
2.4 | CRACK ABOVE BEAM AT CONSTRUCTION JOINT UP TO 2.5MM
A-520

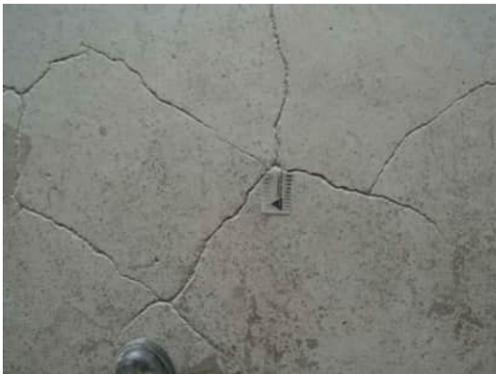
2.5 | CRACKING TO SLAB UP TO 5MM
A-520

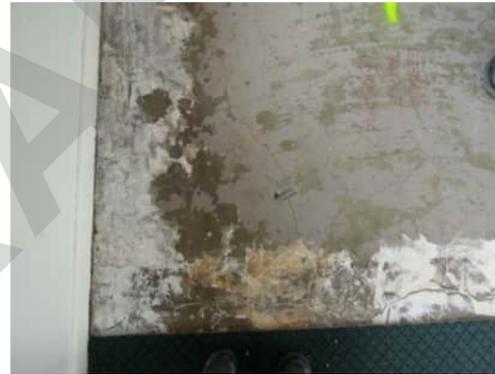
2.7 | PARTIALLY FILLED CRACKS ON SLAB, UP TO 0.8MM
A-520

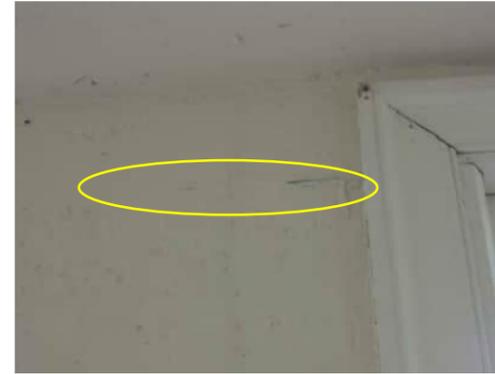
2.8 | CRACK NEAR TOP OF WINDOW ON COLUMN BETWEEN GRID C AND GRID D
A-520
