Damage Assessment Report

Grand National (Public) Stand

Client: Canterbury Jockey Club

Job No.: 60332326

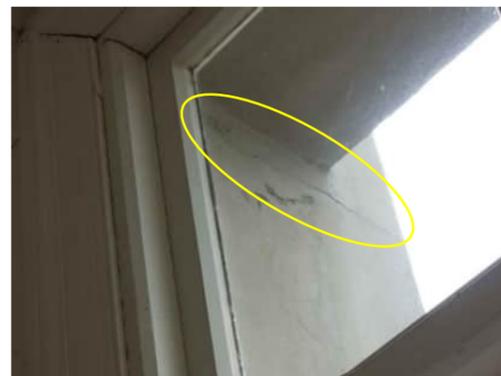
2.9 | CRACK NEAR TOP OF WINDOW ON COLUMN BETWEEN GRID C AND GRID D CONTINUES TO EXTERIOR
A-520

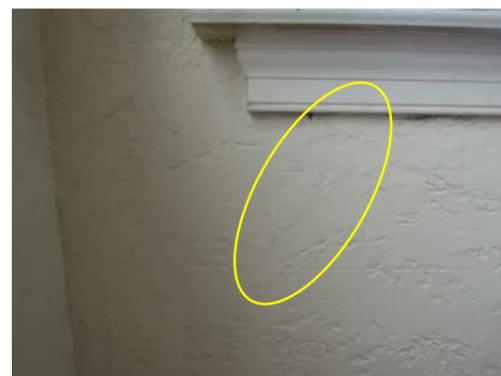
2.10 | 0.1MM DIAGONAL CRACK FROM BOTTOM OF WINDOW AT GRID D
A-520

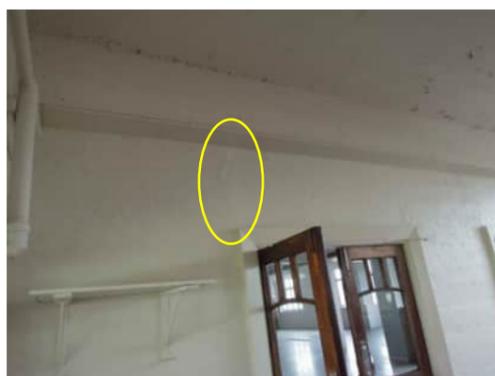
2.11 | CRACKS ABOVE DOOR FRAME IN WALL ALONG GRID 8 BETWEEN GRID C AND GRID D
A-520

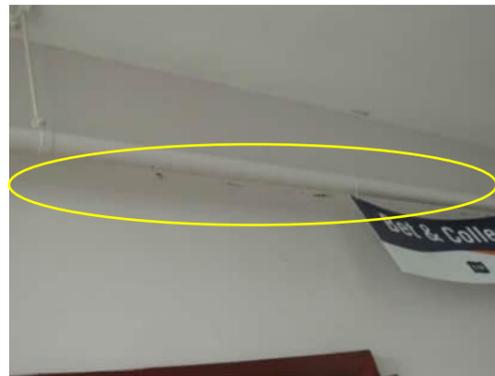
2.12 | SEPARATION BETWEEN WALL AND BEAM BETWEEN GRID C AND GRID D
A-520

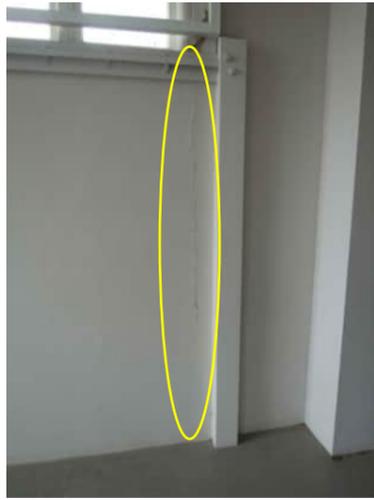
2.13 | VERTICAL CRACK BETWEEN GRID D COLUMN AND WALL
A-520 | AVERAGE 2MM, UP TO 3.5MM

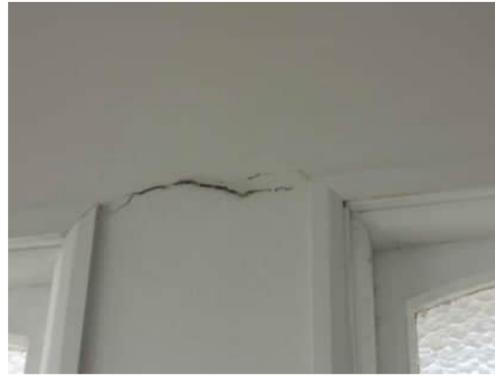
2.14 | SIGNIFICANT HORIZONTAL CRACK WITH SPALLING ON WALL
A-520 | BETWEEN WINDOWS BETWEEN GRID D AND GRID E

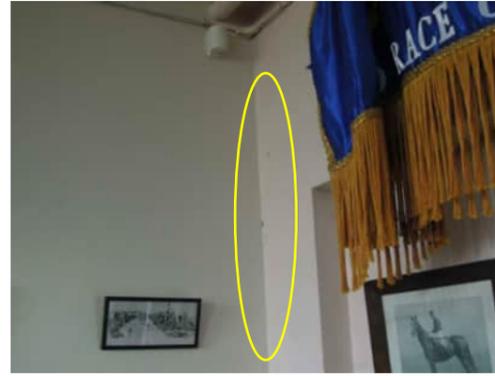
2.15 | SEPARATION BETWEEN GRID D COLUMN AND WALL
A-520

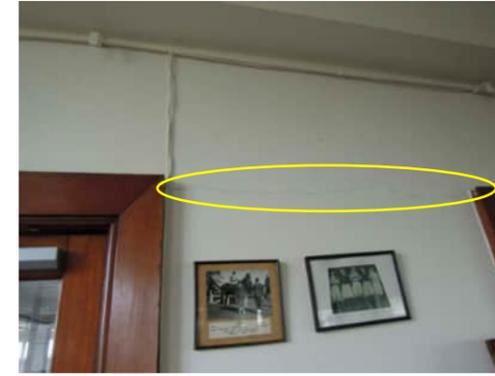
2.16 | CRACK IN WALL BETWEEN GRID C AND GRID D,
A-520 | BETWEEN DOOR FRAMES

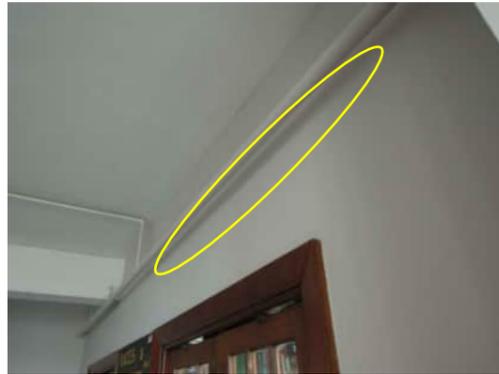
2.17 | SEPARATION BETWEEN WALL AND BEAM BETWEEN
A-520 | GRID C AND GRID D

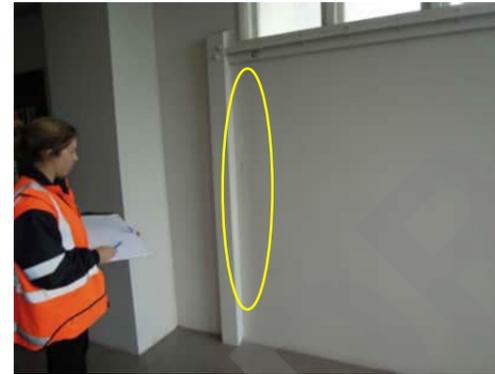
2.18 | 0.7MM VERTICAL CRACK BETWEEN GRID D COLUMN AND
A-520 | WALL

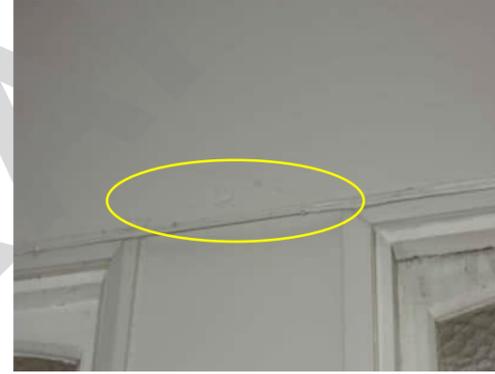
2.19 | CRACK BETWEEN WINDOWS BETWEEN GRID D AND
A-520 | GRID E

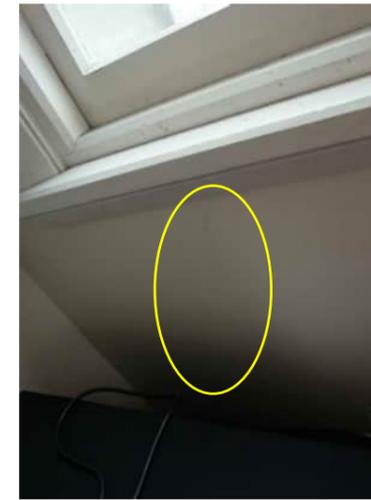
2.20 | HAIRLINE DIAGONAL CRACK BELOW WINDOW NEXT TO
A-520 | GRID C COLUMN

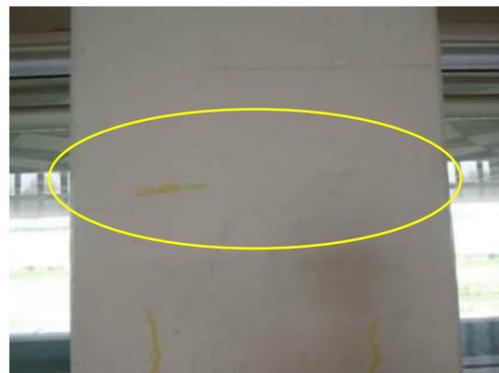
2.21 | HAIRLINE CRACK AROUND GRID 6 COLUMN
A-520 | (GRID 3, 14 AND 15 COLUMNS SIMILAR)

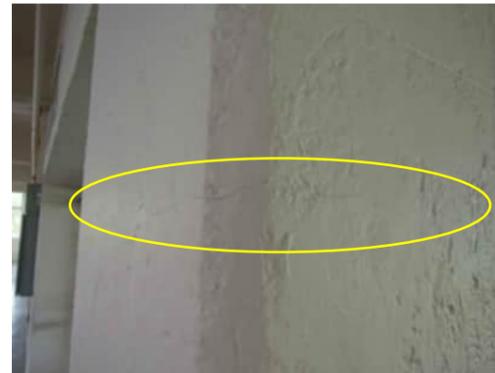
2.22 | HAIRLINE CRACK CONTINUES AROUND GRID 6 COLUMN
A-520 | (GRID 3, 14 AND 15 COLUMNS SIMILAR)

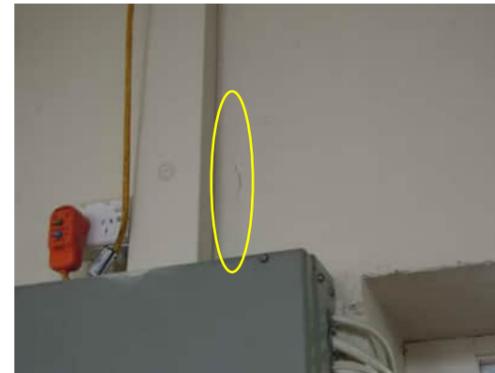
2.23 | VERTICAL CRACK IN BEAM ABOVE GRID 5 COLUMN
A-520

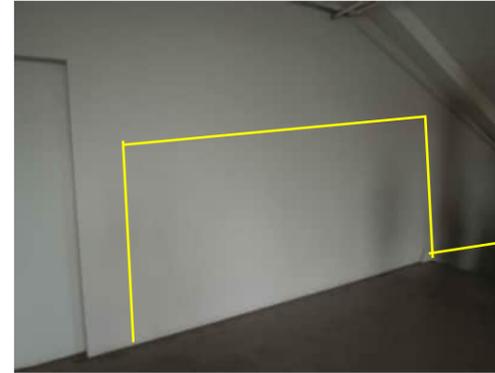
2.24 | 0.3-0.4mm CRACK IN SHEAR WALL AT LOCATION WHERE
A-520 | WALL THICKENS, BETWEEN GRID 8-9 (GRID 12-13 SIMILAR)

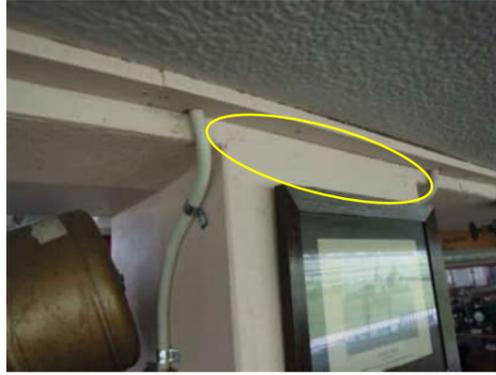
2.25 | CRACK IN BEAM COLUMN JOINT AT GRID 16
A-520

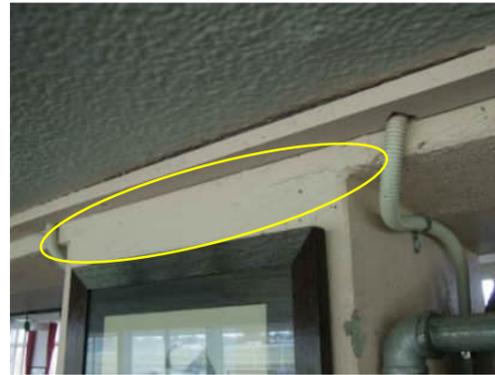
2.26 | CRACK IN BEAM COLUMN JOINT AT GRID 16
A-520

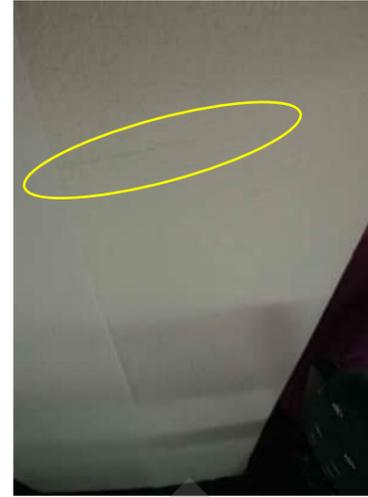
2.27 | MULTIPLE HAIRLINE HORIZONTAL CRACKS DOWN SIDE OF COLUMN ON GRID 16 (GRID 17 SIMILAR)
A-520

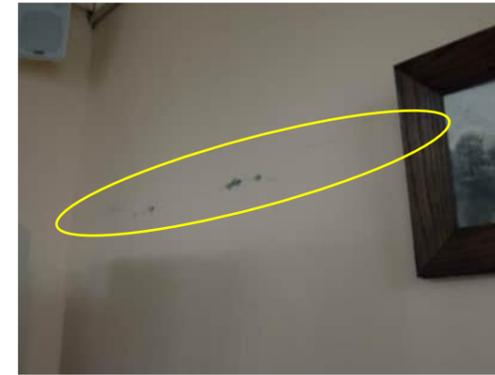
2.28 | CRACK BETWEEN BEAM AND WALL BETWEEN GRID 19 AND 20
A-520

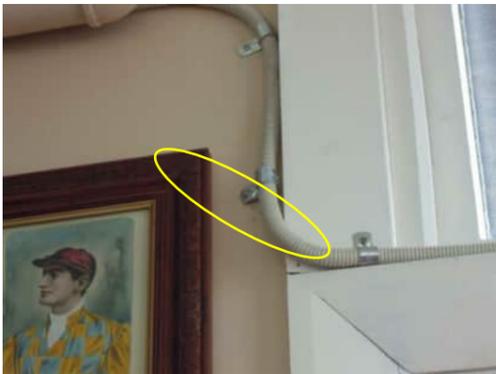
2.29 | DIAGONAL CRACK FROM CORNER OF WINDOW IN GRID 20 COLUMN
A-520

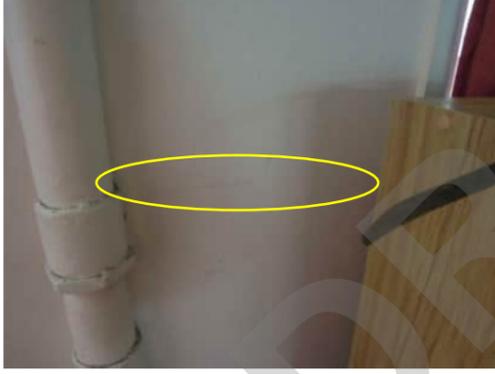
2.30 | HORIZONTAL HAIRLINE CRACK IN COLUMN AT GRID 14 (GRID 8, 17 AND 19 SIMILAR)
A-520

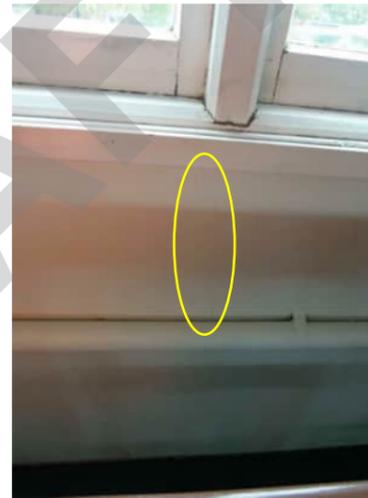
2.31 | 0.1-0.2mm WIDE VERTICAL CRACK BELOW WINDOW BETWEEN GRID 16 AND 17
A-520

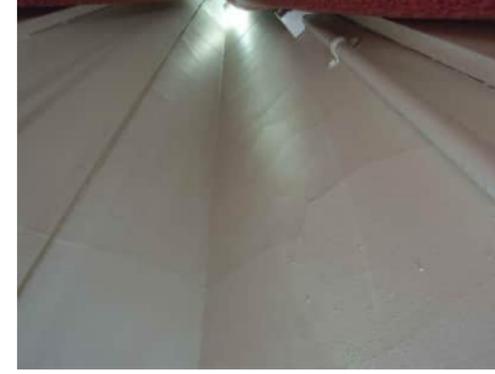
2.32 | CRAZED CRACKS UP WHOLE HEIGHT OF COLUMN AT GRID 21
A-520

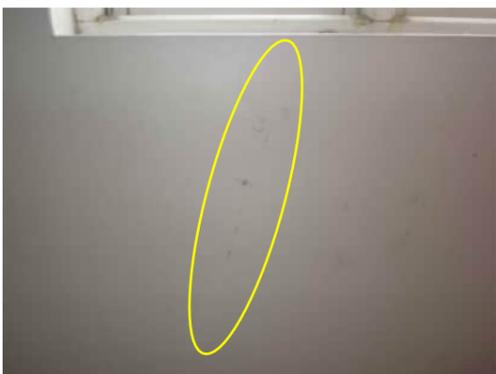
2.33 | HAIRLINE DIAGONAL CRACK BELOW WINDOW BETWEEN GRID 9 AND 10 WITH SOME MOISTURE SEEPAGE
A-520

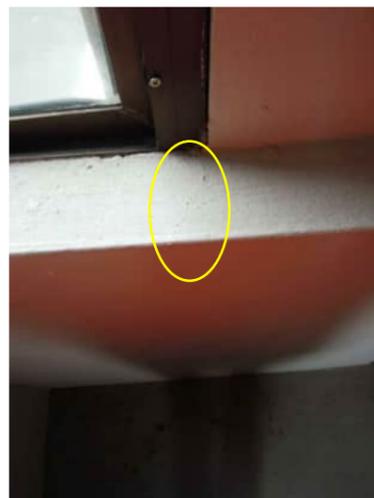
2.34 | HAIRLINE CRACK BELOW WINDOW IN LIFT SHAFT WALL ON GRID 10
A-520

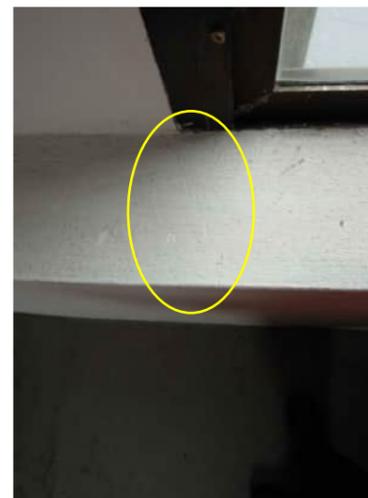
2.35 | HAIRLINE CRACK BELOW WINDOW IN LIFT SHAFT WALL ON GRID 11
A-520

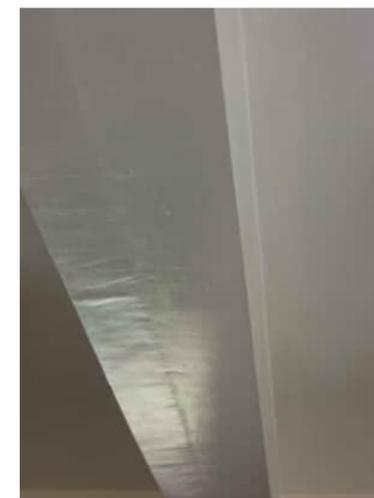
2.36 | TYPICAL CRACKS ALONG LENGTH OF BEAM
A-520

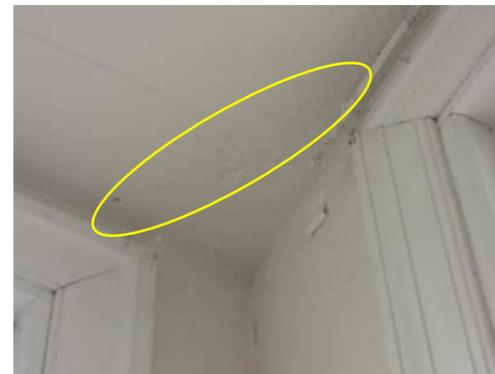
2.39
A-520 | CRACK IN CORNER OF SLAB SOFFIT AT GRID 1/C

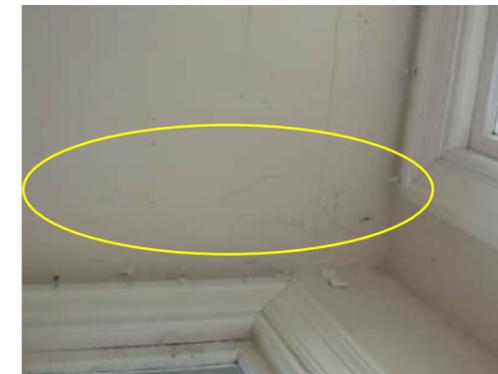
2.40
A-520 | CRACK IN CORNER OF SLAB SOFFIT AT GRID 1/D

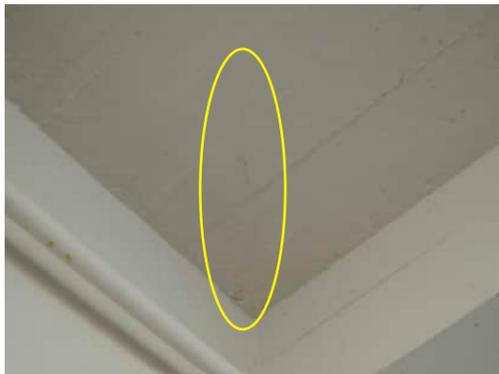
2.41
A-520 | CRACK FROM CORNER OF SLAB SOFFIT AT GRID 7/C

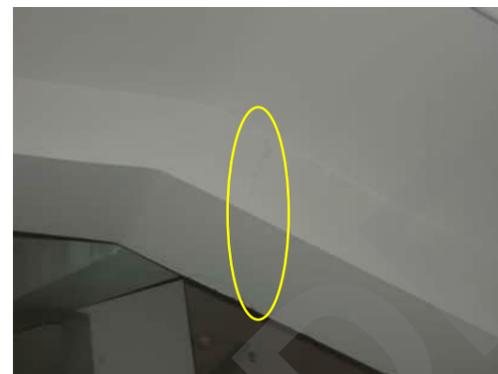
2.42
A-520 | CRACK ON BEAM UNDER STAIRS

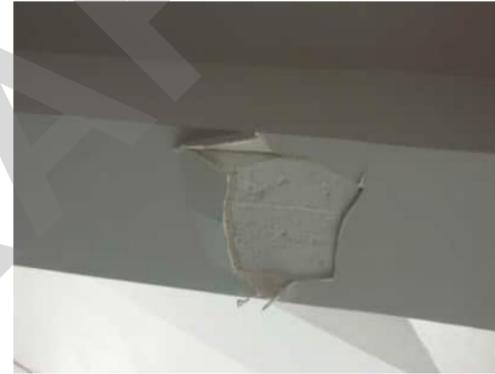
2.43
A-520 | PLASTER BREAKING OFF BEAM UNDERNEATH STAIRS

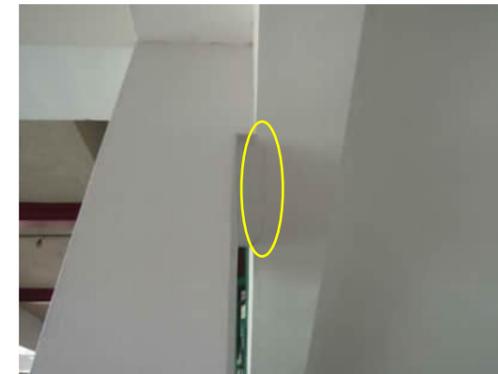
2.44
A-520 | SEPARATION BETWEEN COLUMN AND CEILING AT STAIRS

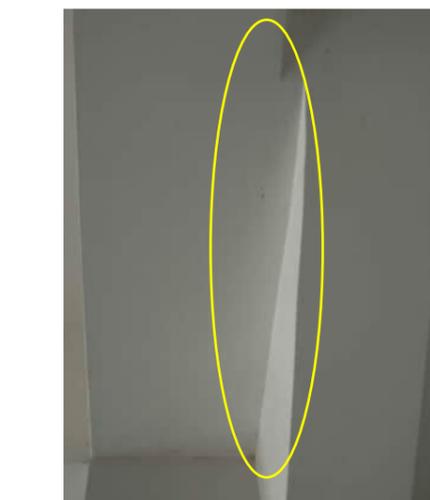
2.45
A-520 | SEPARATION BETWEEN CEILING AND STAIRS

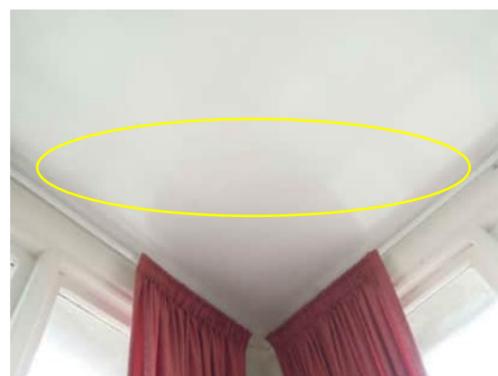
2.46
A-520 | CRACKING TO PLASTER IN CORNER OF SLAB SOFFIT AT GRID 21/D

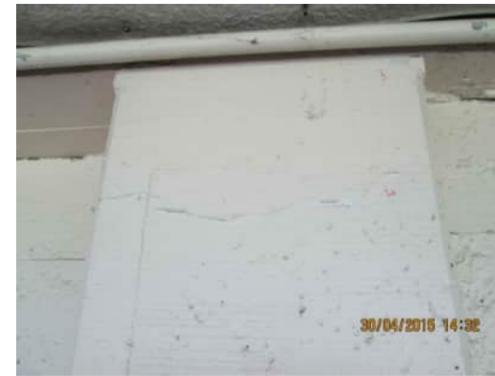
2.47
A-520 | CRACKING TO COLUMN AT GRID 9

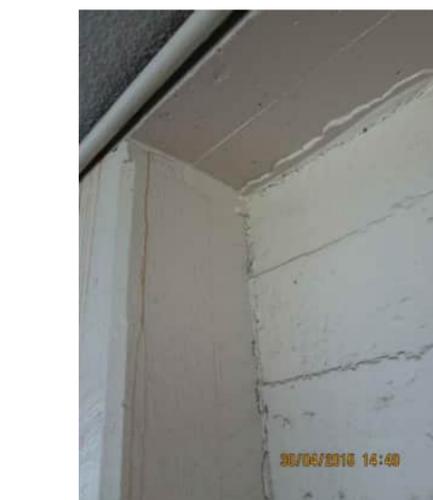
2.48
A-520 | CRACKING TO COLUMN AT GRID 13 AND ADJACENT SHEAR WALL

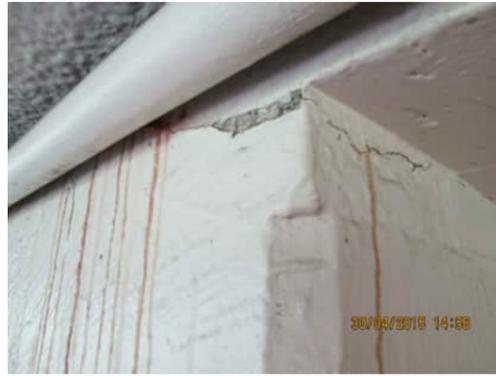
2.49
A-520 | CRACKING TO TOP OF COLUMN AT GRID 13

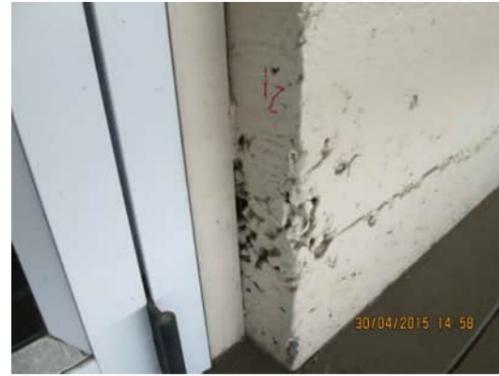
2.50
A-520 | CONCRETE SEGREGATION AT THE BOTTOM OF SHEAR WALL

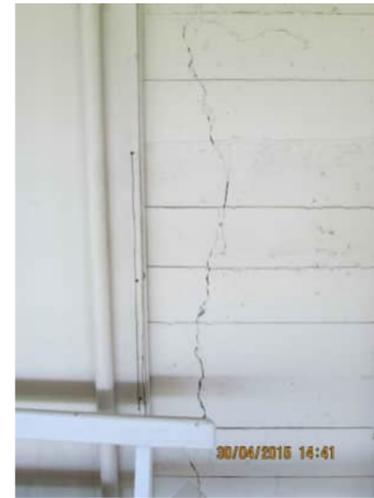
2.51
A-520 | VERTICAL 3.5mm WIDE CRACK TO SHEAR WALL

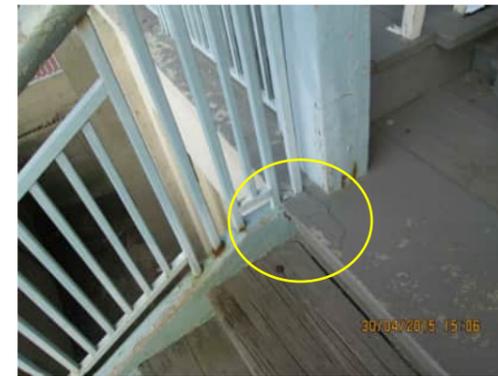
2.52
A-520 | LOWER STAND SLAB EDGE CRACKING

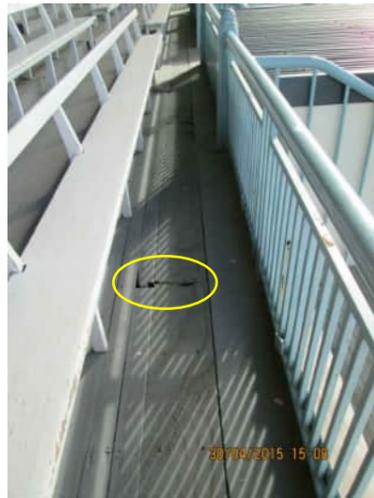
2.53
A-520 | LOWER STAND DAMAGE TO TIMBER DECKING

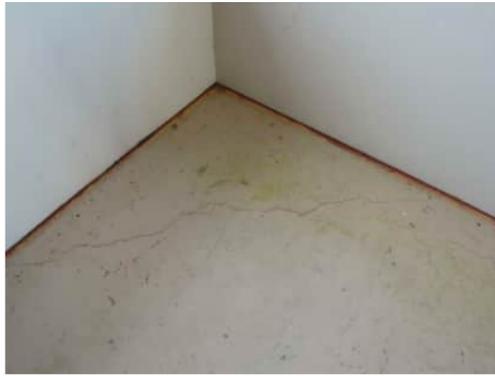
3.1 | DIAGONAL CRACKS AT CORNER OF BUILDING UP TO 3MM
A-530

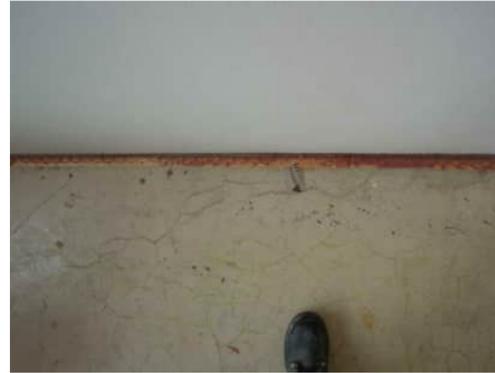
3.2 | CRACK UP TO 0.8MM ALONG GRID 1
A-530

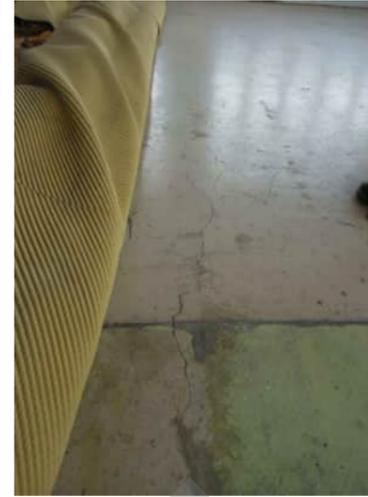
3.3 | CRACK ALONG GRID 2 UP TO 1.8MM WIDE
A-530

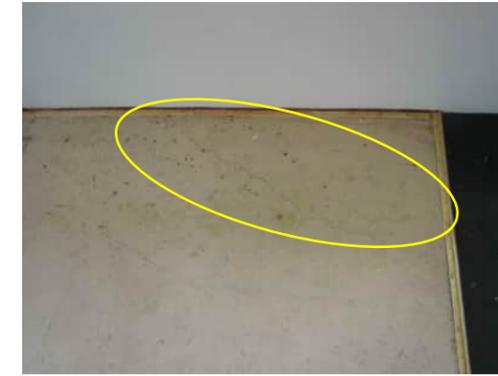
3.4 | DIAGONAL CRACK IN CORNER UP TO 1.2MM
A-530

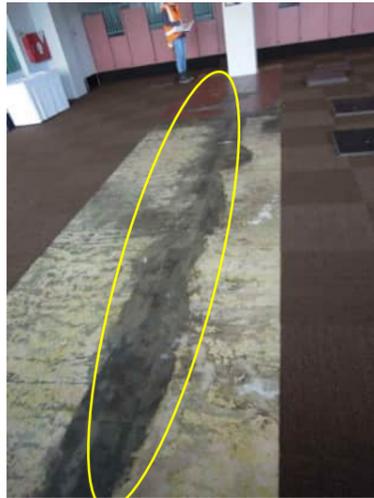
3.5 | CRACK ABOVE GRID 6 BEAM WHICH HAS BEEN PARTIALLY REPAIRED
A-530

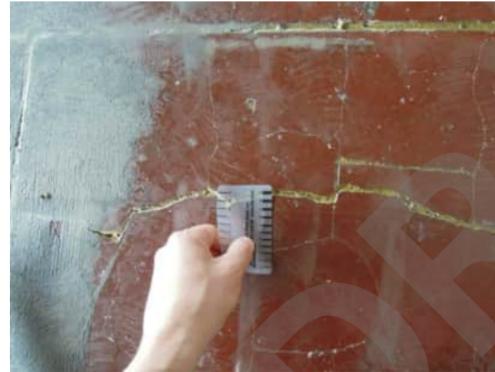
3.6 | CRACK ABOVE GRID 6 BEAM IS UP TO 5MM WIDE
A-530

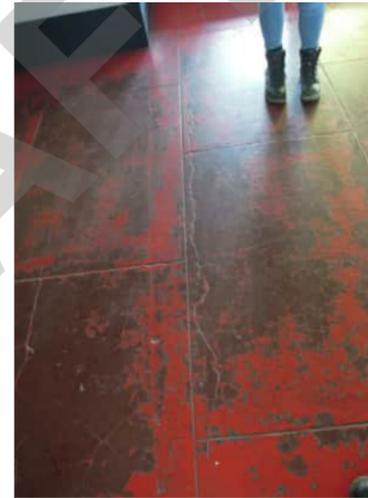
3.7 | CRACK IN COATING, SPALLING UP TO 10MM WIDE AT SURFACE
A-530

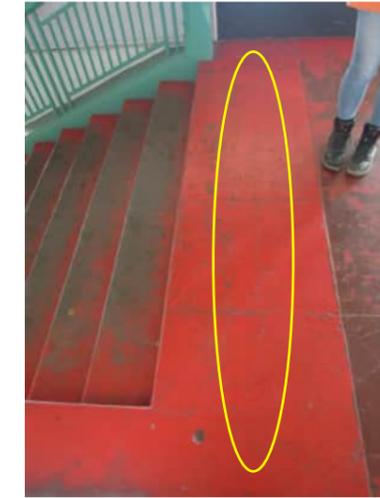
3.8 | CRACK IN COATING ALONG TOP OF STAIRS SPALLING UP TO 10MM WIDE AT SURFACE
A-530

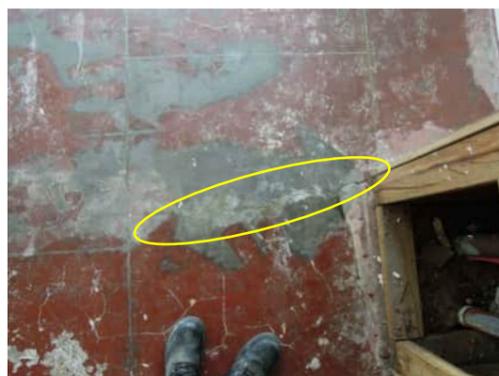
3.9 | CRACK UP TO 5MM WHICH HAS PREVIOUSLY BEEN PARTIALLY REPAIRED
A-530

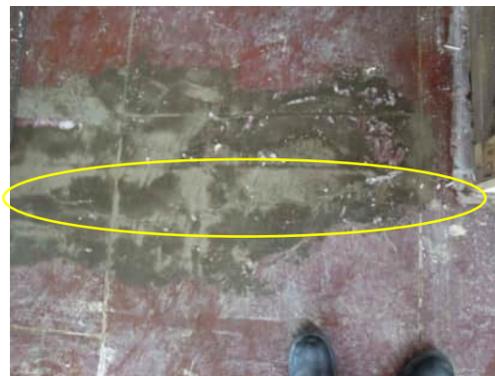
3.10 | CRACK UP TO 2MM WHICH HAS BEEN PREVIOUSLY REPAIRED
A-530

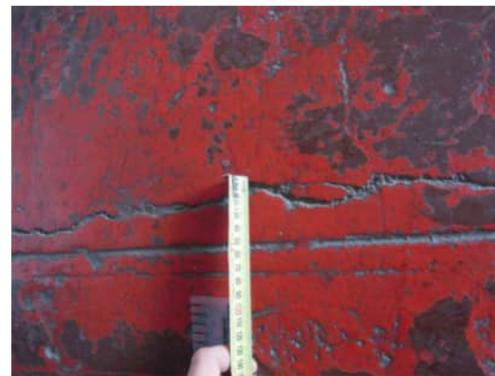
3.11 | CRACK IN COATING SPALLING UP TO 10MM WIDE AT SURFACE
A-530

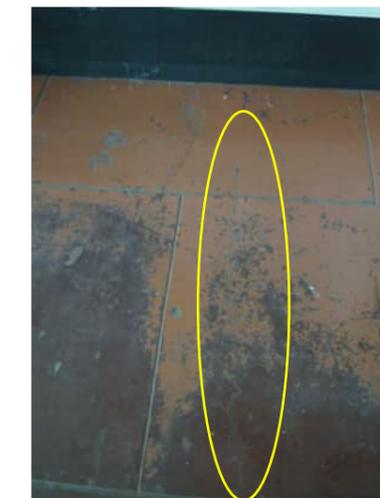
3.12 | CRACK IN COATING UP TO 3MM WIDE
A-530

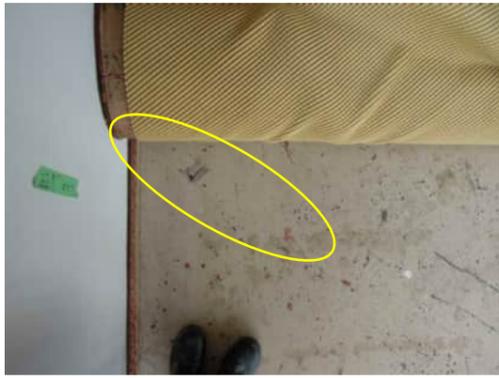
3.13 | CRACK ALONG GRID 20 UP TO 0.9MM WIDE
A-530

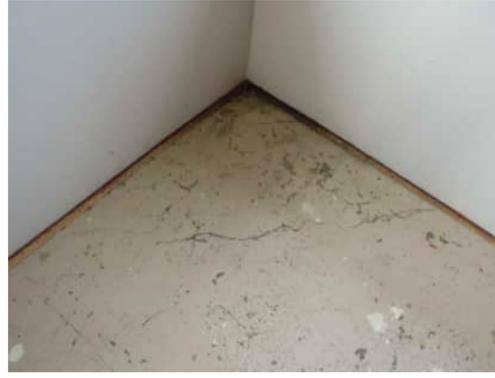
3.14 | CRACKS IN CORNER UP TO 0.6MM
A-530

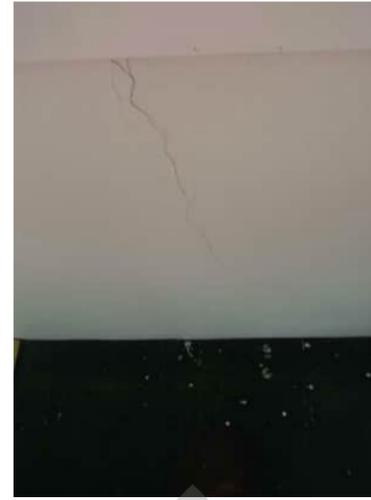
3.15 | VERTICAL CRACK BELOW WINDOW UP TO 0.4MM NEAR GRID C
A-530

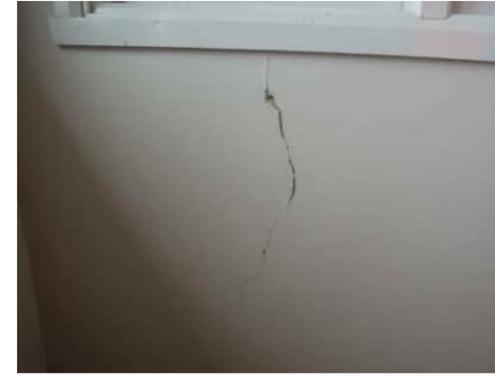
3.16 | 3MM VERTICAL CRACK BELOW WINDOW, CRACK HAS SPALLED UP TO 15MM
A-530

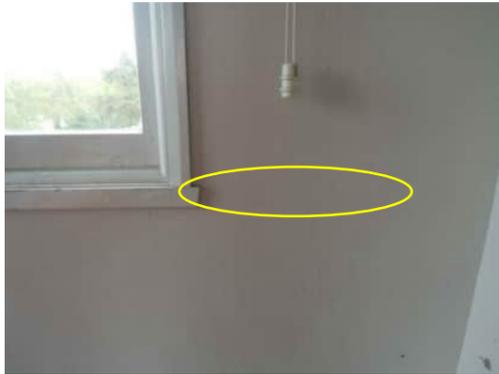
3.17 | HORIZONTAL HAIRLINE CRACK IN GRID D COLUMN AT BOTTOM OF WINDOW
A-530

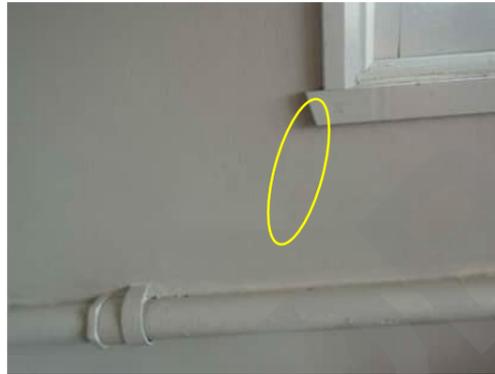
3.18 | HAIRLINE CRACK FROM CORNER OF WINDOW IN GRID D COLUMN
A-530

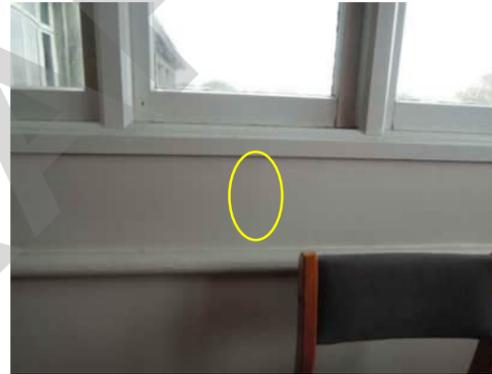
3.19 | HAIRLINE CRACK IN WALL BELOW WINDOW BETWEEN GRID D AND E
A-530

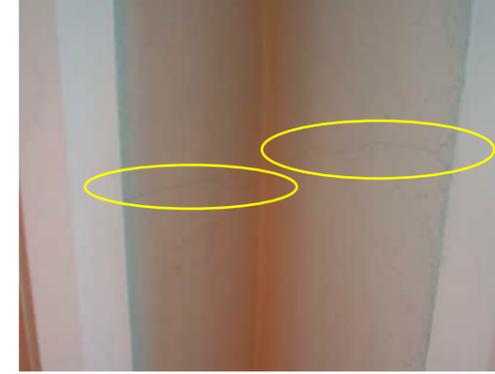
3.20 | HAIRLINE CRACK AROUND 300MM ABOVE BOTTOM WINDOW IN GRID E COLUMN
A-530

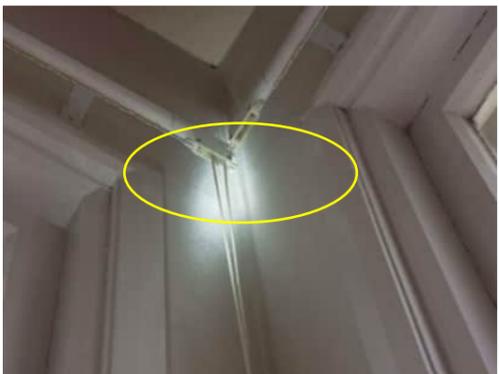
3.21 | HAIRLINE CRACK NEAR TOP OF WINDOW IN GRID E COLUMN
A-530

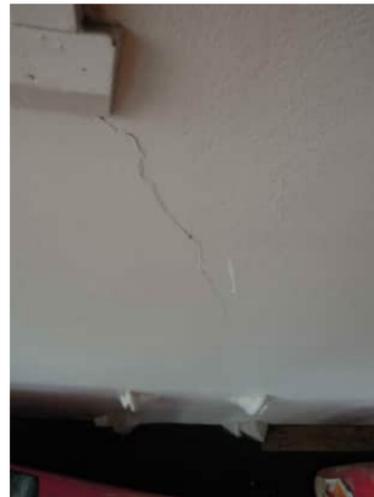
3.22 | 0.3MM DIAGONAL CRACK FROM BOTTOM OF WINDOW AT GRID 2 COLUMN
A-530

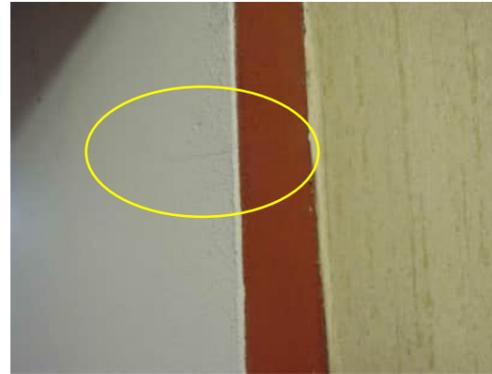
3.23 | HAIRLINE HORIZONTAL CRACK 2M UP THE GRID 9 COLUMN
A-530

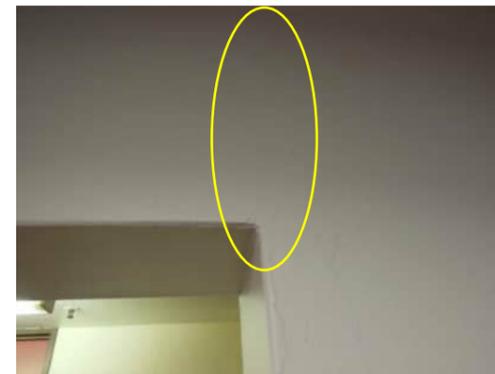
3.24 | DIAGONAL HAIRLINE CRACK IN SHEAR WALL FROM CORNER OF DOORWAY AT GRID 10
A-530

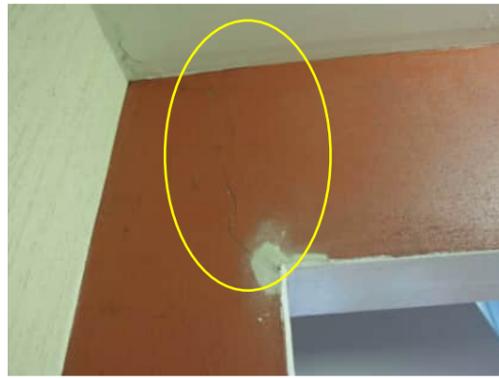
3.25 | 0.8MM DIAGONAL CRACK ON BACK OF SHEAR WALL FROM CORNER OF DOORWAY AT GRID 10
A-530

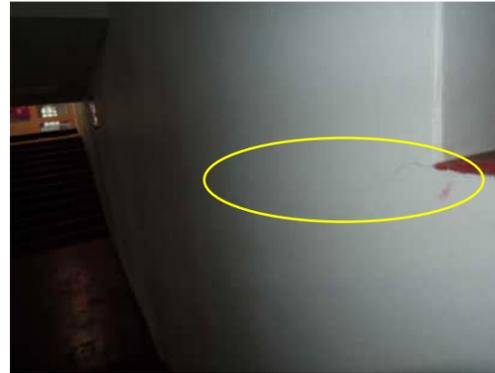
3.26 | HORIZONTAL HAIRLINE CRACK ALONG SHEAR WALL FROM GRID 10 TO GRID 12
A-530

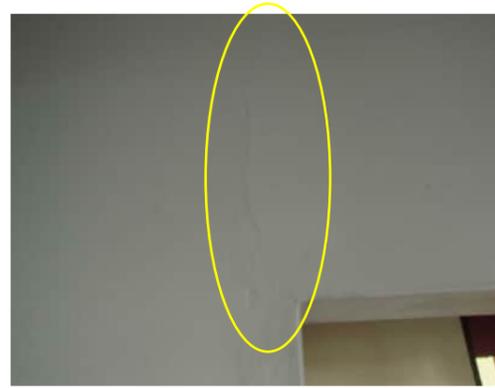
3.27 | VERTICAL CRACK IN SHEAR WALL ABOVE DOOR OPENING NEAR GRID 12
A-530

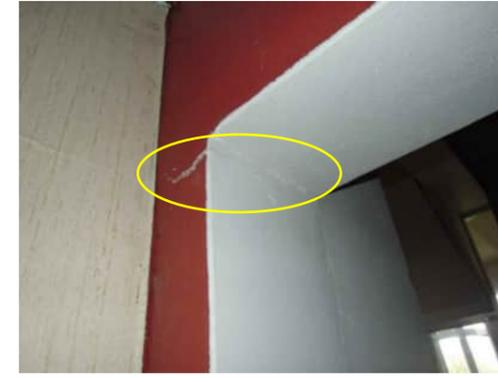
3.28 | HORIZONTAL CRACK AROUND SIDE AND BACK OF GRID 13 COLUMN
A-530

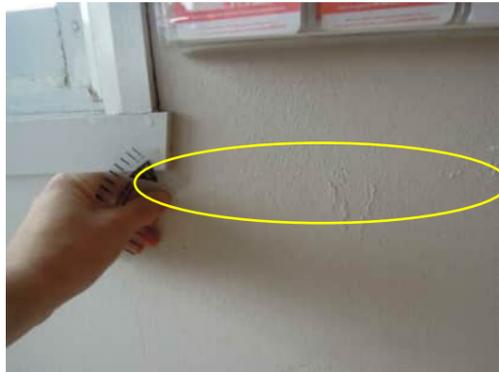
3.29 | HORIZONTAL HAIRLINE CRACK ALONG GRID 20 COLUMN AT BOTTOM OF WINDOW (GRID 1, 2, 3 AND 21 SIMILAR)
A-530

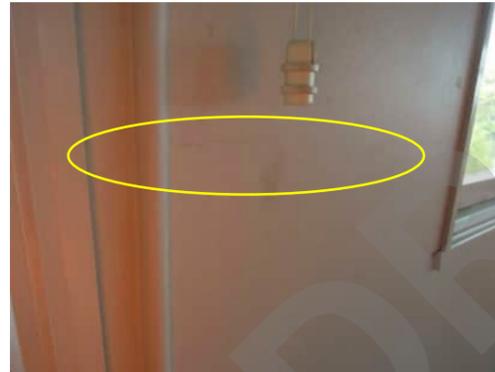
3.30 | HORIZONTAL HAIRLINE CRACK ALONG GRID 4 COLUMN AROUND 300MM ABOVE BOTTOM OF WINDOW (GRIDS 1-9 AND GRIDS 14-19 SIMILAR)
A-530

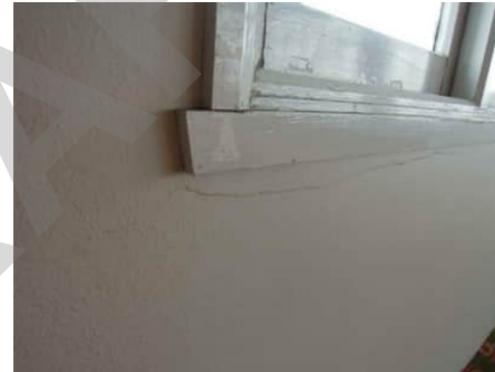
3.31 | HORIZONTAL CRACK IN WALL BELOW WINDOW BETWEEN GRID 2 AND GRID 3
A-530

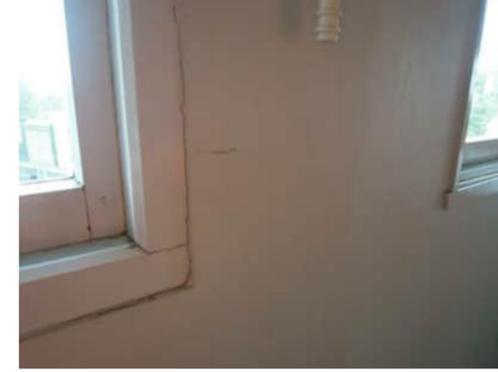
3.32 | SEPARATION OF GIB FROM WINDOW FRAME AND HORIZONTAL CRACK UP TO 0.8MM IN GRID 6 COLUMN
A-530

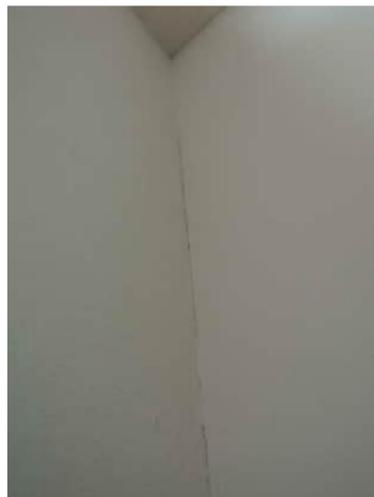
3.33 | SEPARATION BETWEEN COLUMN AND SERVICE SHAFT AT GRID 13
A-530

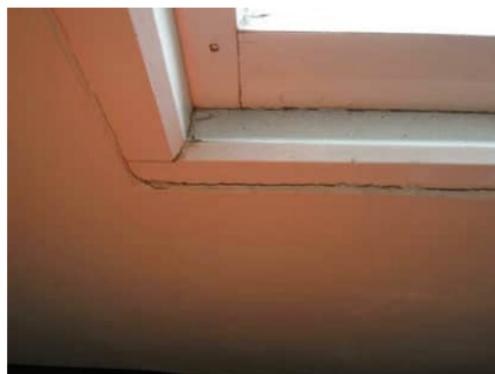
3.34 | SEPARATION OF GIB FROM WINDOW FRAME BETWEEN GRID 15 AND 16. GRID 14 TO 15 SIMILAR. THESE WINDOW FRAMES DIFFER FROM OTHERS ALONG THIS WALL
A-530

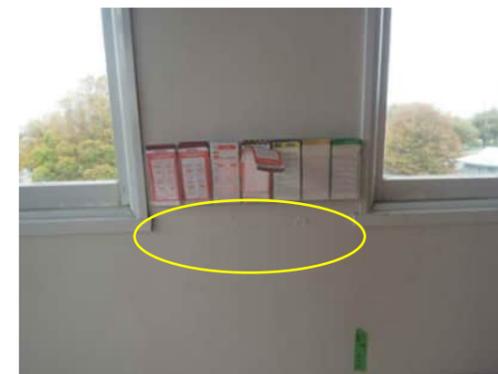
3.36 | EVIDENCE OF MOISTURE ON GRID 20 COLUMN. SIMILAR AT GRID 3 AND 5
A-530

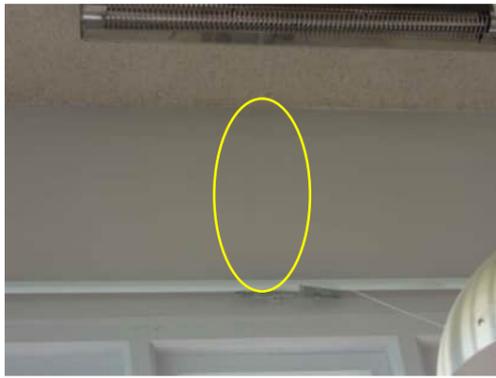
3.37 | VERTICAL CRACK ABOVE WINDOW BETWEEN GRID 20 AND GRID 21
A-530

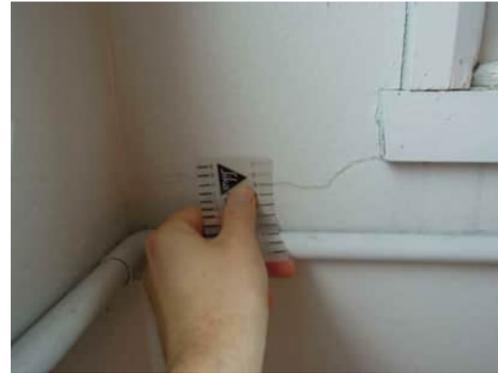
3.38 | 0.3MM HORIZONTAL CRACK IN GRID 21 COLUMN FROM CORNER OF WINDOW
A-530

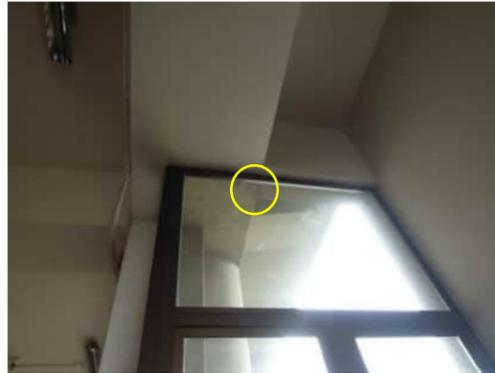
3.39 | CRACK ON UNDERSIDE OF BEAMS BETWEEN GRID E BEAM AND BEAM FOR THE LIFT SHAFT EXTENSION, NEAR GRID 11
A-530

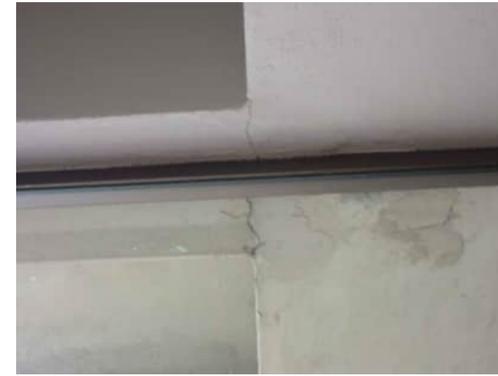
3.40 | CRACK ON UNDERSIDE OF BEAMS BETWEEN GRID E BEAM AND BEAM FOR THE LIFT SHAFT EXTENSION, NEAR GRID 10
A-530

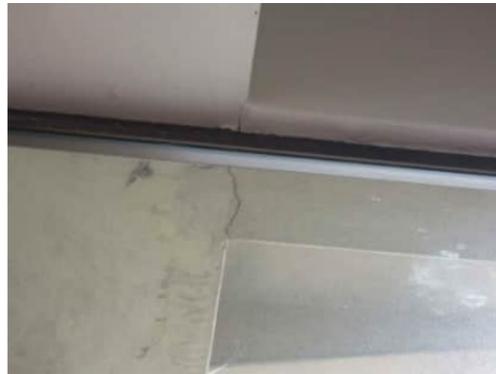
3.41 | CRACK ON UNDERSIDE OF BEAMS BETWEEN GRID E BEAM AND BEAM FOR THE LIFT SHAFT EXTENSION, NEAR GRID 11
A-530

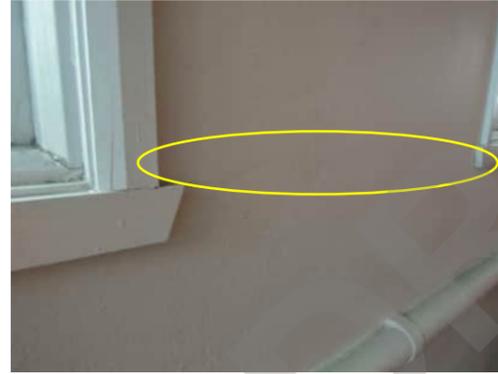
3.42 | HORIZONTAL HAIRLINE CRACK ON GRID 12 COLUMN AT BOTTOM OF WINDOW
A-530

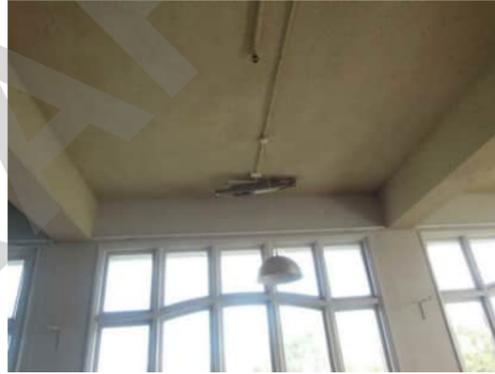
3.43 | HEATER INADEQUATELY CONNECTED TO CEILING - HAZARD
A-530

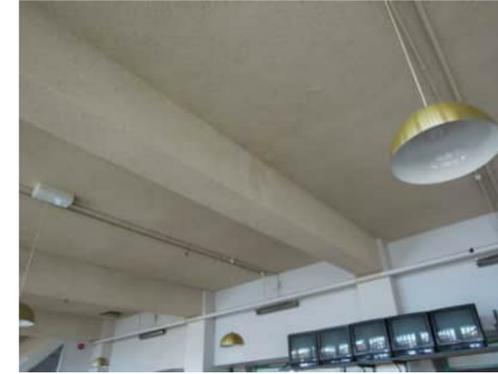
3.44 | MOISTURE DAMAGE TO BEAM AND CEILING AT GRID 7
A-530

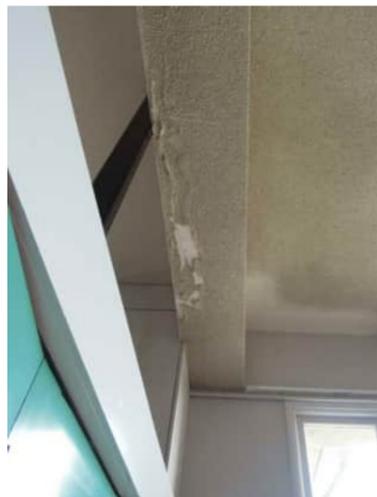
3.45 | DAMAGE TO GRID 9 BEAM
A-530

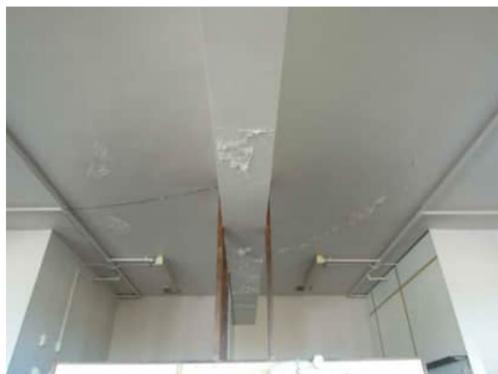
3.46 | MOISTURE DAMAGE TO CEILING AND BEAM ON GRID 11
A-530

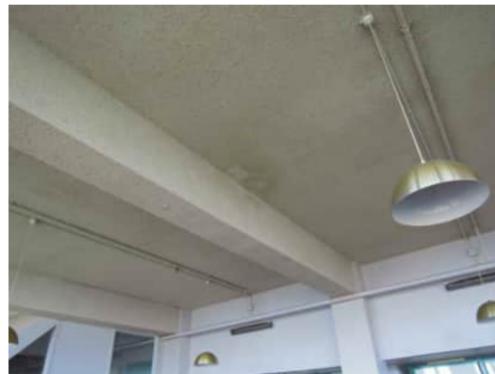
3.47 | MOISTURE DAMAGE TO BEAM AND CEILING AT GRID 15
A-530

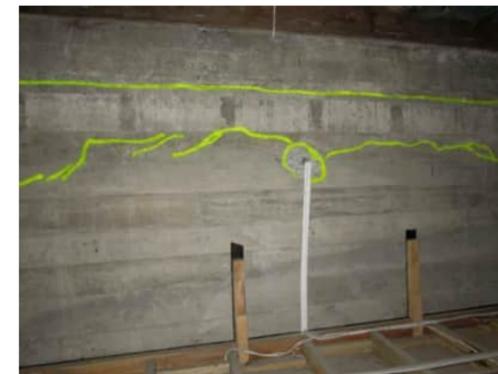
3.48 | HORIZONTAL CRACKS TO SHEAR WALL. UPPER CRACK IS THROUGH POUR LINE. LOWER CRACK IS 0.2 TO 0.5MM WIDE
A-530

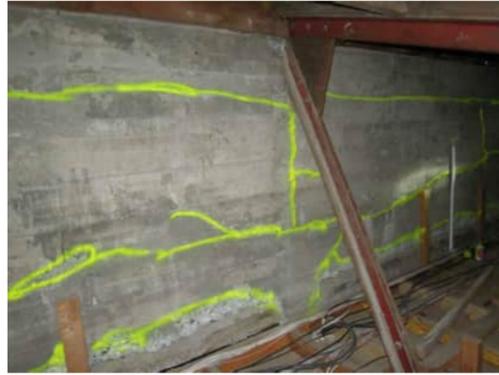
3.49 MULTIPLE CRACKS TO SHEAR WALL. UPPER CRACK IS THROUGH POUR LINE. VERTICAL CRACK UNDER TRUSS IS 1.2MM WIDE. POOR QUALITY CONCRETE IN BEAM AT BOTTOM. MIDDLE HORIZONTAL CRACK IS 1.8 TO 2MM WIDE
A-530

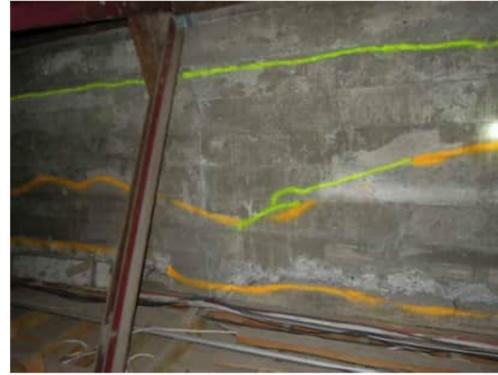
3.50 UPPER CRACK IS THROUGH POUR LINE. POOR QUALITY CONCRETE AT BOTTOM. MIDDLE HORIZONTAL CRACK 0.8 TO 1.6mm WIDE
A-530

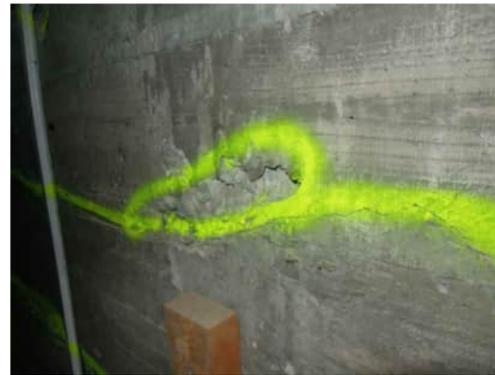
3.51 POOR QUALITY CONCRETE ON GRID 4 WITH 2MM WIDE HORIZONTAL CRACK
A-530

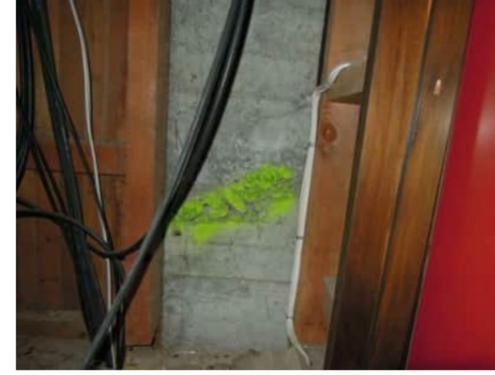
3.52 POOR QUALITY CONCRETE BETWEEN TWO VOIDS
A-530

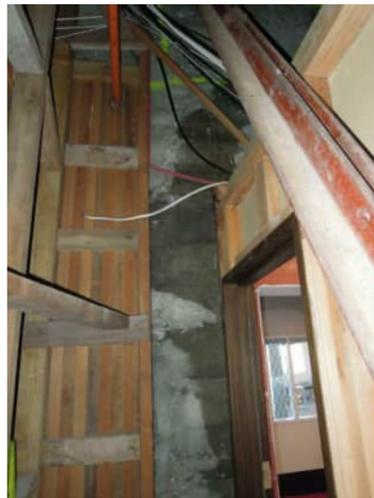
3.53 WATER INGRESS DAMAGE AT GRID 13 THROUGH CRACKING AT TOP
A-530

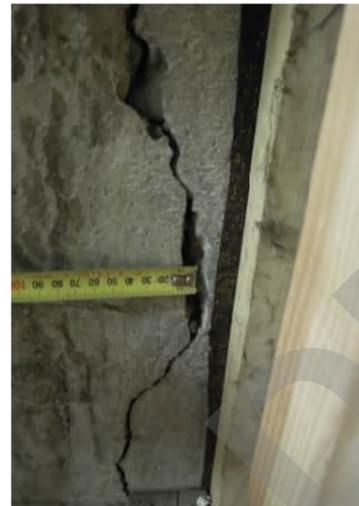
3.54 FULL HEIGHT VERTICAL CRACK UP TO 15MM WIDE
A-530

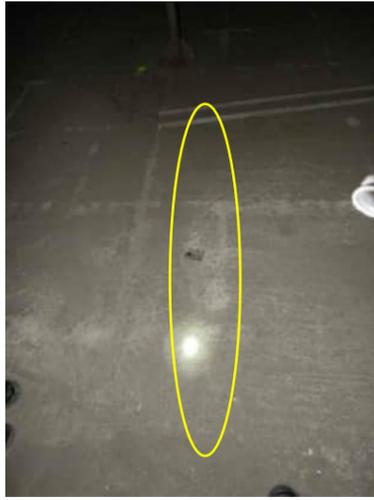
4.1
A-500 | TYPICAL CRACK NEAR GRIDLINE BETWEEN STEEL COLUMNS

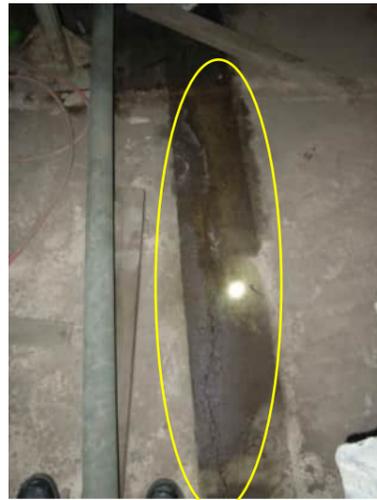
4.2
A-540 | CRACK THROUGH DRAINAGE CHANNEL, UP TO 1.4MM

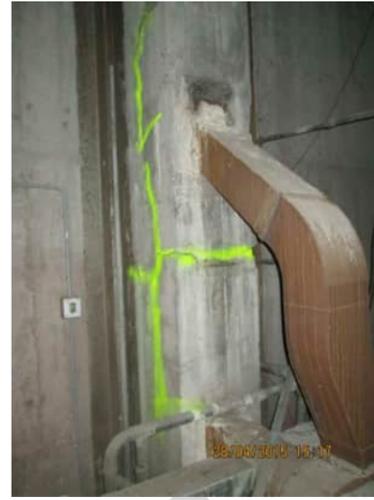
4.3
A-540 | CONCRETE COLUMN HAS SEPARATED FROM THE SHEAR WALL. THE COLUMN HAS MULTIPLE HORIZONTAL CRACKS SHOWING IT HAS BEEN BENT IN FLEXURE

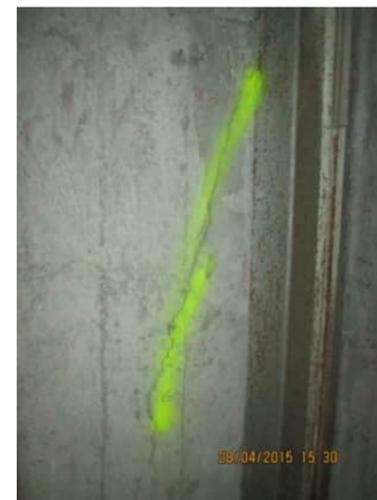
4.4
A-540 | CRACK RUNNING FROM THE STEEL COLUMN VERTICALLY

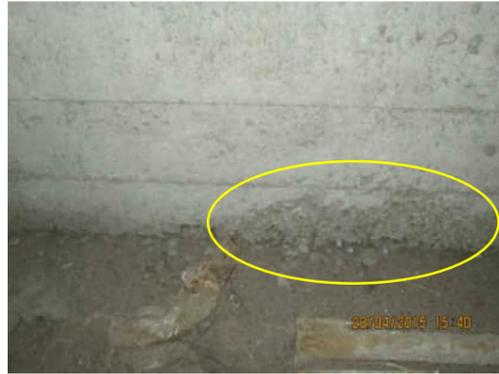
4.5
A-540 | POOR QUALITY CONCRETE OVER HANGING THE FLOOR SLAB

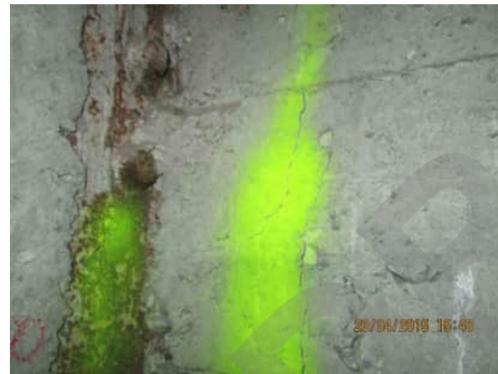
4.6
A-540 | VERTICAL CRACKS NEAR THE CONNECTION BETWEEN SHEAR WALL AND BUTTRESS. POOR CONCRETE AROUND THE CONNECTION

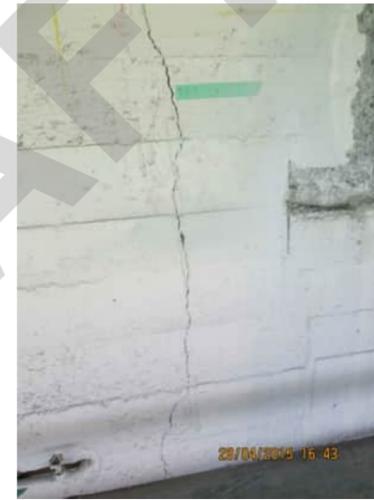
4.7
A-540 | VERTICAL CRACK ON THE EXTERNAL FACE OF THE SHEAR WALL AT GRID 6, RUNNING PARALLEL TO THE STEEL COLUMN ON INTERNAL FACE

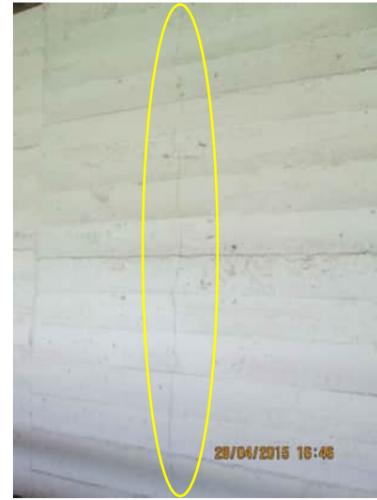
4.8
A-540 | VERTICAL CRACK ON THE EXTERNAL FACE OF THE SHEAR WALL RUNNING PARALLEL TO THE STEEL COLUMN ON INTERNAL FACE

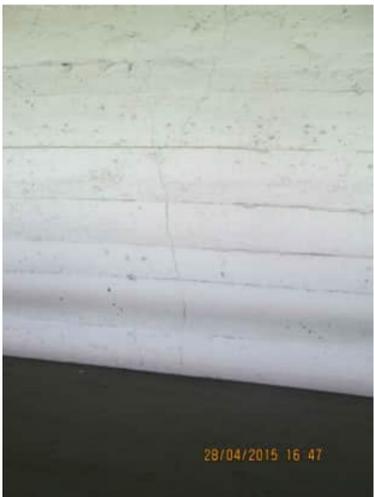
4.9
A-540 | VERTICAL CRACK ON THE EXTERNAL FACE OF THE SHEAR WALL RUNNING PARALLEL TO THE STEEL COLUMN ON INTERNAL FACE

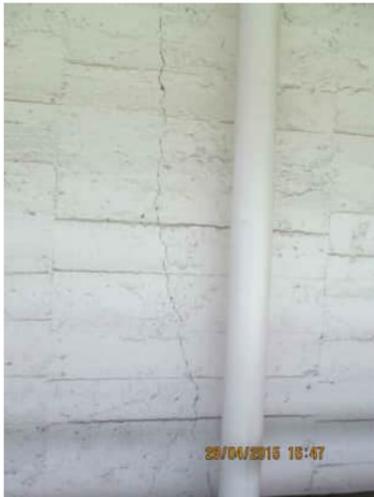
4.10
A-540 | VERTICAL CRACK ON THE EXTERNAL FACE OF THE SHEAR WALL RUNNING PARALLEL TO THE STEEL COLUMN ON INTERNAL FACE

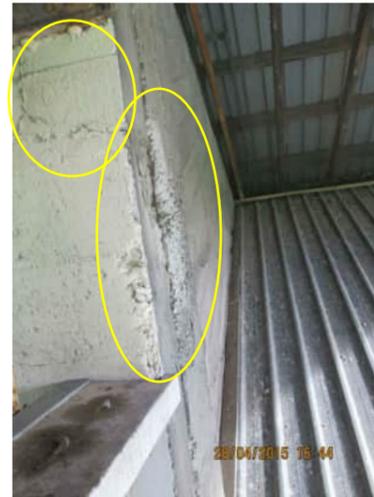
4.11
A-540 | VIEW OF THE WESTERN WING WALL FROM UPPER STAND SHOWING DAMAGE AROUND CONNECTION OF SHEAR WALL TO BUTTRESS WALL

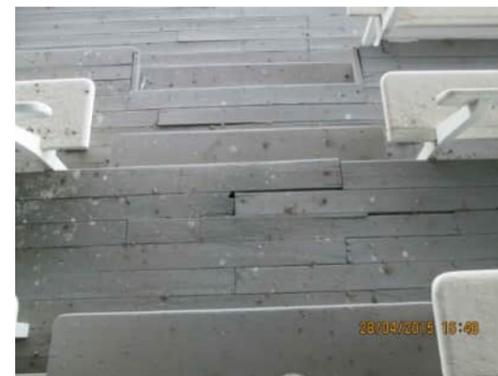
4.12
A-540 | CONDITION OF TIMBER DECKING ON THE UPPER STAND

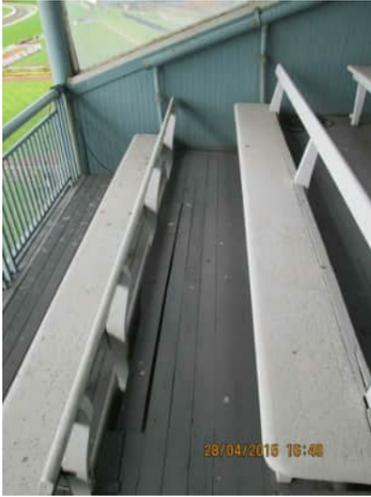
4.13
A-540 | CONDITION OF TIMBER DECKING ON THE UPPER STAND

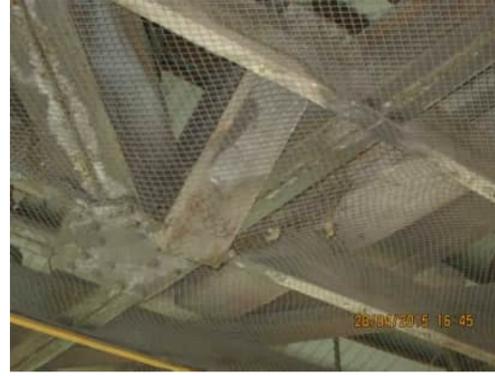
4.14
A-540 | LOOSE TIMBER PIECES CAUGHT IN THE PROTECTIVE MESH

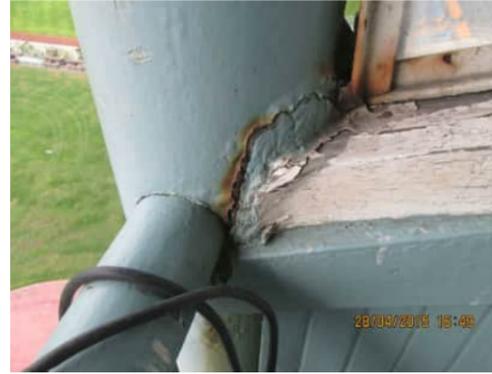
4.15
A-540 | DAMAGE TO INTERFACE BETWEEN COLUMN AND TIMBER INFILL
