Damage Assessment Report

Grand National (Public) Stand

Client: Canterbury Jockey Club

Job No.: 60332326

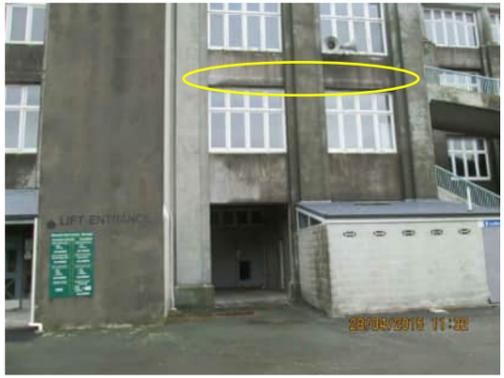
ES1
A-550 HORIZONTAL CRACK ABOVE FIRST FLOOR WINDOWS

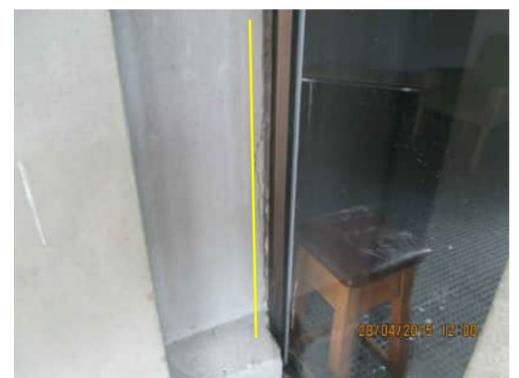
ES2
A-550 SEPARATION BETWEEN GRID 10 COLUMN AND LIFT SHAFT EXTENSION

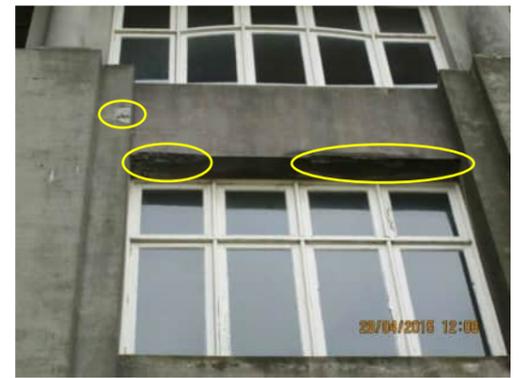
ES3
A-550 DAMAGED RENDER ABOVE SECOND FLOOR WINDOW EXPOSING REINFORCEMENT

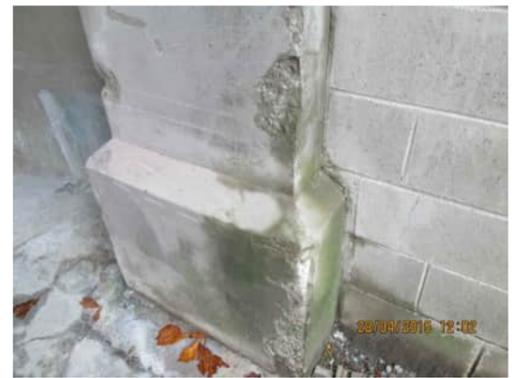
ES4
A-550 DAMAGE TO RENDER AT BASE OF GRID 12 COLUMN

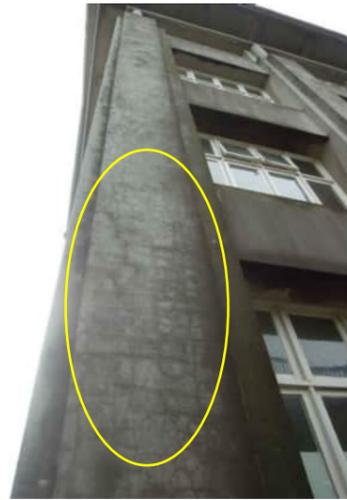
ES5
A-550 | TYPICAL CRAZED CRACKING TO RENDER

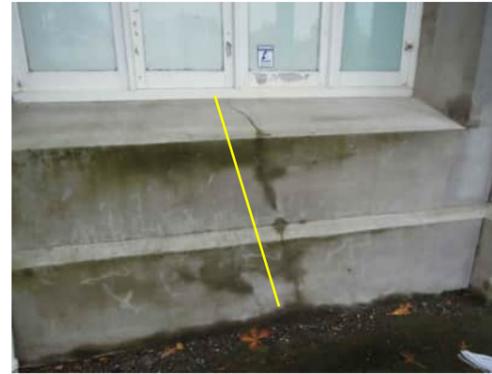
ES6
A-550 | TYPICAL HORIZONTAL CRACK BELOW WINDOW

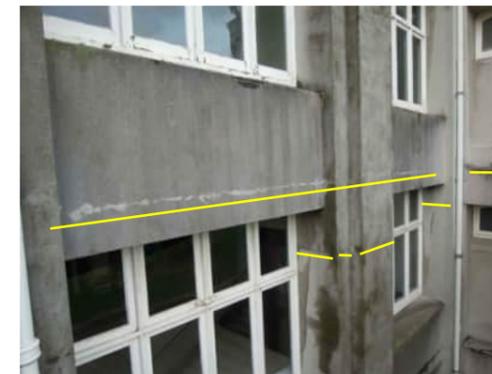
ES7
A-550 | TYPICAL VERTICAL CRACK BELOW WINDOW ON GROUND FLOOR

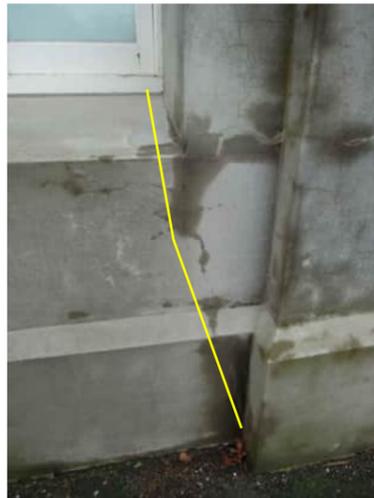
ES8
A-550 | TYPICAL HORIZONTAL CRACK ABOVE WINDOW AND HORIZONTAL CRACK AROUND COLUMN

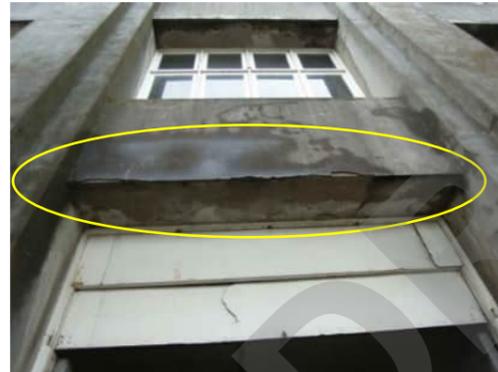
ES9
A-550 | VERTICAL CRACK UP TO 0.3MM FROM CORNER OF WINDOW ON GROUND FLOOR AT GRID 4 COLUMN

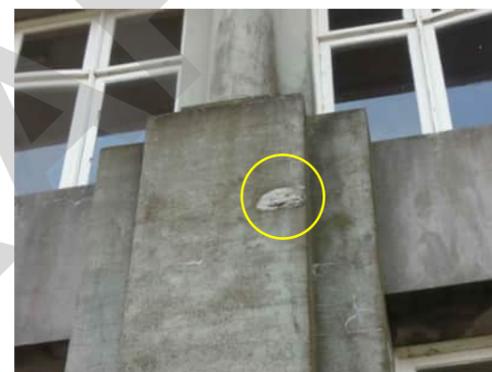
ES10
A-550 | RENDER HAS BROKEN OFF ABOVE DOOR OPENING BETWEEN GRID 5 AND 6

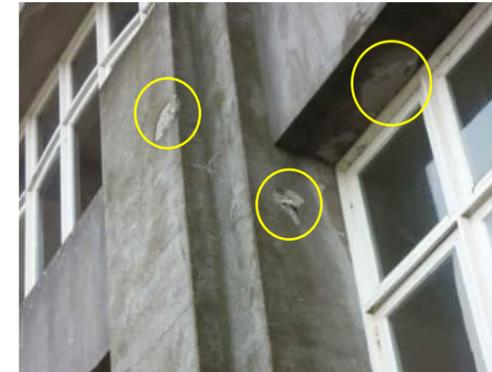
ES11
A-550 | SPALLING NEAR TOP OF GRID 3 COLUMN EXPOSING REINFORCING

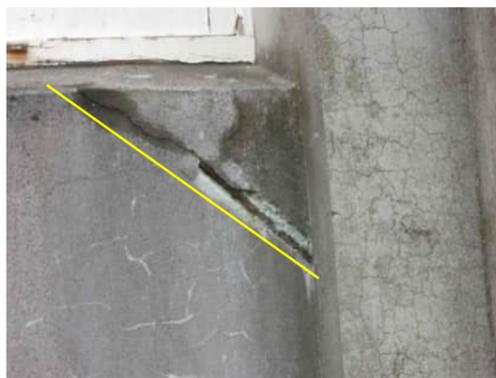
ES12
A-550 | SPALLING ON SIDE OF GRID 3 COLUMN EXPOSING REINFORCING

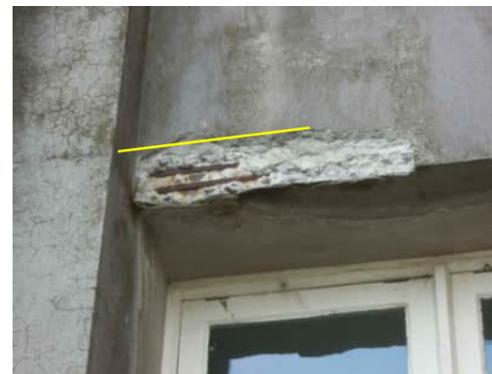
ES13
A-550 | CRACK EXPOSING REINFORCING BELOW SECOND FLOOR WINDOW AT GRID 7

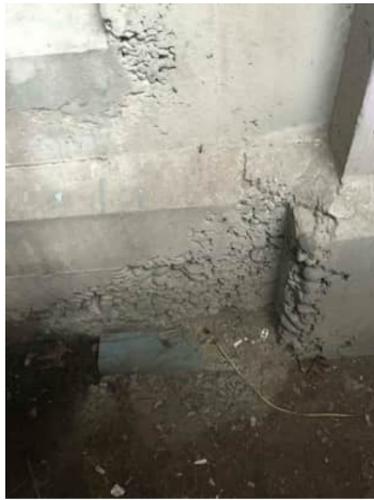
EN1
A-552 AREA OF SEGREGATED CONCRETE AT BASE OF COLUMN AND WALL

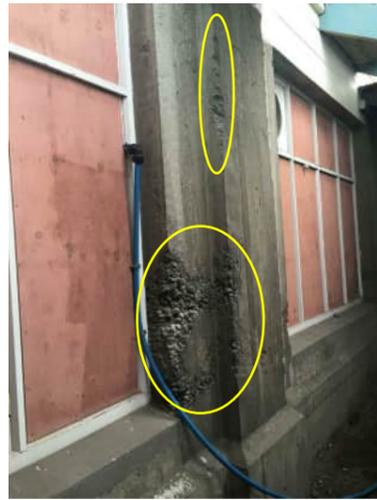
EN2
A-552 AREA OF SEGREGATED CONCRETE ON COLUMN FACE AND SIDES

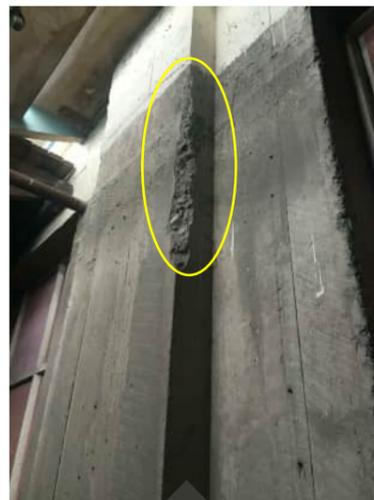
EN3
A-552 SPALLING TO CORNERS OF COLUMNS

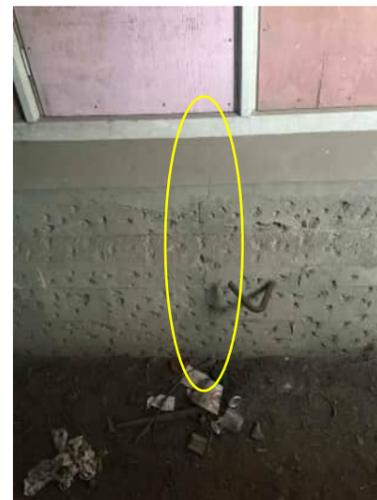
EN4
A-552 VERTICAL CRACK BELOW WINDOW

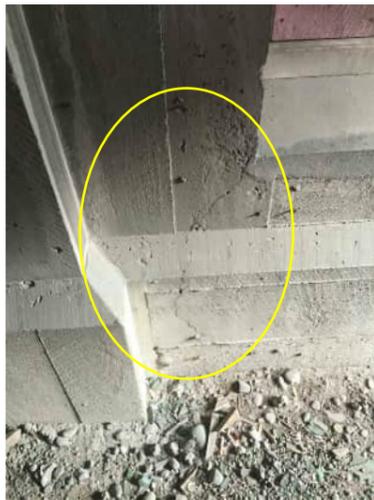
EN5
A-552 CRACK FROM CORNER OF WINDOW

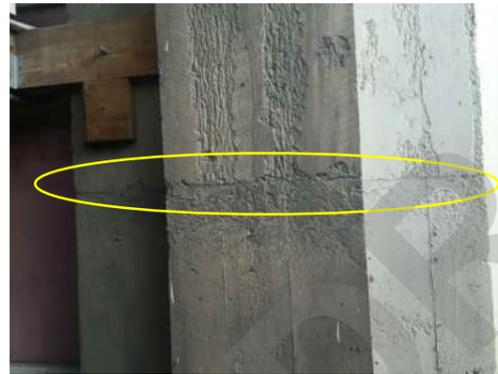
EN6
A-552 MINOR HORIZONTAL CRACK AT LOCATION OF CONSTRUCTION JOINT

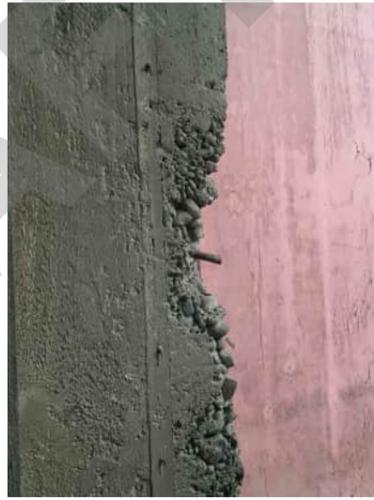
EN7
A-552 CONCRETE SPALLING WITH PROTRUDING STEEL BAR AT CORNER OF GRID 10 COLUMN

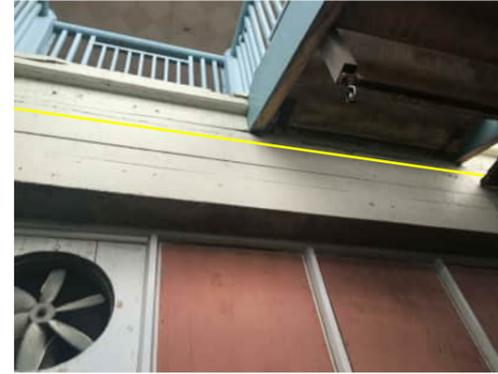
EN8
A-552 SIGNIFICANT HORIZONTAL CRACK ALONG TOP OF WALL AROUND 10MM WIDE, AT LOCATION WHERE STAIRS TO STANDS HAVE BEEN CAST INTO THE WALL

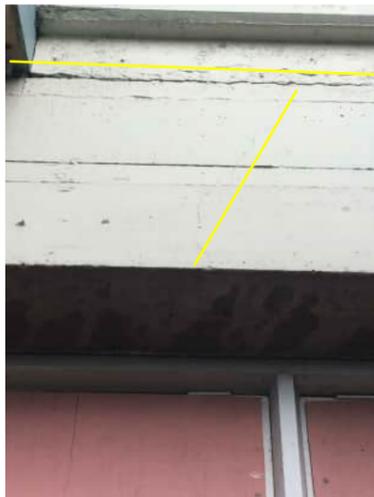
EN9
A-552 SIGNIFICANT HORIZONTAL CRACK AND MINOR VERTICAL CRACK ABOVE WINDOW BETWEEN GRID 10 AND 11, AT LOCATION WHERE STAIRS TO STANDS HAVE BEEN CAST INTO THE WALL

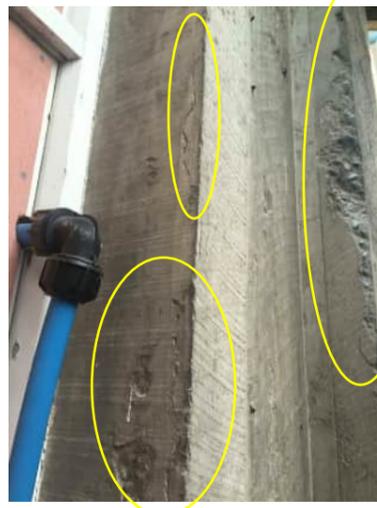
EN10
A-552 VERTICAL CRACK UP TO 0.4MM ON SIDE OF COLUMN AT GRID 11

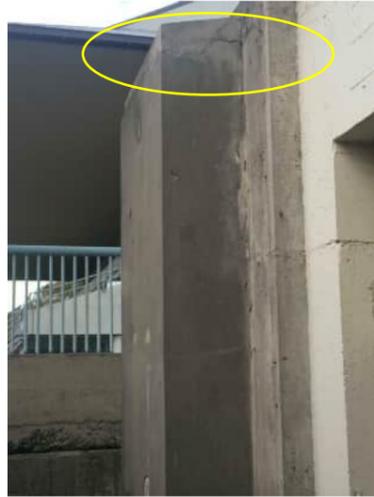
EN11
A-552 HORIZONTAL CRACK AT TOP OF GRID 20 COLUMN

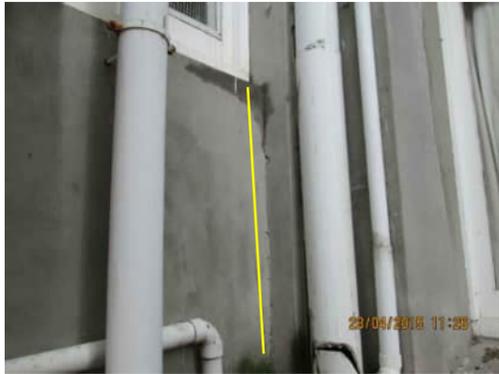
EE1
A-554 TYPICAL CRACK BETWEEN GRID D COLUMN AND CONCRETE INFILL WALL

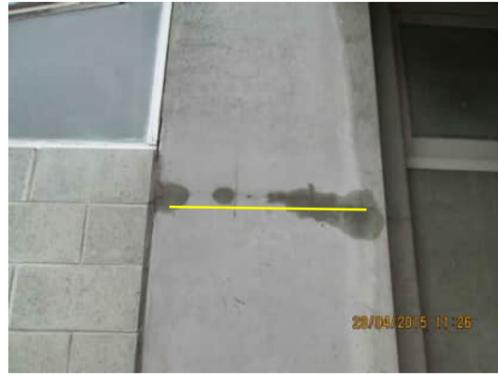
EE2
A-554 HAIRLINE CRACK TO GRID E COLUMN AT GROUND LEVEL

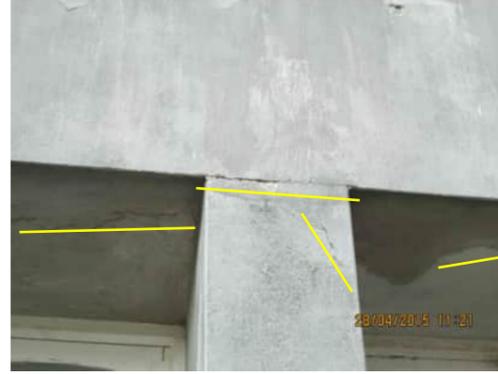
EE3
A-554 HORIZONTAL CRACK AND DIAGONAL CRACKS BETWEEN CENTRAL COLUMN AND THIRD FLOOR WALL

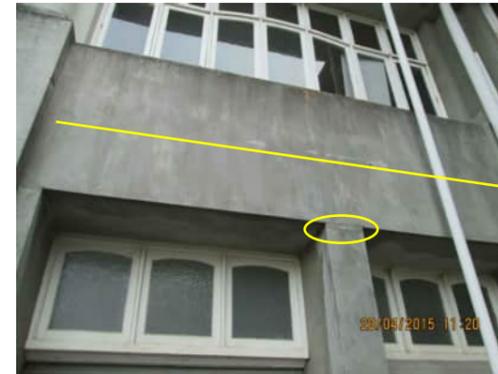
EE4
A-554 HORIZONTAL CRACK ALONG WALL ON THE THIRD FLOOR

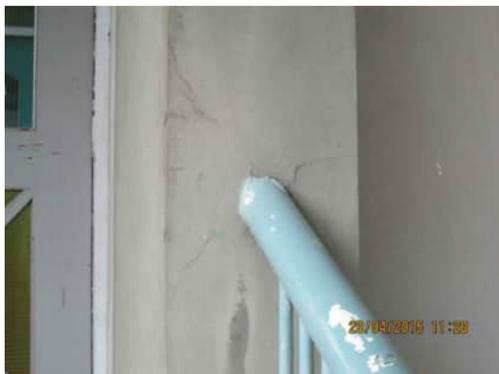
EE5
A-554 CRACKING AROUND CAST-IN HANDRAIL AT THE FIRST FLOOR

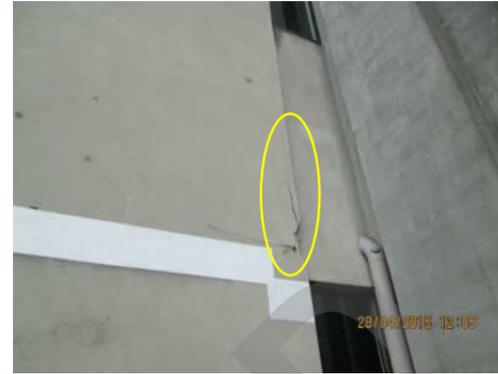
EE6
A-554 DAMAGE TO LIFT SHAFT AT CONNECTION TO MAIN BUILDING

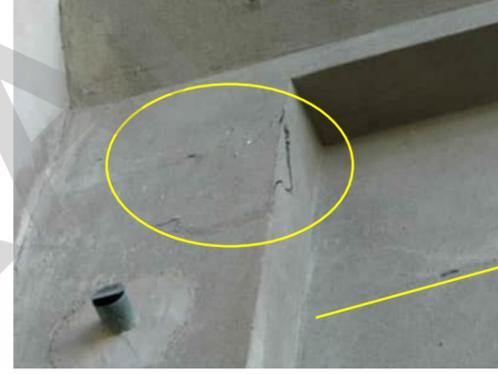
EE7
A-554 CRACKS AND DAMAGE TO RENDER ON THE GRID C COLUMN

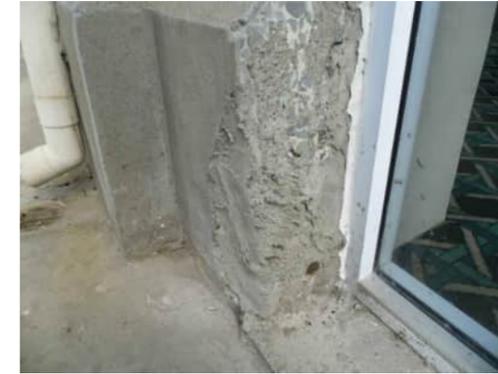
EE8
A-554 DAMAGED CONCRETE AROUND DOOR WITH REINFORCING EXPOSED (WALL APPEARS TO HAVE BEEN CUT TO FORM DOOR)

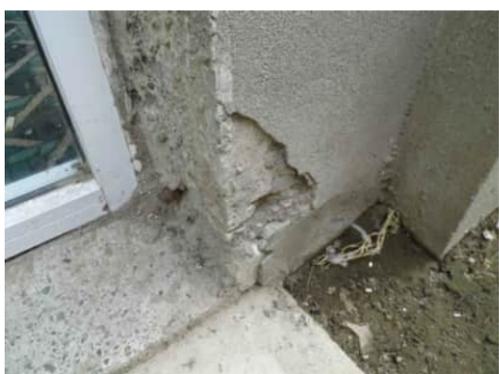
EE9
A-554 DAMAGED CONCRETE ON OTHER SIDE OF DOOR, REINFORCING IS ALSO EXPOSED (WALL APPEARS TO HAVE BEEN CUT TO FORM DOOR)

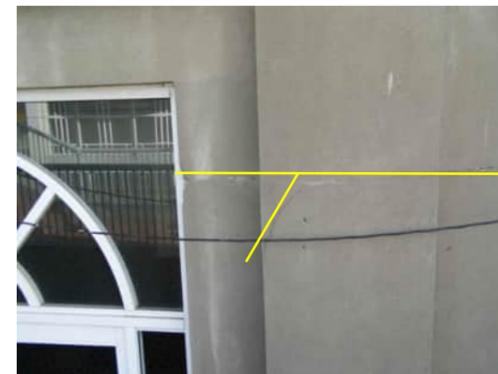
EE10
A-554 SIGNIFICANT HORIZONTAL CRACK ALONG WALL

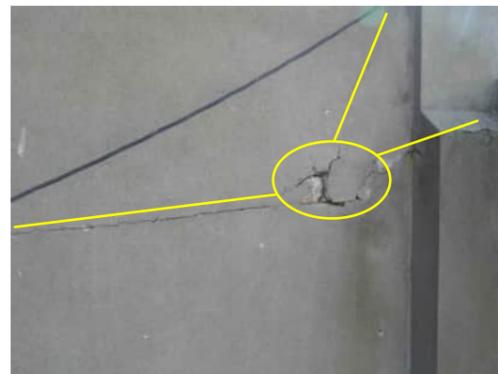
EE11
A-554 CONTINUATION OF CRACK SHOWN IN EE10 WITH SOME CONCRETE BREAKING OUT

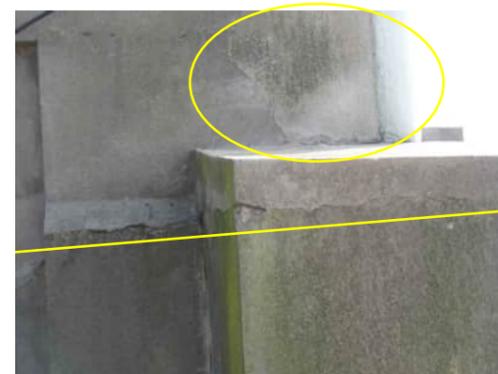
EE12
A-554 CONTINUATION OF CRACK SHOWN IN EE11 THROUGH GRID A COLUMN

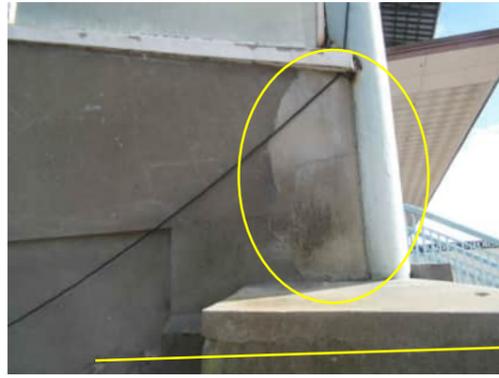
EE13 | CRACKING TO WALL ABOVE GRID A COLUMN
A-554

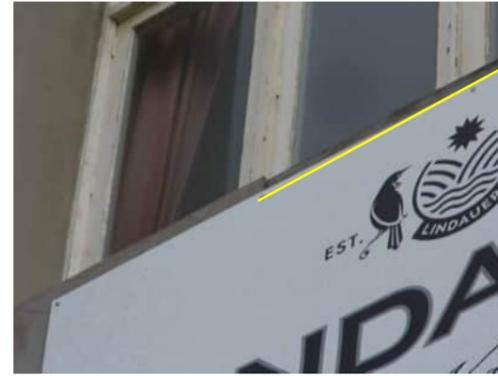
EE15 | RENDER HAS BROKEN OFF BEHIND SIGN
A-554

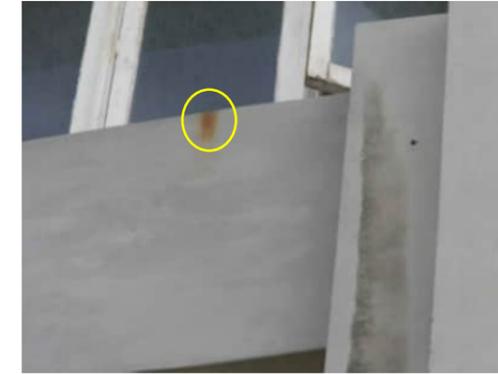
EE16 | EVIDENCE OF RUST BELOW THE THIRD FLOOR WINDOW
A-554

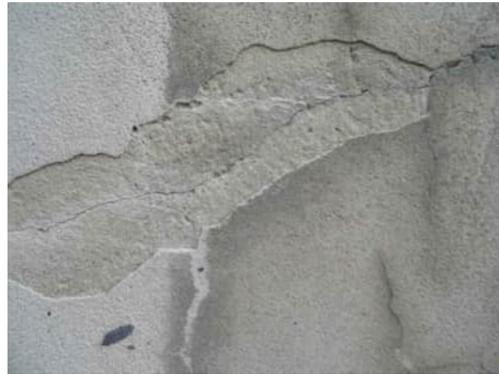
EE17 | 0.2MM CRACK IN GRID C COLUMN
A-554

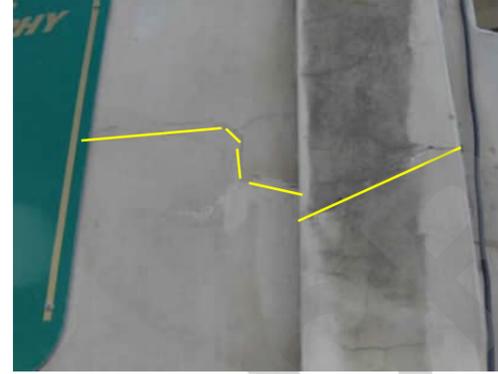
EE18 | HORIZONTAL CRACK IN WALL AND COLUMN BETWEEN GRID B AND C
A-554

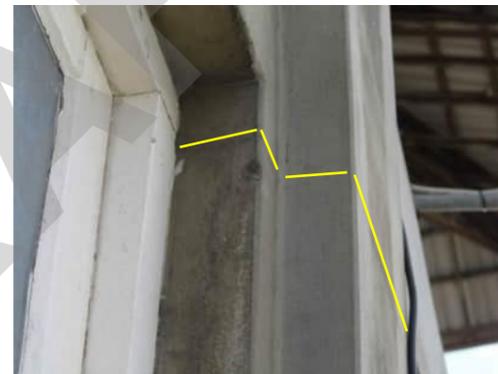
EE19 | HORIZONTAL CRACK IN COLUMN BETWEEN GRID B AND C
A-554

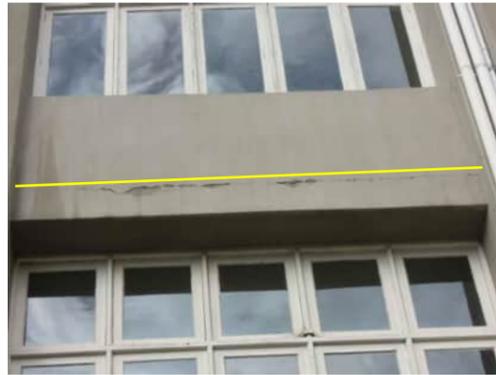
EW1 | SIGNIFICANT CRACK ABOVE FIRST FLOOR WINDOW BETWEEN GRID C AND GRID D
A-557

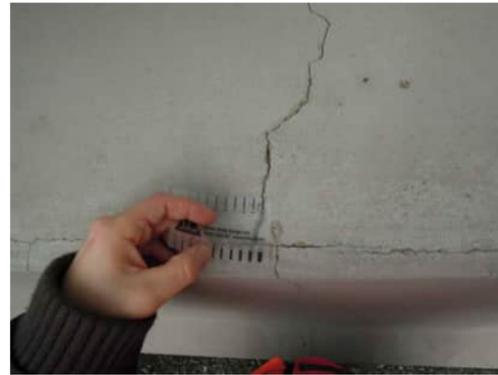
EW2 | 1.0MM VERTICAL CRACK BELOW GROUND FLOOR WINDOW
A-557

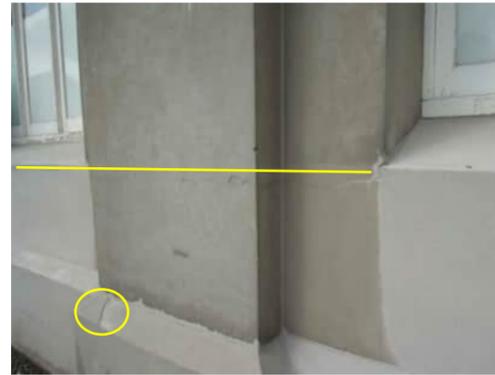
EW3 | 0.2MM HORIZONTAL CRACK NEAR BASE OF CENTRAL COLUMN
A-557

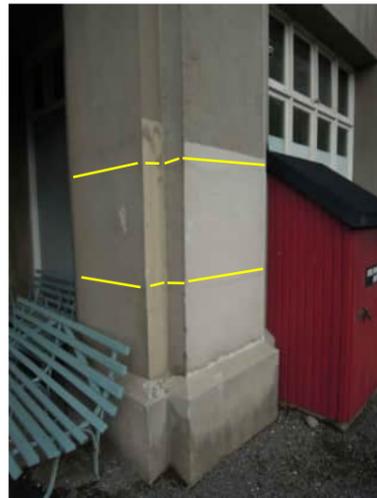
EW5 | 0.2MM HORIZONTAL CRACKS NEAR BASE OF GRID C COLUMN
A-557

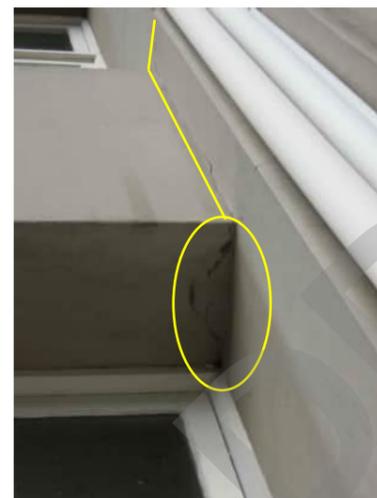
EW6 | TYPICAL SEPARATION BETWEEN WALLS AND COLUMNS
A-557

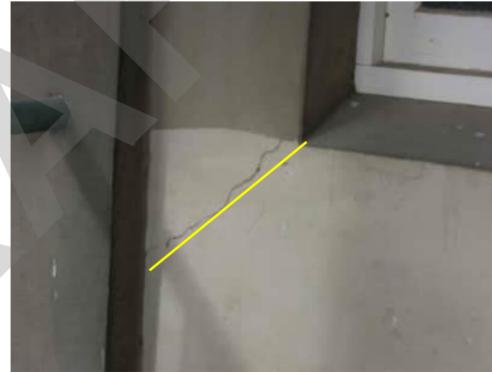
EW7 | DIAGONAL CRACK BELOW WINDOW ON COLUMN BETWEEN AND GRID C
A-557

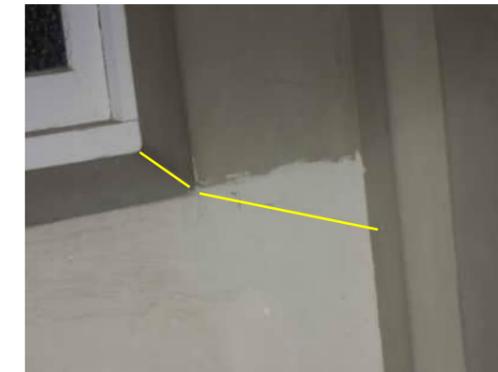
EW8 | DIAGONAL CRACK BELOW WINDOW ON COLUMN BETWEEN GRID B AND GRID C
A-557

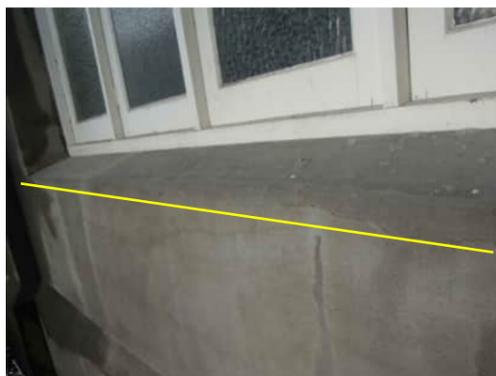
EW9 | HORIZONTAL CRACK BELOW WINDOW
A-557

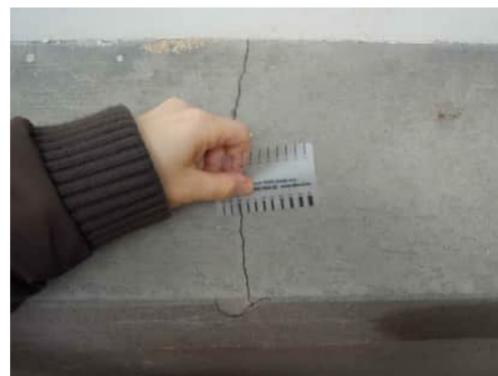
EW10 | 1.0MM VERTICAL CRACK BELOW WINDOW
A-557

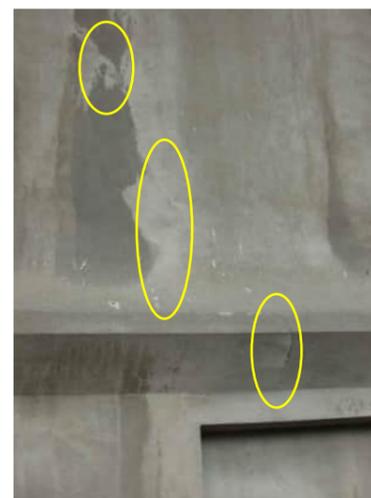
EW11 | VERTICAL CRACK ABOVE GROUND FLOOR WINDOW GRID A AND GRID B
A-557

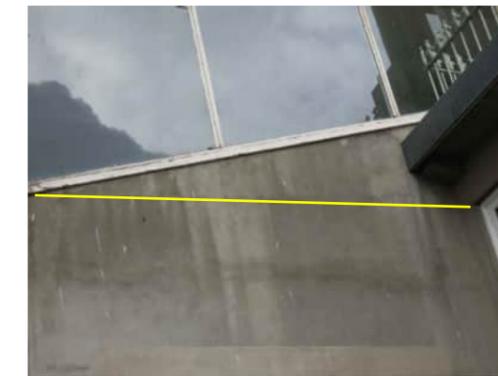
EW12 | HORIZONTAL CRACK IN CONCRETE WALL OF LOWER STAND
A-557

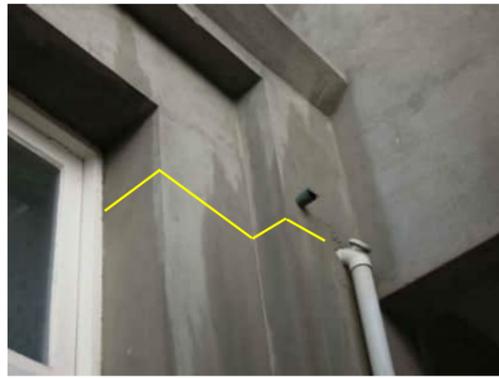
EW13 | HORIZONTAL CRACK NEAR CEILING LEVEL OF GROUND FLOOR, ON COLUMN BETWEEN GRID B AND GRID C
A-557

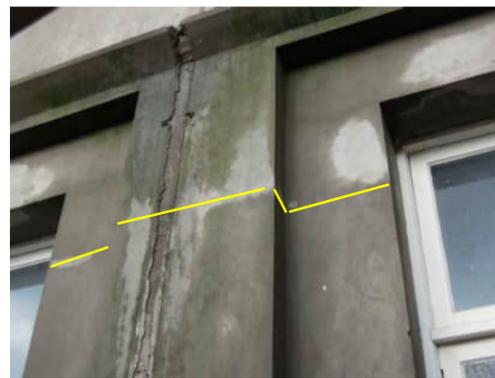
EW14 | HORIZONTAL CRACK NEAR CEILING LEVEL OF GROUND FLOOR ON COLUMN AT GRID B
A-557

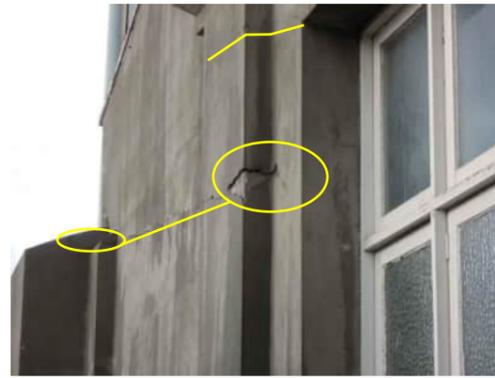
EW15 | HORIZONTAL CRACK BECOMES WIDER TOWARDS GRID A
A-557

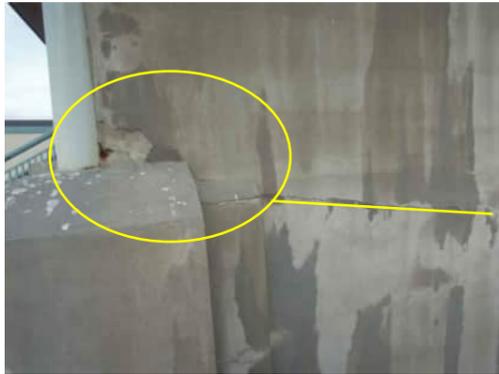
EW17 | HORIZONTAL CRACK AT GRID A COLUMN WITH SPALLING AND EVIDENCE OF RUST
A-557

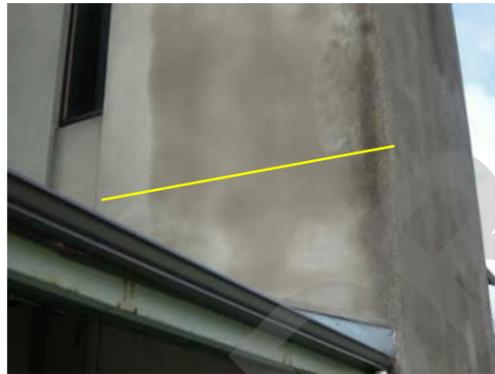
EW18 | CRACK IN LIFT SHAFT NEAR FLOOR LEVEL OF FIRST FLOOR
A-557

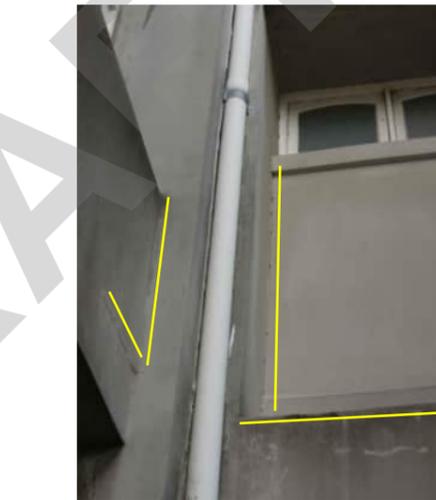
EW19 | SEPARATION BETWEEN GRID D COLUMN AND INFILL WALL
A-557

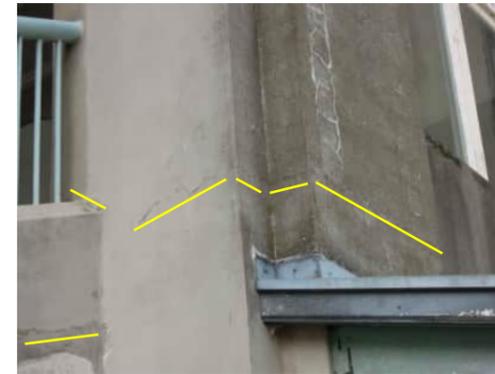
EW20 | HORIZONTAL CRACK AROUND GRID E COLUMN
A-557

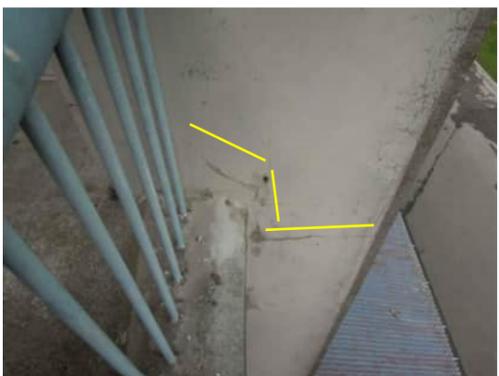
EW21 | CRACKING TO GRID E COLUMN NEAR WHERE STAIRS CONNECT AT SECOND FLOOR UP TO 0.5MM
A-557

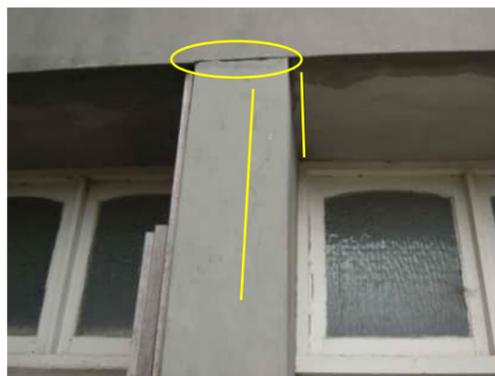
EW22 | VERTICAL CRACKING TO CENTRAL COLUMN AND SEPARATION BETWEEN THE COLUMN AND THE WALL BETWEEN THE SECOND AND THE THIRD FLOOR
A-557

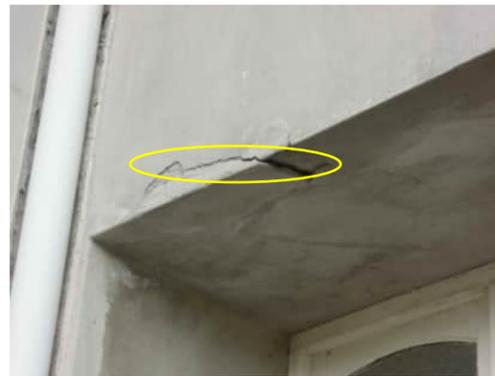
EW23 | RENDER BREAKING OFF ABOVE SECOND FLOOR WINDOW
A-557

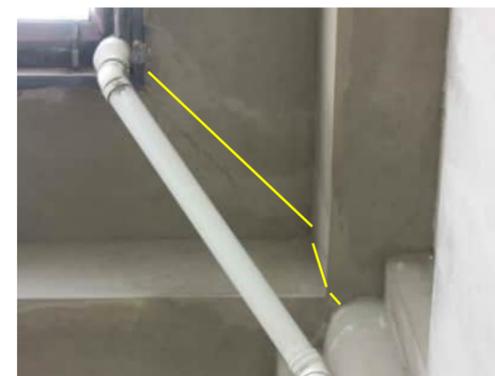
EW24 | CRACKING TO THE SOFFIT AT GRID D
A-557

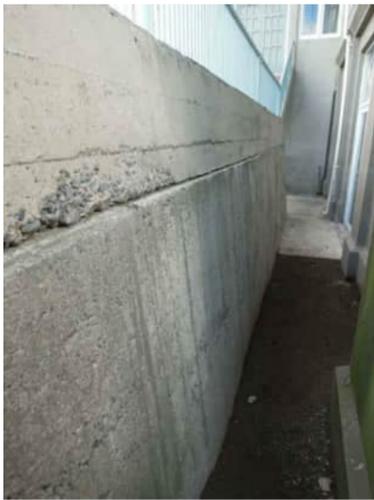
RW.1 VIEW OF RETURN OF RETAINING WALL AT EASTERN END, JOINT IS UP TO 10MM
A.710

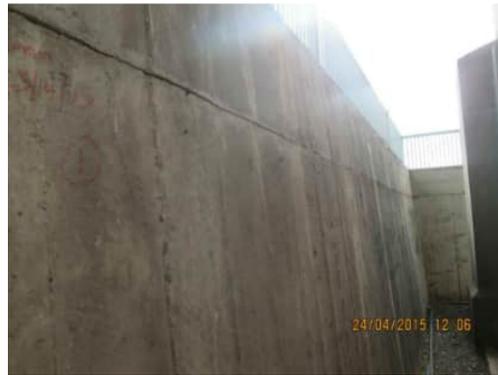
RW.2 VIEW OF RETURN OF RETAINING WALL AT WESTERN END, JOINT IS 0.6MM
A.710

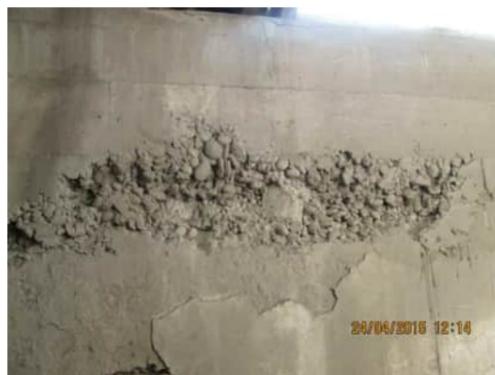
RW.3 TYPICAL AREA WITH POORLY COMPACTED CONCRETE
A.710

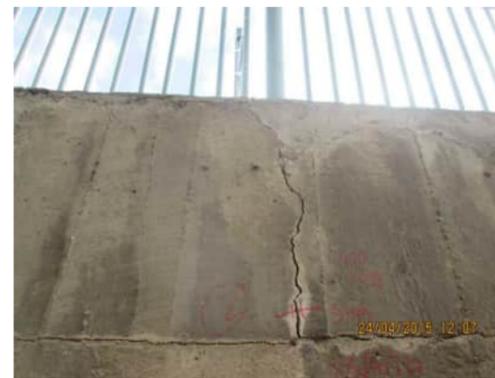
RW.4 TYPICAL CRACK FROM TOP OF WALL TO JOINT, CRACKS RANGE FROM 0.2MM TO 5MM
A.710

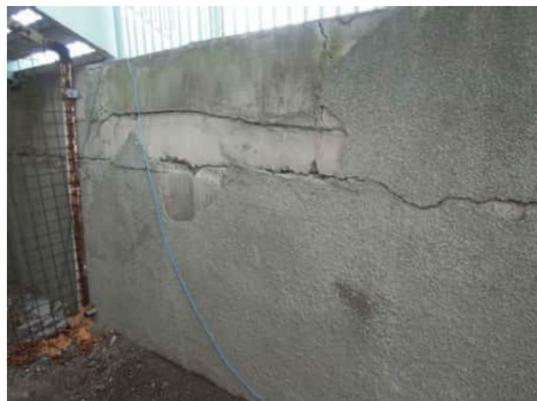
RW.5 SIGNIFICANT CRACKS UP TO 10MM AND DAMAGE TO RENDER
A.710

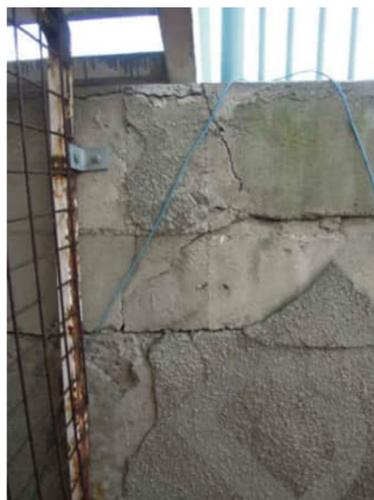
RW.6 SIGNIFICANT CRACKS BELOW STAIRS UP TO 3MM
A.710

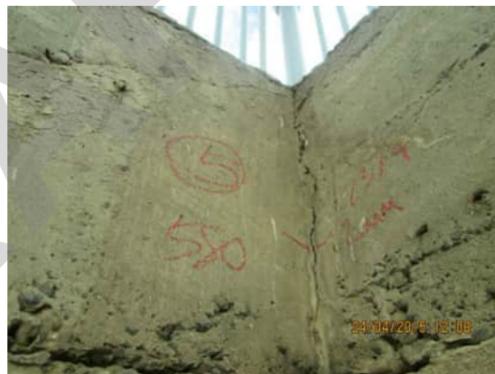
RW.7 CRACK IN CORNER OF RETAINING WALL, 2MM WIDE
A.710

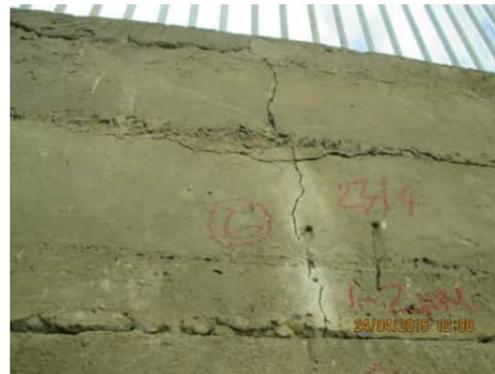
RW.8 VERTICAL CRACK FROM TOP OF WALL TO JOINT AND A HORIZONTAL CRACK RUNNING THROUGH
A.710

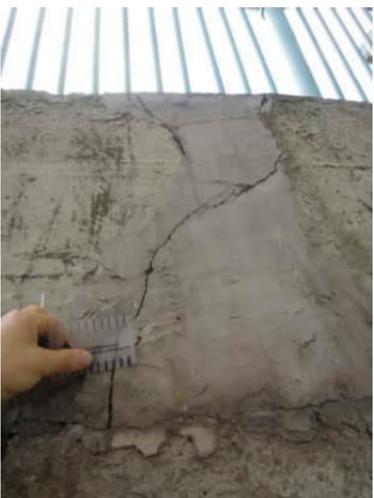
RW.9 CRACKS UP TO 2.5MM WHICH HAVE PREVIOUSLY BEEN REPAIRED BUT HAVE REAPPEARED
A.710

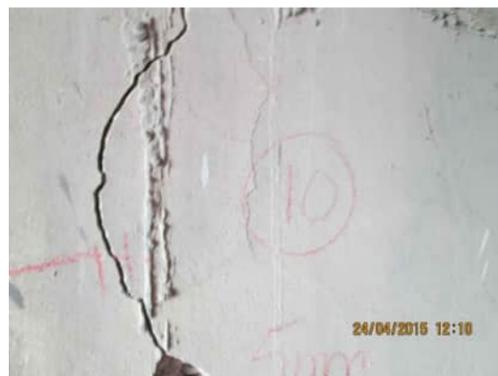
RW.10 1.8M LONG VERTICAL CRACK, UP TO 5MM WIDE, STARTING FROM THE BOTTOM OF THE WALL
A.710

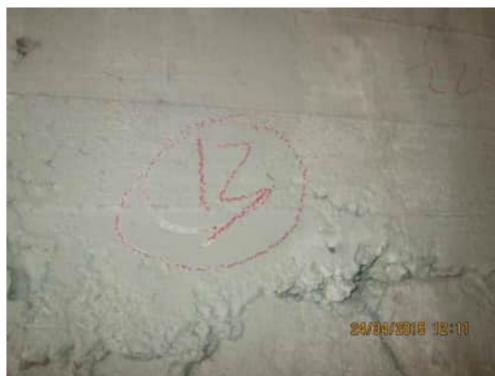
RW.11 SEVERE CONCRETE SPALLING
A.710

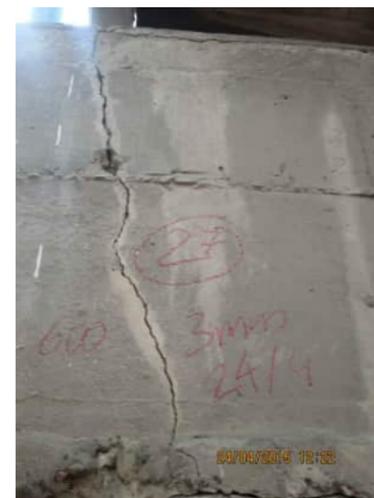
RW.12 APPROXIMATELY 600MM LONG VERTICAL CRACK, STARTING FROM THE TOP OF THE WALL, UP TO 3MM WIDE
A.710

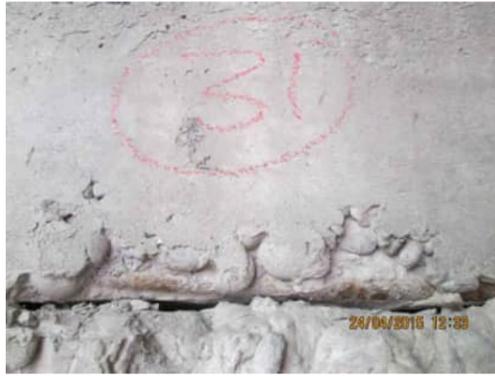
RW.13 | SIGNIFICANT HORIZONTAL CRACK AT JOINT AND EXPOSED REINFORCEMENT AT APPROXIMATELY 600MM FROM THE TOP OF THE WALL
A.710

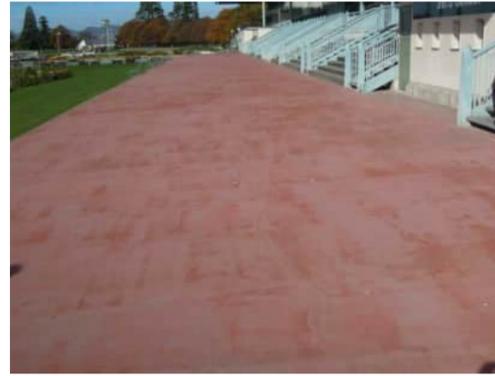
EXT.1 | CRACK ALONG ENTIRE LENGTH OF SLAB
A.710

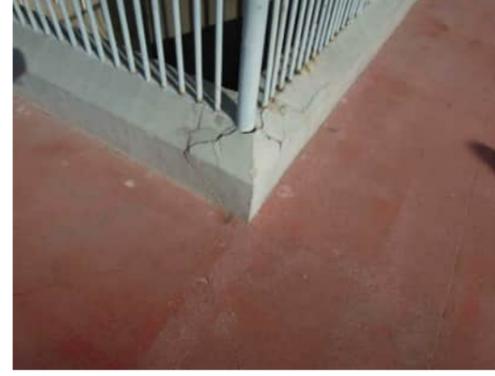
EXT.2 | DAMAGE TO TOP OF RETAINING WALL AROUND CAST-IN HANDRAIL
A.710

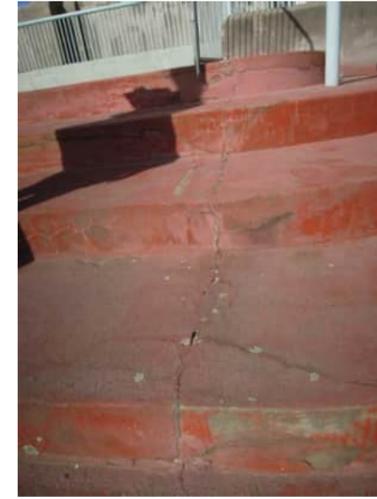
EXT.3 | CRACKS THROUGH STEPS, OCCURS THROUGHOUT
A.710

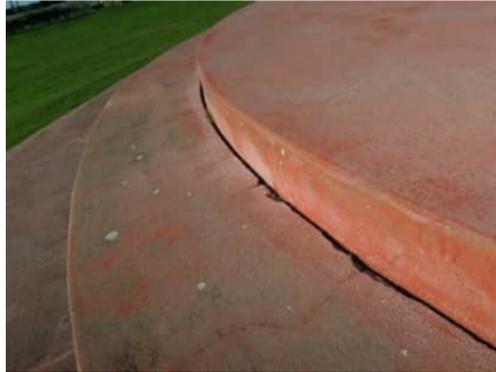
EXT.4 | SEPARATION BETWEEN SLAB AND FIRST STEP UP TO 25MM
A.710

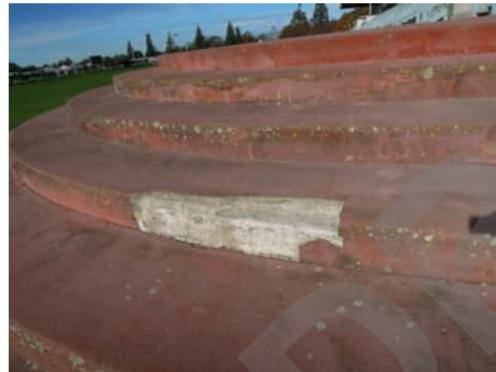
EXT.5 | SPALLING DAMAGE TO TOP OF STEP
A.710

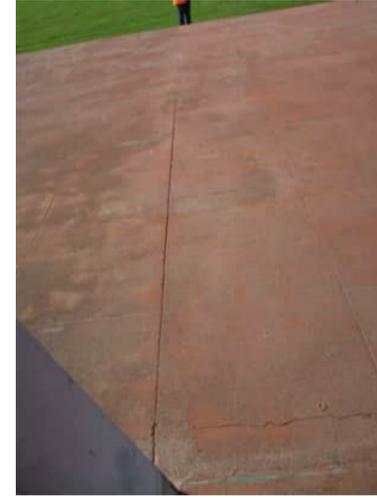
EXT.7 | TYPICAL CRACK IN JOINT
A.710

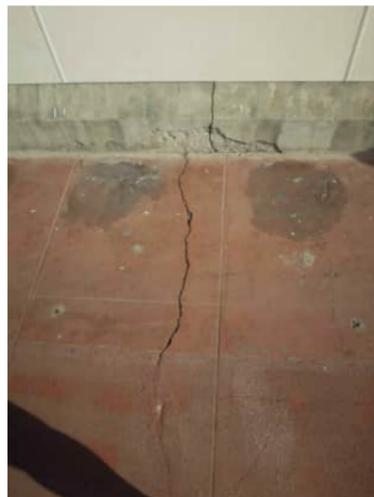
EXT.8 | CRACK IN SLAB AND RETAINING WALL
A.710

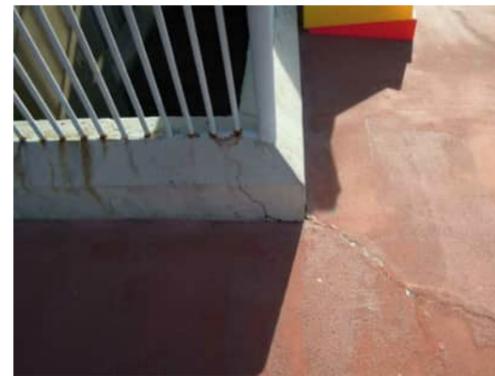
EXT.10 | CRACK IN SLAB FROM CORNER OF RETAINING WALL
A.710

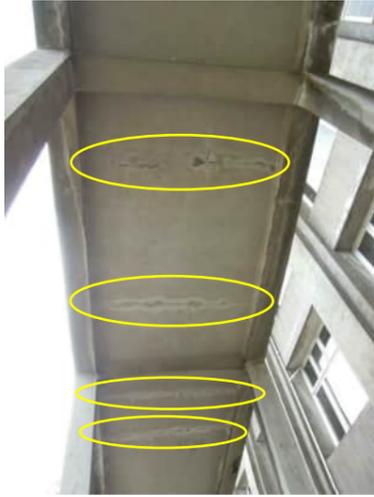
R1
A-810 TYPICAL CRACKS ON UNDERSIDE OF RAMP

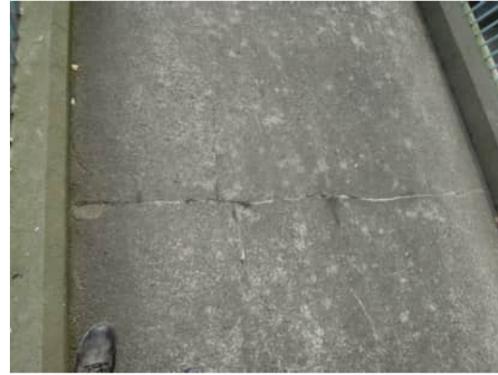
R2
A-810 TYPICAL CONSTRUCTION JOINT ON TOP SIDE OF RAMP

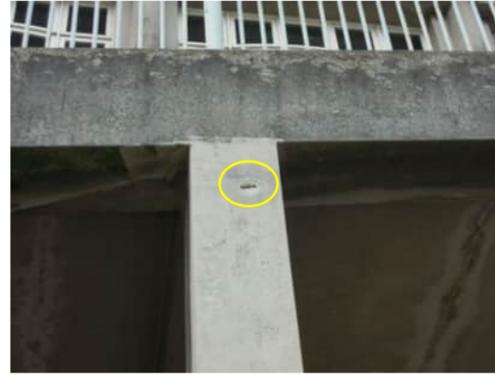
R3
A-810 SPALLING EXPOSING THE REINFORCING

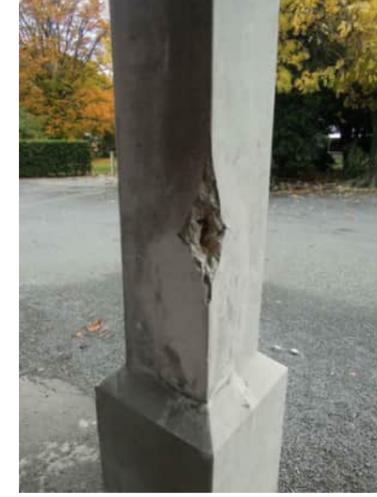
R4
A-810 SPALLING EXPOSING REINFORCING ON THE CORNER OF COLUMN

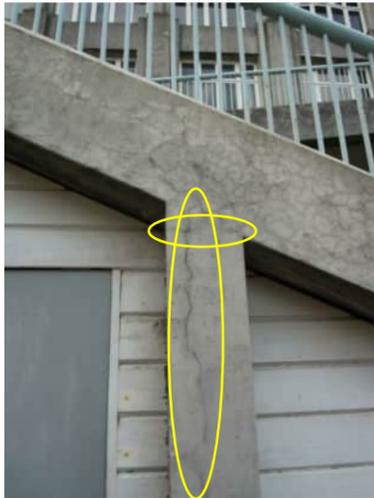
R5
A-810 VERTICAL CRACK DOWN COLUMN AND HORIZONTAL CRACK AT JOINT

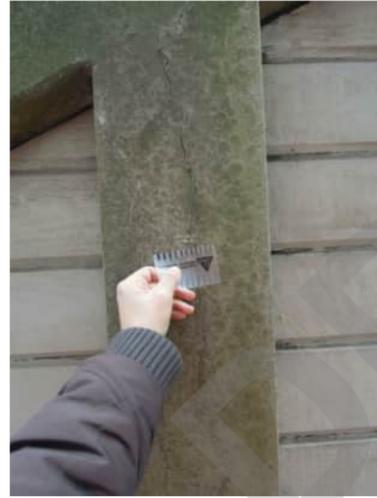
R6
A-810 VERTICAL CRACK DOWN COLUMN UP TO 1.2MM

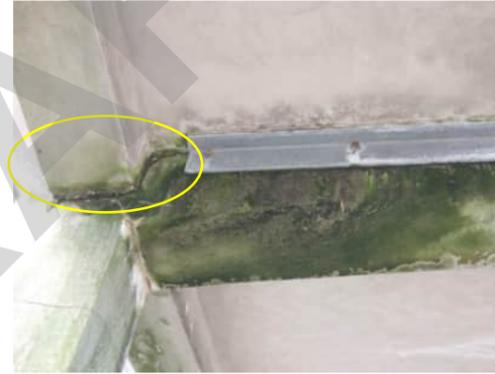
R7
A-810 SIGNIFICANT CRACK BETWEEN BEAM AND SLAB, BENEATH STEEL ANGLE

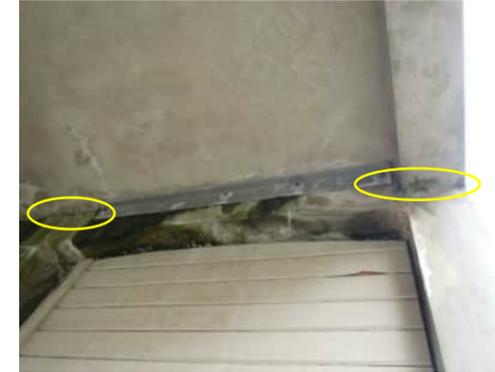
R8
A-810 CRACK CONTINUES TO OTHER SIDE OF PLATFORM

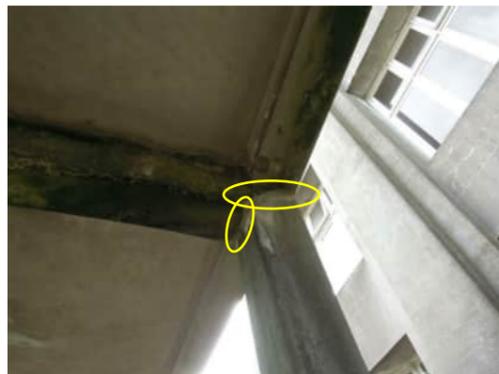
R9
A-810 HORIZONTAL CRACKS AROUND COLUMNS

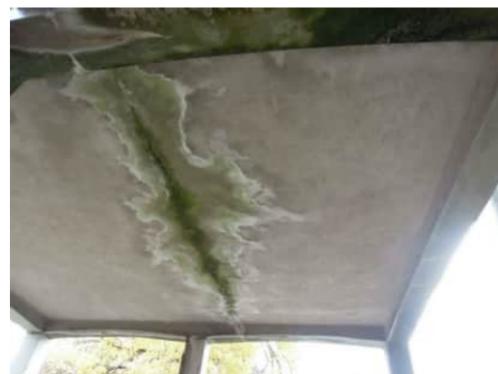
R10
A-810 SIGNIFICANT CRACK THROUGH PLATFORM

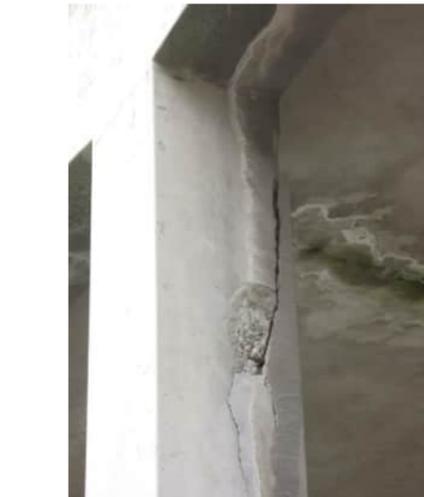
R11
A-810 CORNER BREAKING OFF COLUMN EXPOSING REINFORCING

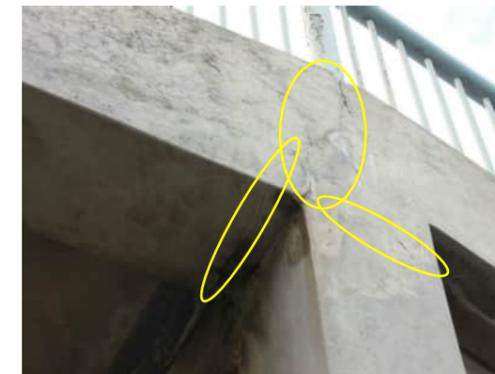
R12
A-810 CRACK THROUGH BEAM COLUMN JOINT WHERE STAIRS CONNECT TO PLATFORM

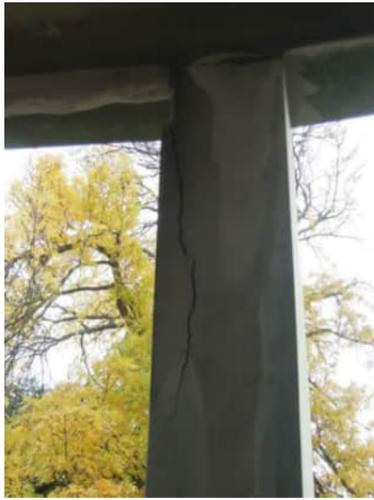
R13
A-810 | CORNER SPALLING OFF COLUMN

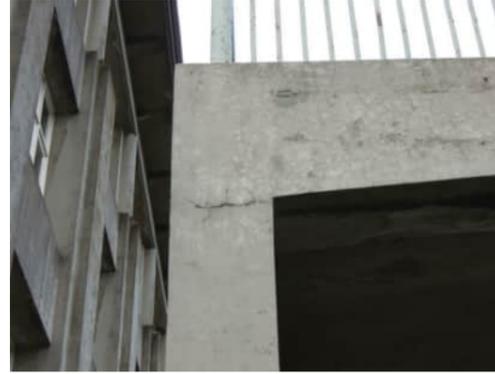
R14
A-810 | HORIZONTAL CRACK AT TOP OF COLUMN

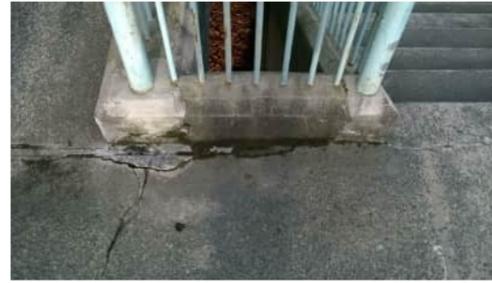
R15
A-810 | CRACKING THROUGH LANDING SLAB BETWEEN STAIRS AND RAMP

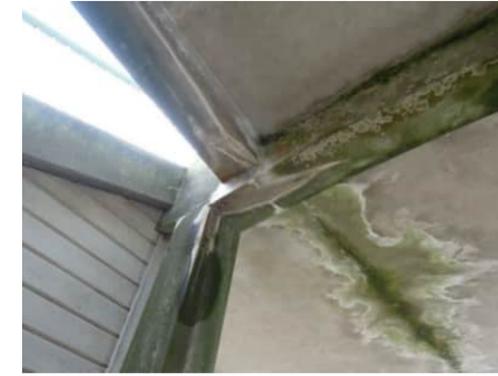
R16
A-810 | MULTIPLE CRACKS TO BEAMS AND COLUMNS WHERE RAMP'S CONNECTS TO LANDING

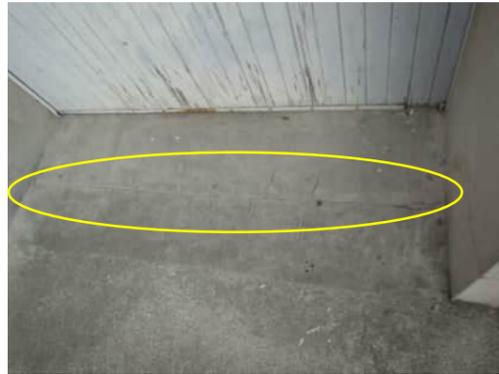
R17
A-810 | CRACK IN SLAB WHERE THE RAMP CONNECTS TO THE BUILDING

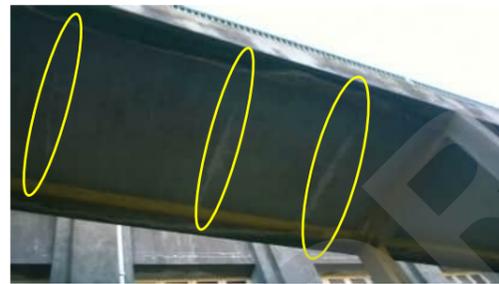
R18
A-810 | TYPICAL CRACKS TO UNDERSIDE OF RAMP

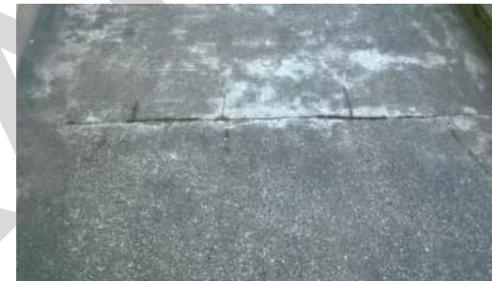
R19
A-810 | TYPICAL CONSTRUCTION JOINT ON TOP SIDE OF RAMP

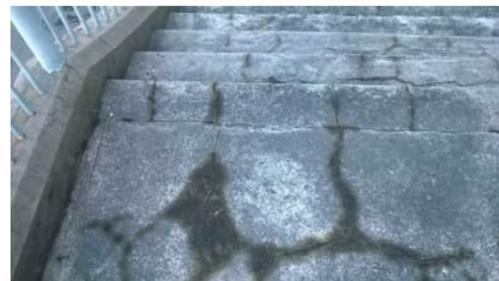
R21
A-810 | MULTIPLE CRACKS TO LANDING AND STAIRS

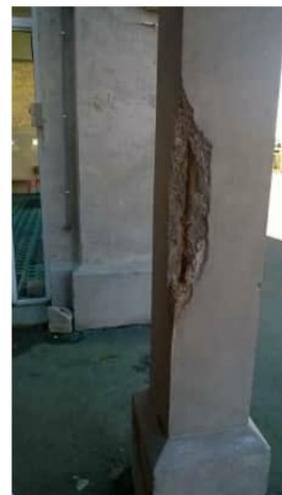
R22
A-810 | CORNER SPALLED OFF COLUMN EXPOSING REINFORCING

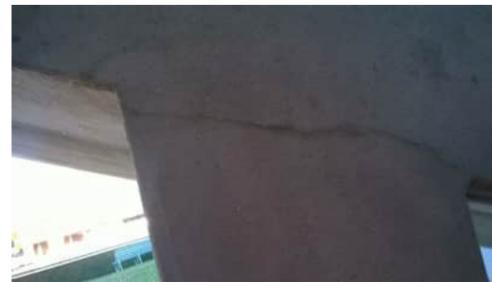
R23
A-810 | CRACK AT TOP OF COLUMN

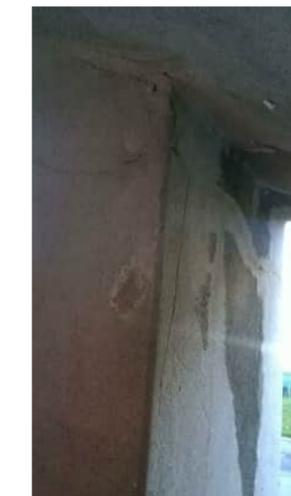
R24
A-810 | MULTIPLE CRACKS AT TOP OF COLUMN

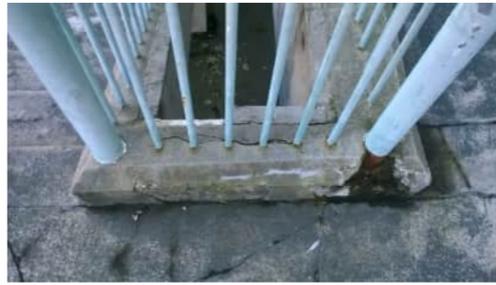
R25 | CRACKING TO THE BEAM AND LANDING SLAB BETWEEN THE STAIRS AND RAMP, CONCRETE BROKEN OUT AROUND HANDRAIL
A-810

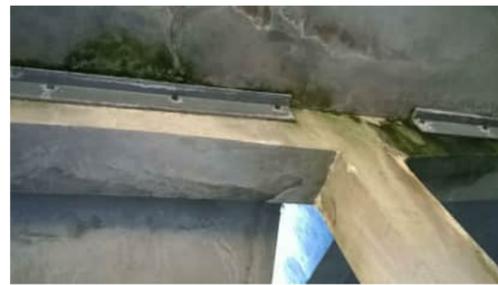
R26 | CRACK BETWEEN SLAB AND BEAM UNDER LANDING SLAB. STEEL ANGLES HAVE BEEN FITTED TO SUPPORT SLAB
A-810

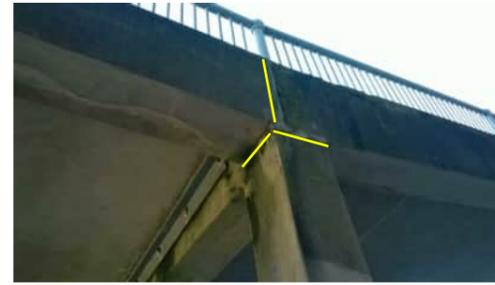
R27 | CRACK SHOWN IN PHOTO R26 CONTINUES THROUGH BEAM TO TOP OF COLUMN. VERTICAL CRACK THROUGH BEAM WHERE RAMP AND LANDING INTERSECT
A-810

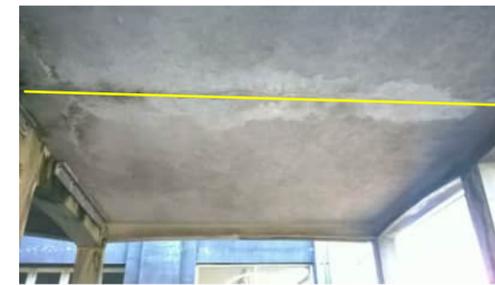
R28 | CRACK ON UNDERSIDE OF LANDING SLAB
A-810

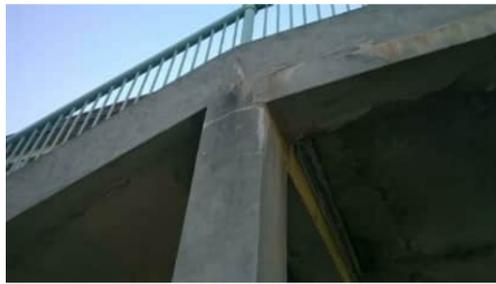
R29 | CRACKS TO BEAM AND COLUMN
A-810

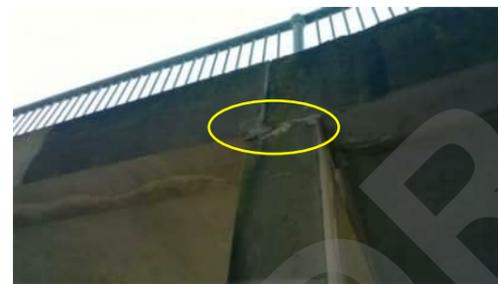
R30 | CRACK BETWEEN BEAM AND COLUMN
A-810

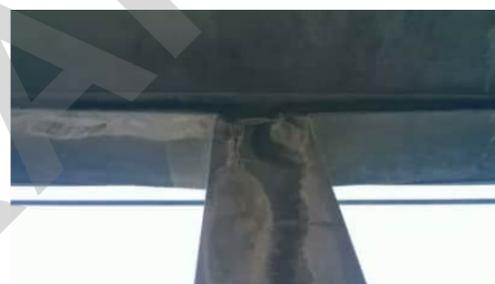
R31 | SIGNIFICANT VERTICAL CRACK NEAR TOP OF COLUMN
A-810
