Damage Assessment Report

Grand National (Public) Stand

Client: Canterbury Jockey Club

Job No.: 60332326

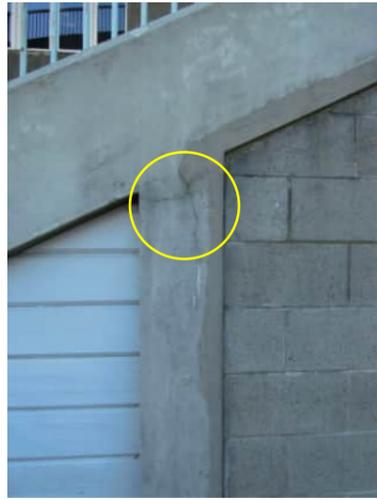
S1
A-814 | CRACKS AT THE TOP OF THE COLUMN UP TO 0.4MM

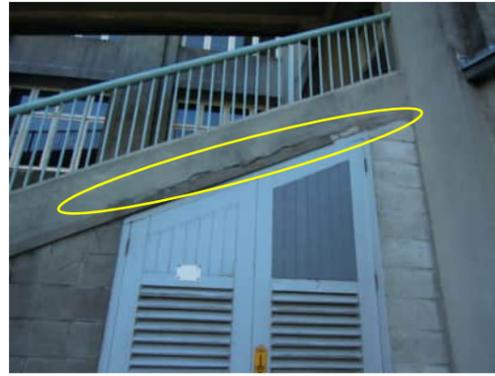
S2
A-814 | CRACK UP TO 20MM ALONG THE SIDE OF THE STRINGER

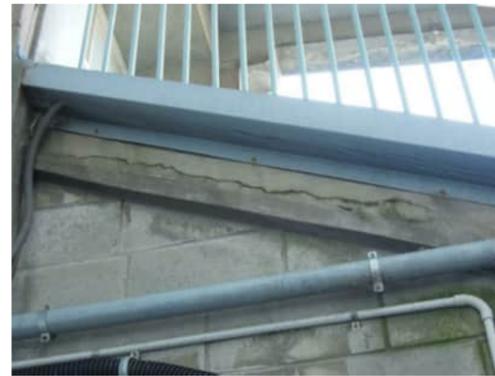
S3
A-814 | CRACK UP TO 5MM ALONG THE OTHER SIDE OF THE STRINGER

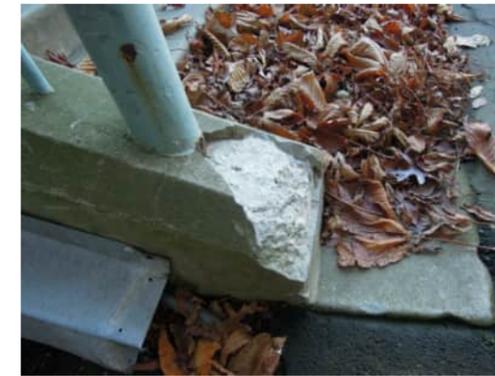
S4
A-814 | DAMAGE TO THE SURFACE OF THE CONCRETE AT BASE OF THE STRINGER

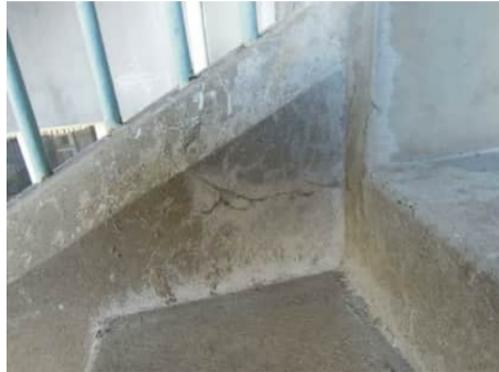
S5
A-814 | CRACK WHERE THE STAIRS CONNECT TO THE BUILDING

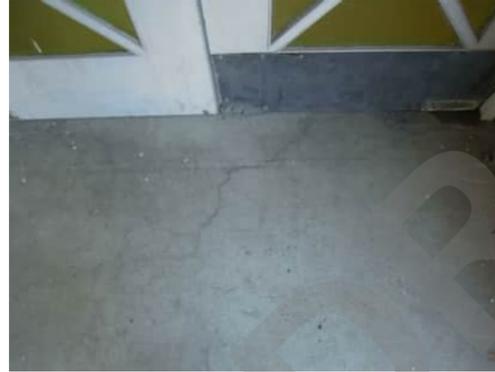
S6
A-814 | CRACK UP TO 1.6MM IN THE SLAB AT THE TOP OF THE STAIRS

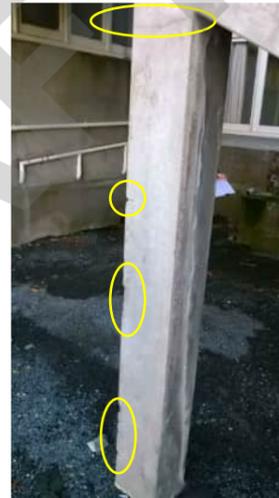
S7
A-814 | HAIRLINE HORIZONTAL CRACK AT TOP OF COLUMN AND SPALLING DAMAGE ALONG HEIGHT

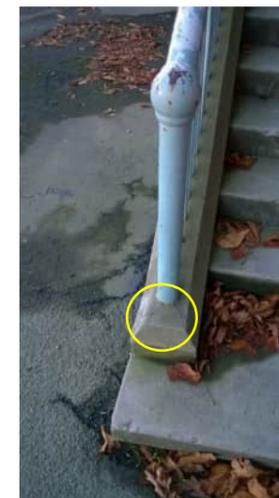
S8
A-814 | CRACKING AROUND WHERE HANDRAIL IS CAST INTO THE CONCRETE

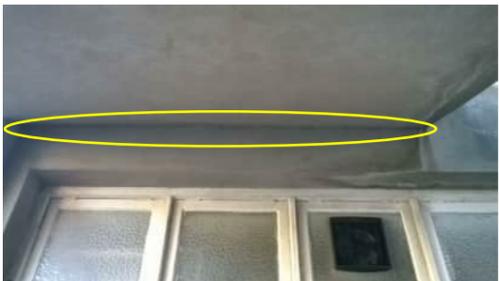
S9
A-814 | SEPARATION BETWEEN UNDERSIDE OF STAIRS AND THE MAIN BUILDING

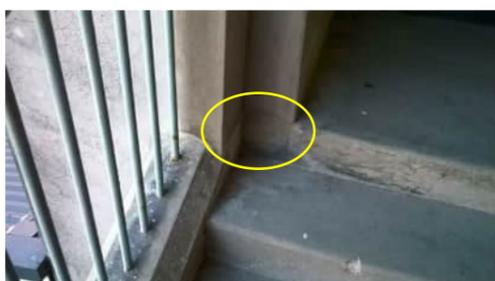
S10
A-814 | CRACKING IN THE CORNER WHERE THE STAIRS CONNECT TO THE MAIN BUILDING

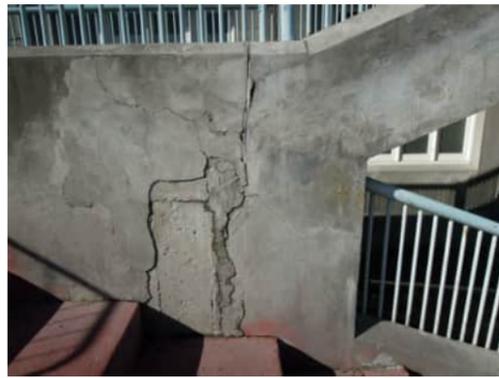
S11 | SIGNIFICANT CRACKS ON THE SIDE OF THE STAIRS UP TO 3.5MM WITH RENDER SPALLING OFF
A-816

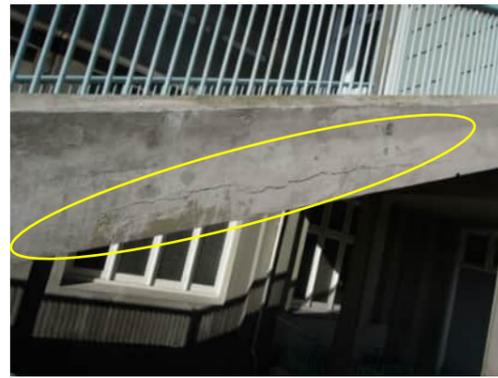
S12 | CRACK UP TO 4MM ALONG THE STRINGER
A-816

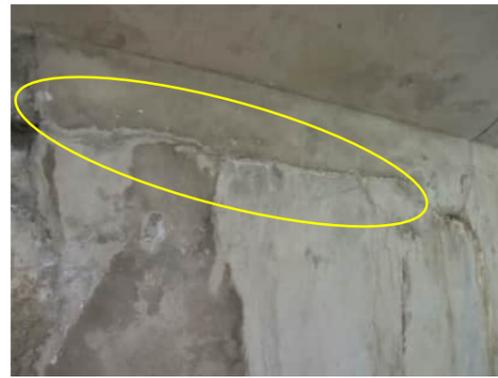
S13 | HORIZONTAL CRACK UP TO 0.5MM ON WALL BELOW STAIRS
A-816

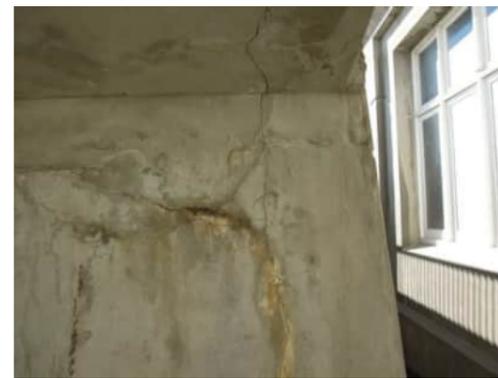
S14 | VERTICAL CRACKS UP TO 0.8MM WIDE ON THE UNDERSIDE OF THE STAIRS AND DOWN THE WALL BELOW THE STAIRS
A-816

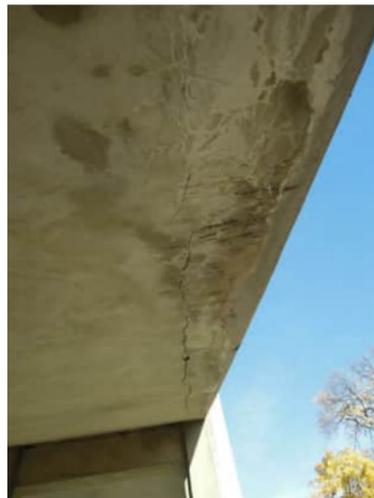
S15 | CRACK ON UNDERSIDE OF STAIRS UP TO 4MM WIDE
A-816

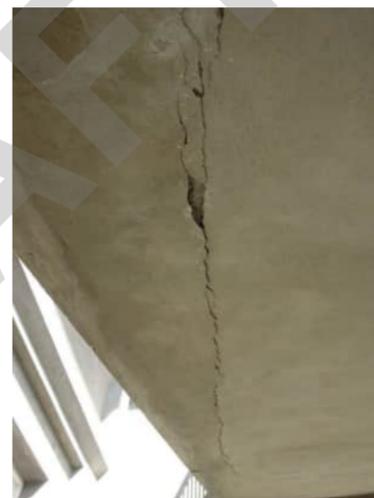
S16 | CRACK ON UNDERSIDE OF STAIRS UP TO 4MM WIDE
A-816

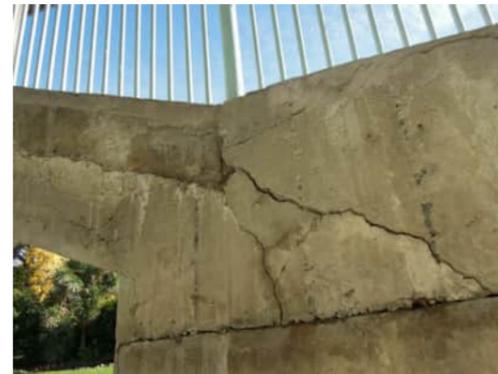
S17 | CRACK ON UNDERSIDE OF STAIRS UP TO 4MM WIDE WITH LOCALISED SPALLING TO RENDER
A-816

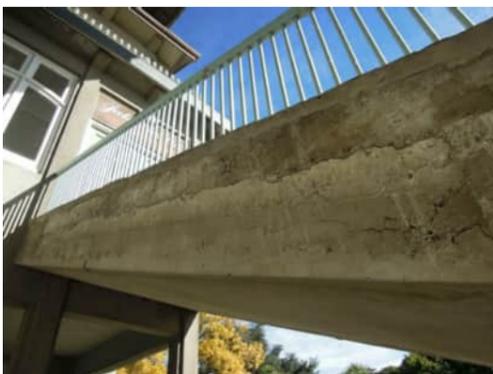
S18 | CRACKS UP TO 15MM AT TOP OF WALL WHERE STAIRS BEGIN
A-816

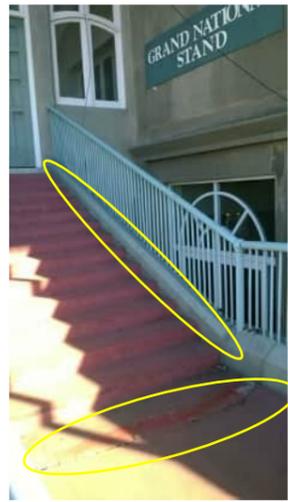
S20
A-818 | SIGNIFICANT CRACK ALONG STRINGER AND ANOTHER SIGNIFICANT CRACK ACROSS LANDING SLAB AT BOTTOM OF STAIRS

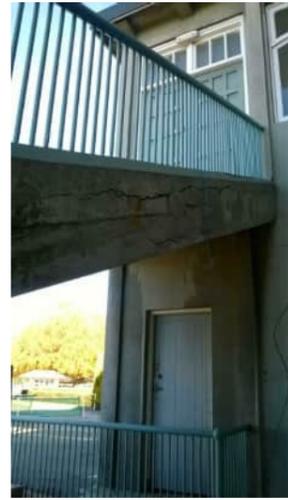
S21
A-818 | SIGNIFICANT CRACK ALONG STRINGER SHOWN IN PHOTO S20 IS ALSO VISIBLE ON OUTSIDE OF STAIRS

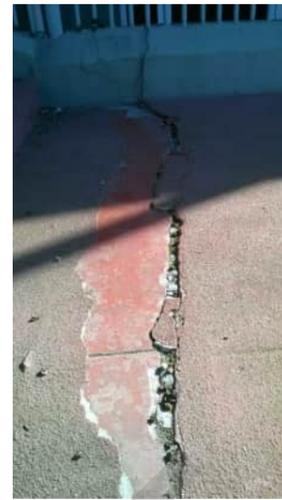
S22
A-818 | SIGNIFICANT CRACK IN LANDING SLAB AT BOTTOM OF STAIRS SHOWN IN PHOTO S20 HAS EVIDENCE OF SETTLEMENT TO THE STAIR SIDE

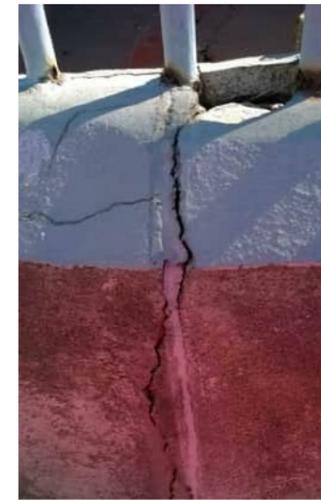
S23
A-818 | SIGNIFICANT CRACK IN LANDING SLAB AT BOTTOM OF STAIRS SHOWN IN PHOTO S22 CONTINUES INTO WALL

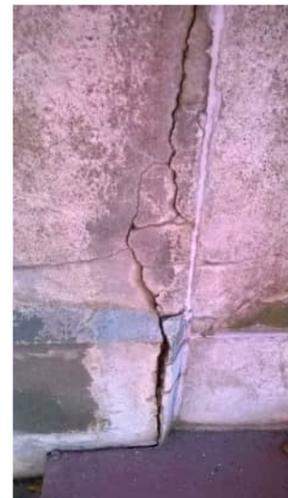
S24
A-818 | SIGNIFICANT CRACK IN WALL WITH SPALLING UP TO 10MM WIDE

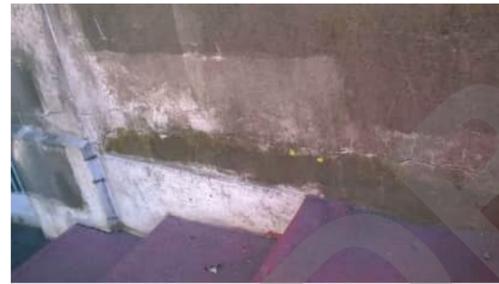
S25
A-818 | HORIZONTAL CRACK ALONG WALL AT THE BOTTOM OF THE STAIRS 3MM WIDE

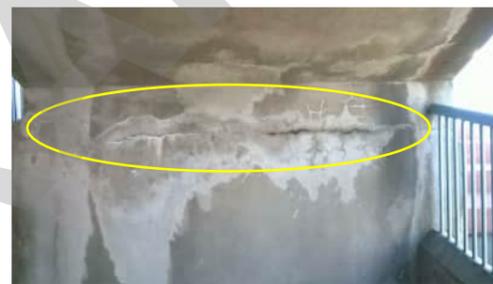
S26
A-818 | HORIZONTAL CRACK IN WALL CONTINUES TO THE WALL BENEATH THE STAIRS

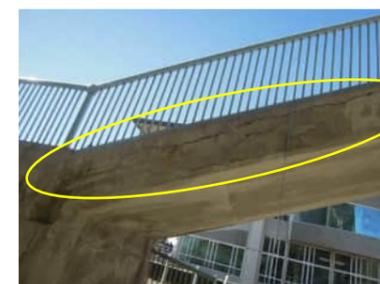
S27
A-818 | HORIZONTAL CRACK IN WALL CONTINUES TO THE WALL BENEATH THE STAIRS
