Christchurch City Council
BE 0574 EQ2 (excluding BU 0574-003)
Aorangi Elderly Persons Home
110 Aorangi Road

QUANTITATIVE REPORT
FINAL

QUANTITATIVE ASSESSMENT REPORT

- Rev C
- 30 April 2013

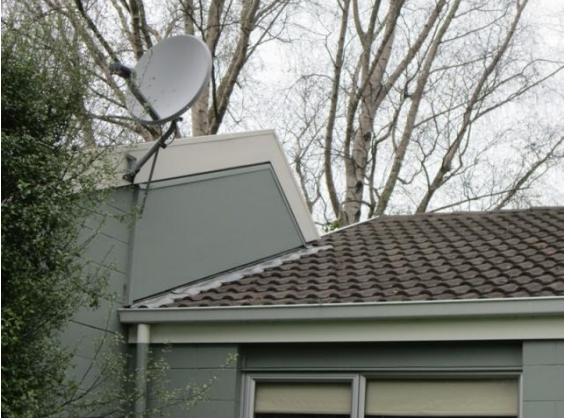
Photo 9: Gap opening up between wall lining, masonry wall and ceiling cladding	Photo 10: Steel flashing present between offset units

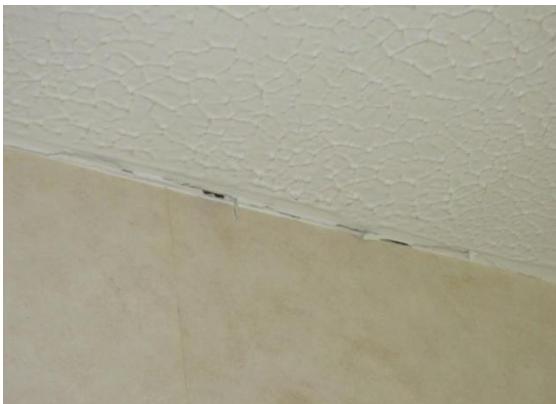
Photo 11: Gap opening up between wall lining and ceiling cladding	Photo 12: Gap opening up between masonry wall and ceiling cladding

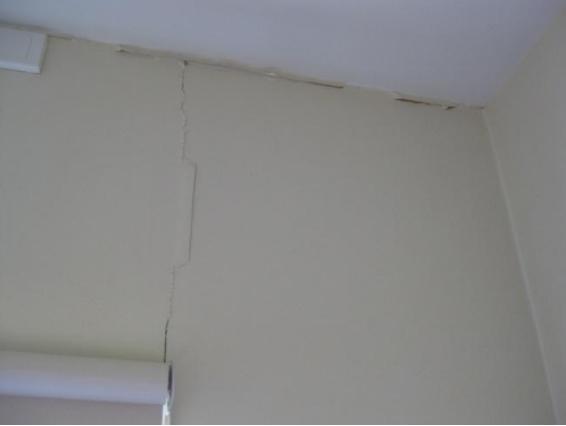
Photo 5: Tearing of wall lining along joints	Photo 6: Gap opening up between wall cladding elements

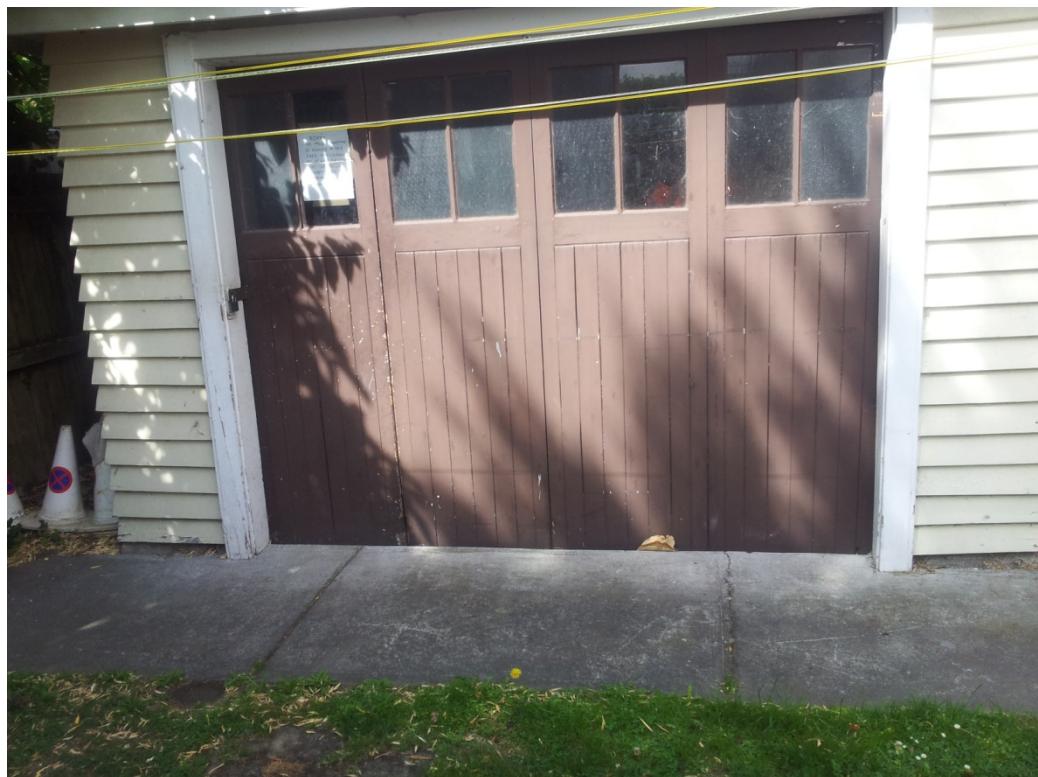
▪ **Figure 10 – Shed, middle of structure appeared to be sagging.**
