**Hei Hei Community Centre**  
**BU 1559-001 EQ2**  
Detailed Engineering Evaluation  
Quantitative Report  
Version FINAL

16 Wycola Avenue, Hei Hei

Christchurch City Council

**Date**  
17/12/12

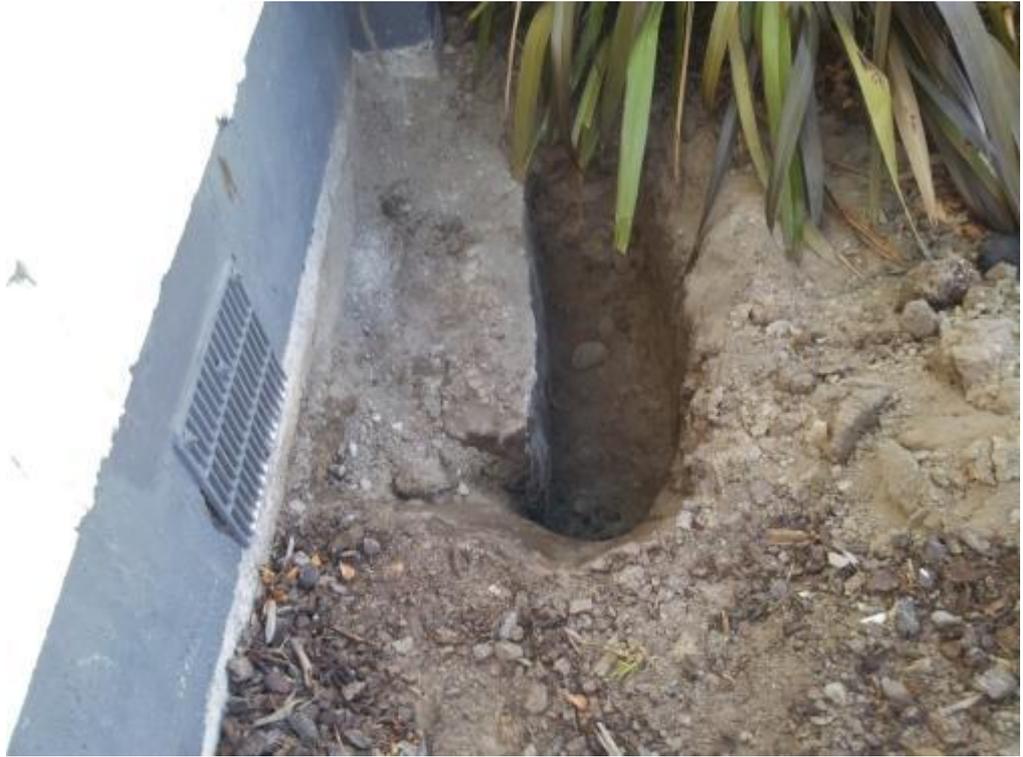
The building has a light weight corrugated iron roof. The foundations for the building consist of pad footings for the portal frame with the external walls of the 'lean-to' supported a strip foundations (See Photograph 13, 14, 17 and 18).

**Photograph 13: Opening up works at exterior masonry wall showing the connection to foundation**

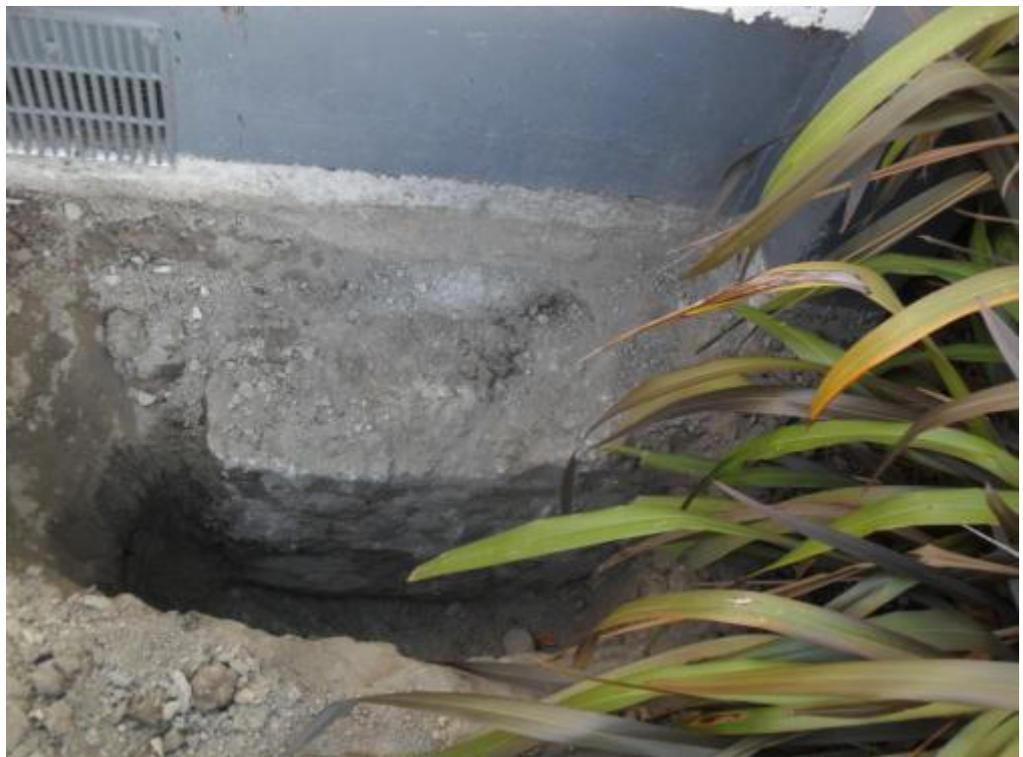
**Photograph 14: As above**

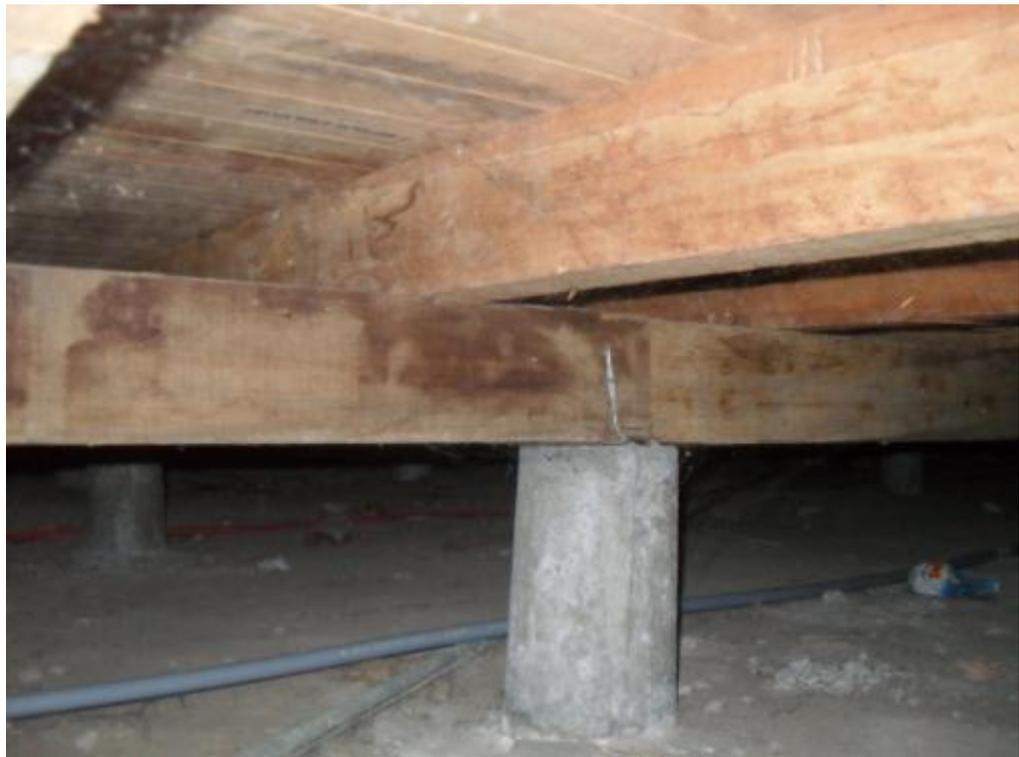
**Photograph 15: Opening up works showing the timber floor system and foundation support**

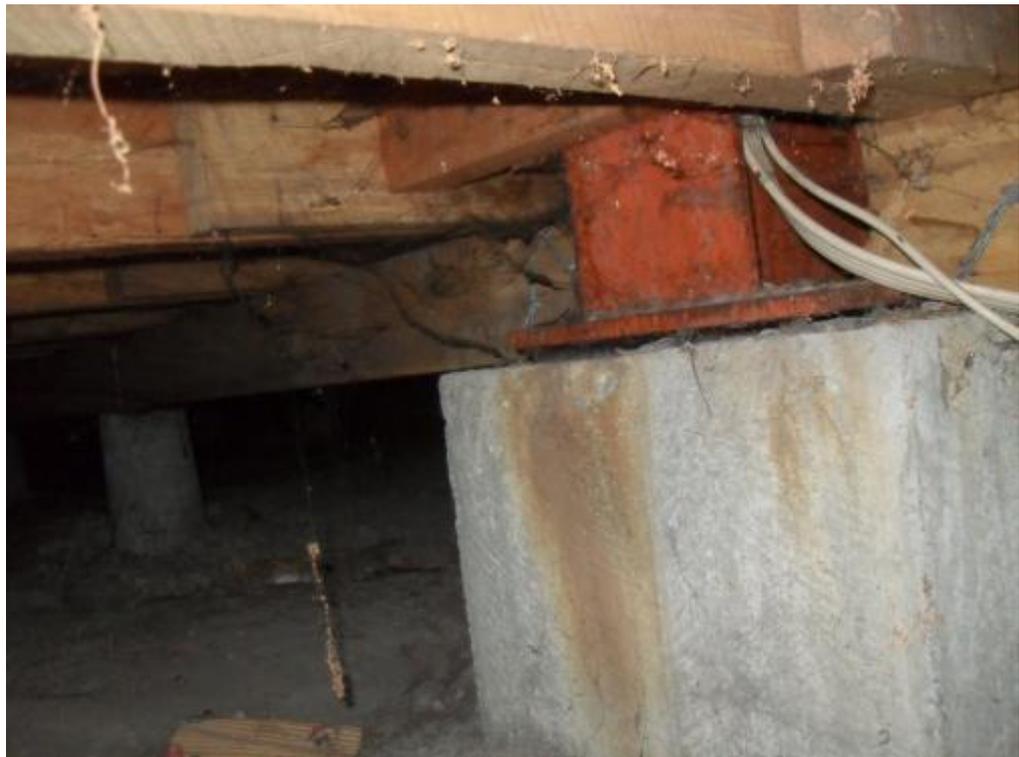
**Photograph 17: Opening up work showing the foundation support under the steel portal frame**

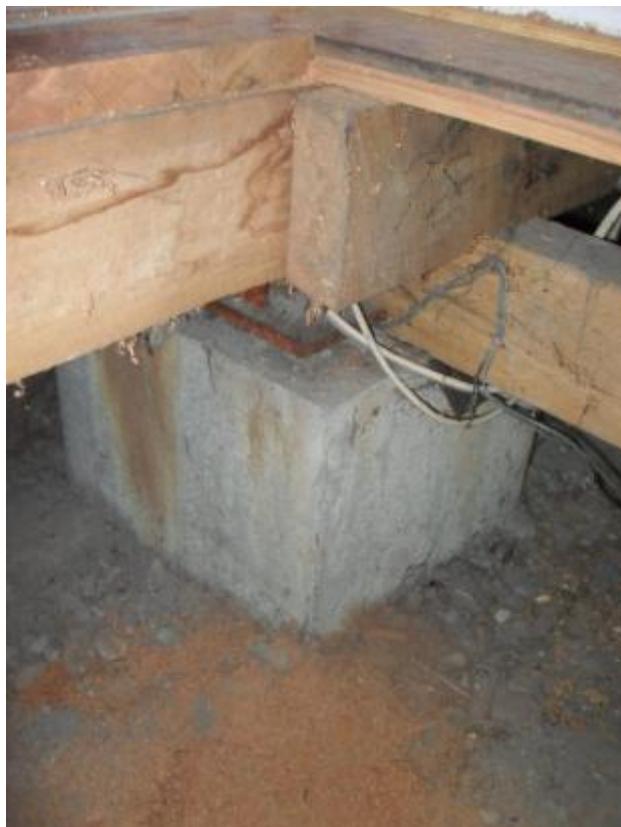
**Photograph 18: As above**

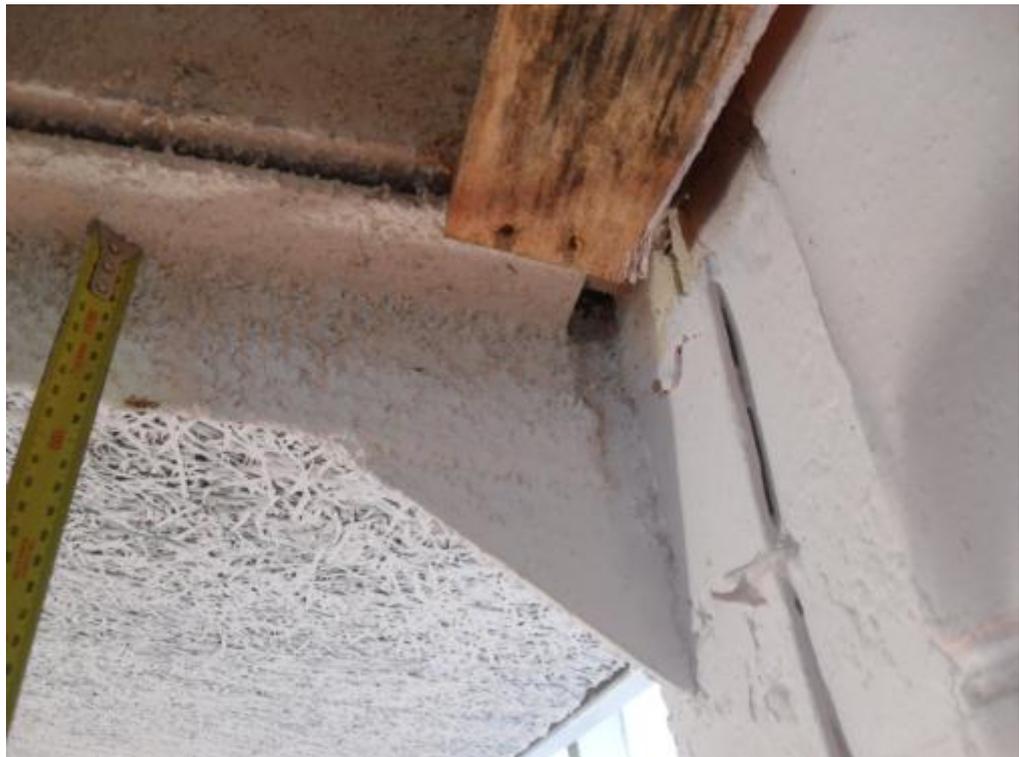
**Photograph 21: Opening up works on roof showing connections between the steel frame and reinforced concrete column**

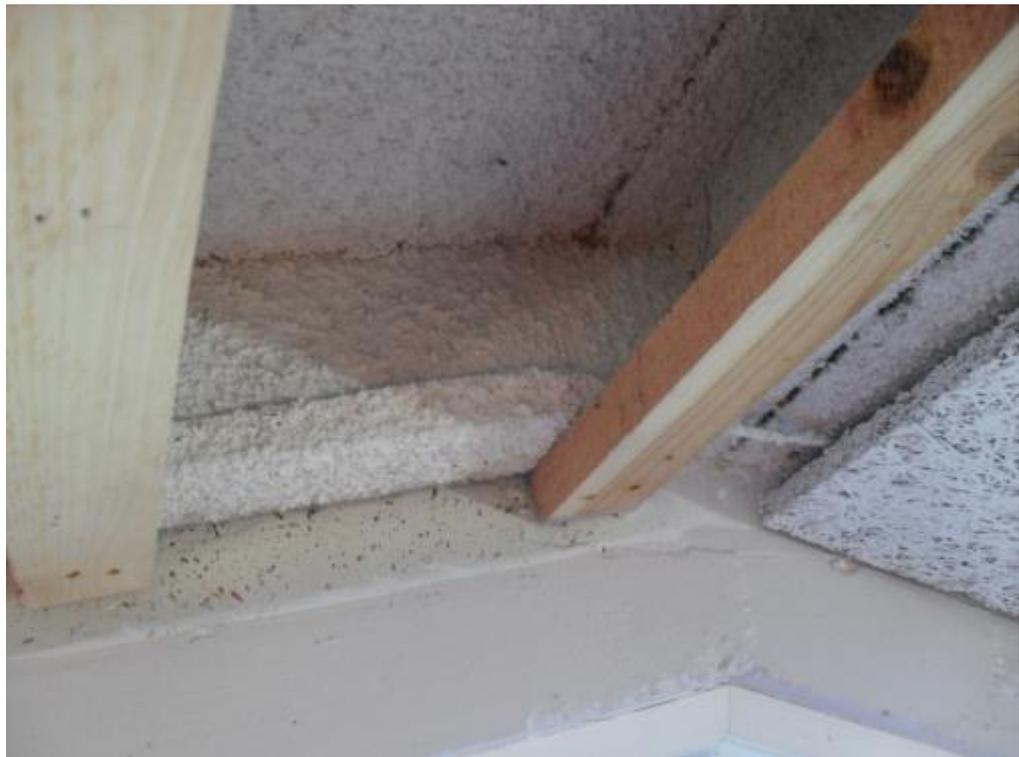
It was noted that bolts connecting the rolled steel joists (RSJ's) to the portal frames were missing (See Photograph 27). In addition, the connection between the RSJ's and the concrete frames at the front and rear of the building (See Photograph 23 and 24) could not be confirmed due to the presence of ceiling linings.

**Photograph 23: Opening up works on roof showing steel and concrete frame connections**

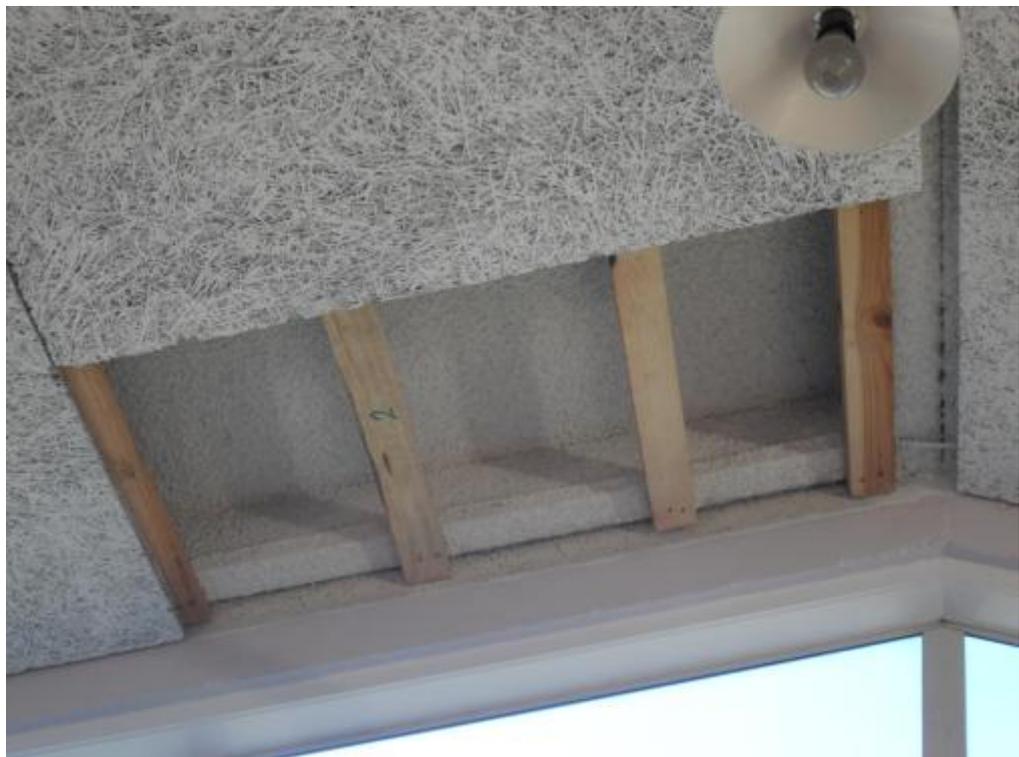
**Photograph 24: As above**

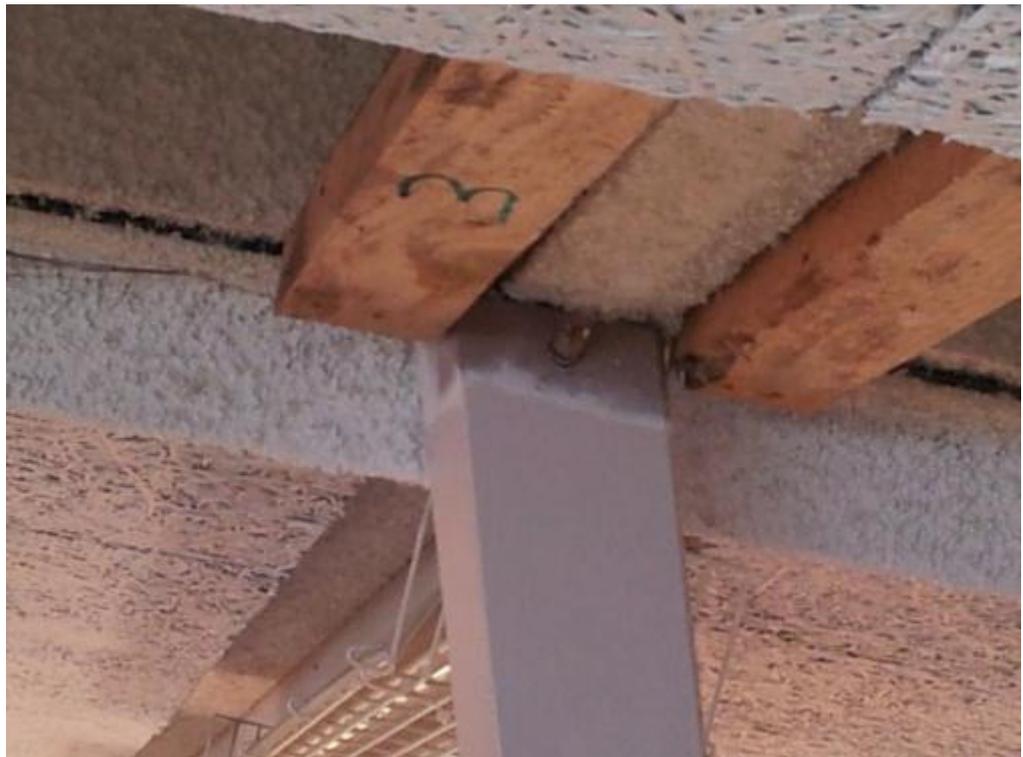
**Photograph 25: Opening up works on roof showing the connection between the angle and box steel frame.**

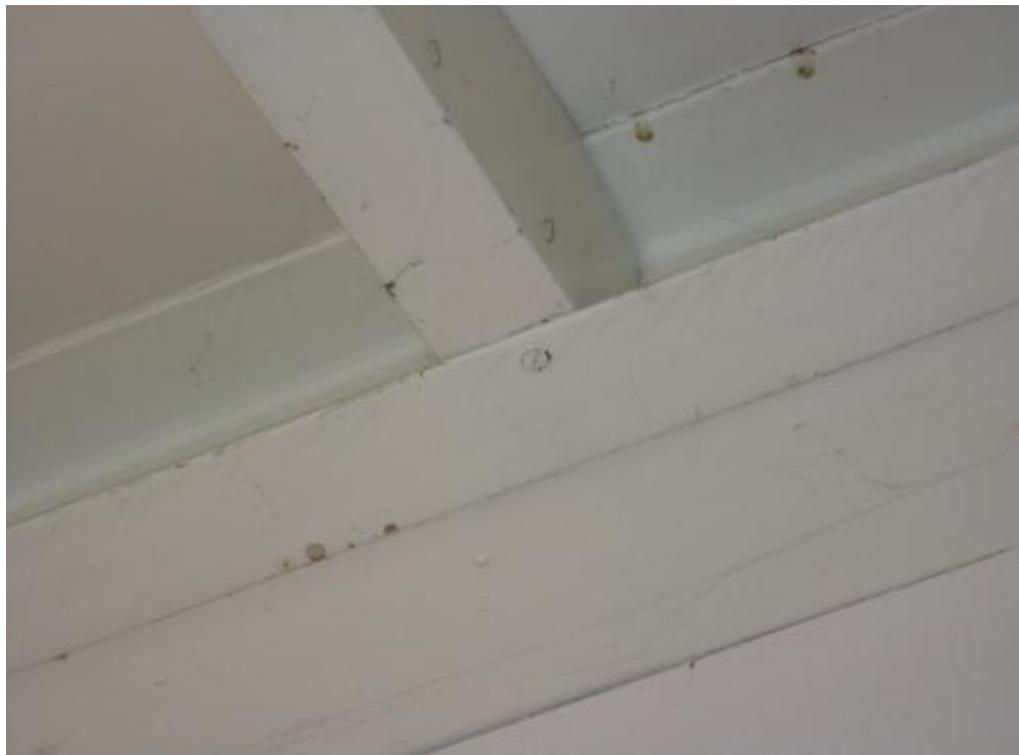
Further inspections were carried out on the 22<sup>nd</sup> of May 2012 to confirm the structural connection between the rolled steel joists and steel portal frames (See Photograph 27). Further, inspections were undertaken to confirm foundations for the unreinforced masonry walls and steel portal frames (See Photographs 13, 14, 17, 18 and 19). Also, the connections between the roof steel members to the reinforced concrete frame located at the mezzanine floor area of the building (See Photographs 21, 22, 23 and 24) and between the RSC and timber frames at the 'lean-to' areas (See Photographs 31 and 32) were identified.

**Photograph 32: As above**
