**Jellie Park
Recreation & Sport
Centre
PRO 0266-007**

**Detailed Engineering Evaluation
Quantitative Assessment Report**

Date: February 2014
Reference: 6-QUCCC.62
Status: Final V4

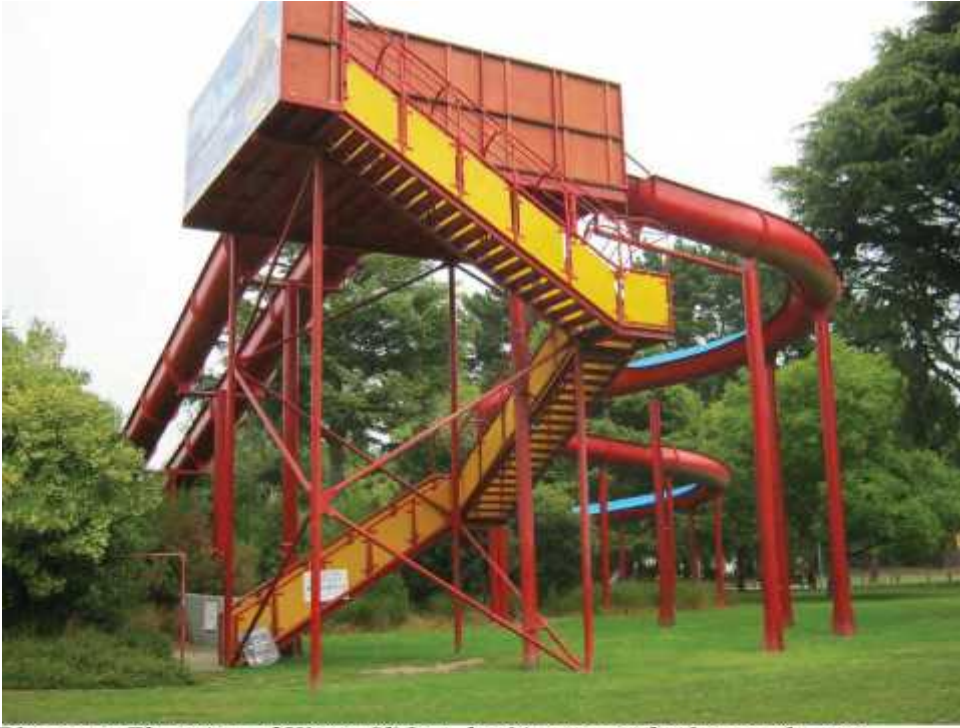
- There was no observed ground damage within the vicinity of Water Slide 1. Refer to Photos 19, 20 and 21.
- There was no observed ground damage within the vicinity of Water Slide 2. Refer to Photos 22 and 23.

Photo 19: Elevation of Water Slide 1, looking towards the south-west.

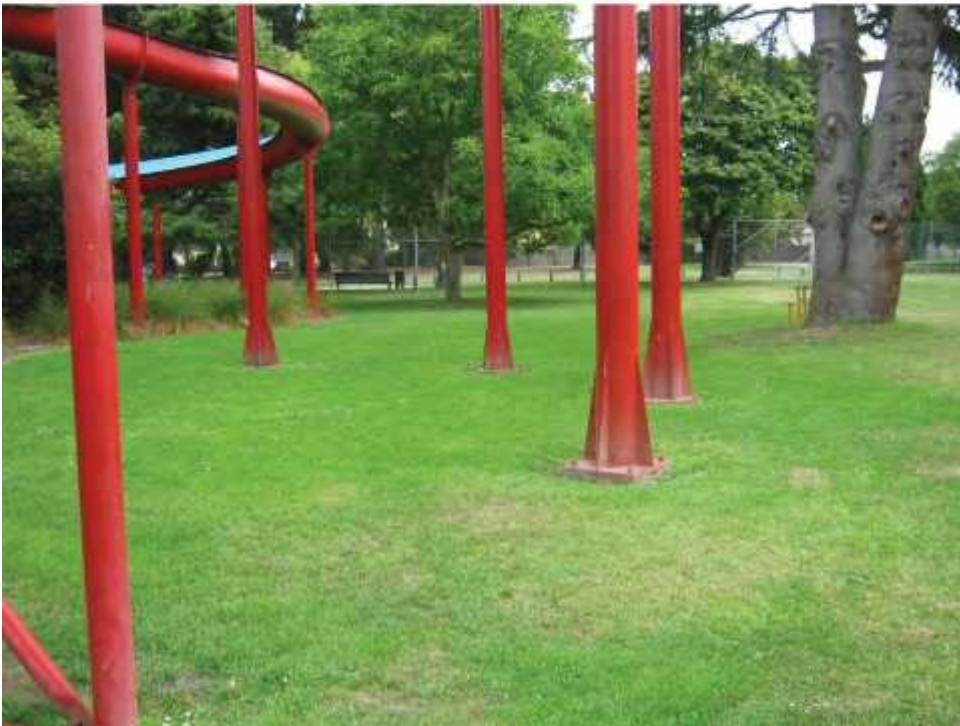
There are no structural drawings available for the external water slide (Water Slide 1), however from the site walkover it appears the steel frames are founded on approximately 300mm by 300mm concrete pad to an unknown depth. Refer to Photo 20 in Appendix A.

Photo 20: Steel supports of Water Slide 1 looking towards the south-west.

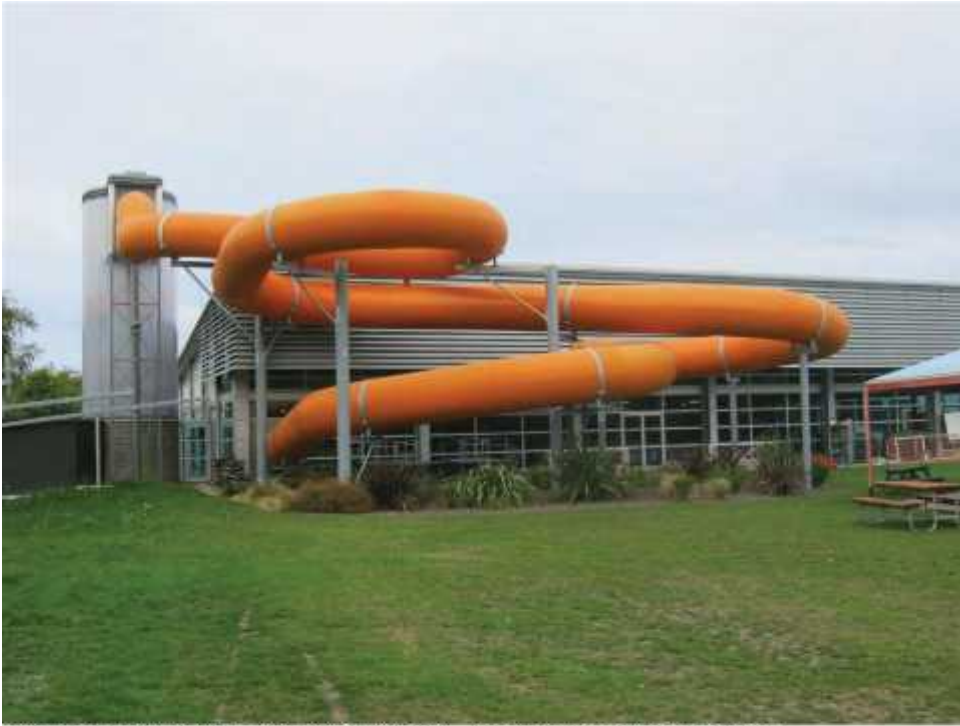
Photo 21: Elevation of Water Slide 2, looking towards the east.

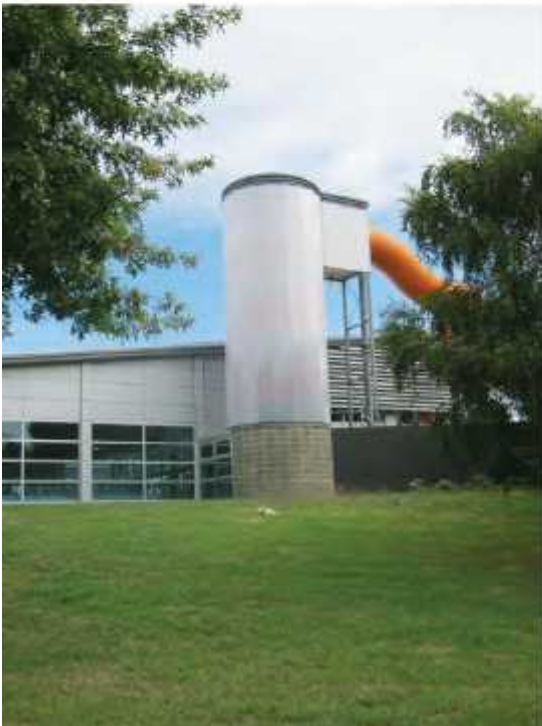
Photo 22: Water Slide 2 spiral stair, looking towards the south-west.

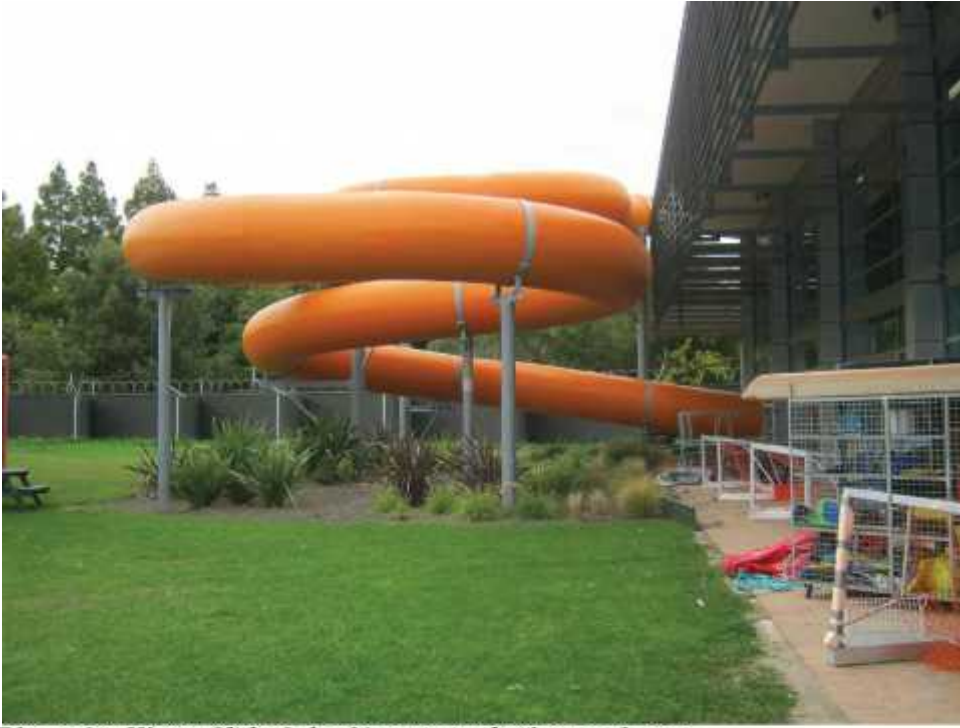
Photo 23: Water Slide 2, looking towards the north-east.
