City Care Milton Street Depot Plant Maintenance Workshop, Part 1 & 2 Detailed Engineering Evaluation BU 1141-002 EQ2 Quantitative Report

14 June 2013

City Care Milton Street Depot – Plant Maintenance Workshop, Part 1 & 2 BU 1141-002 EQ2

Detailed Engineering Evaluation Quantitative Report – SUMMARY Version 1

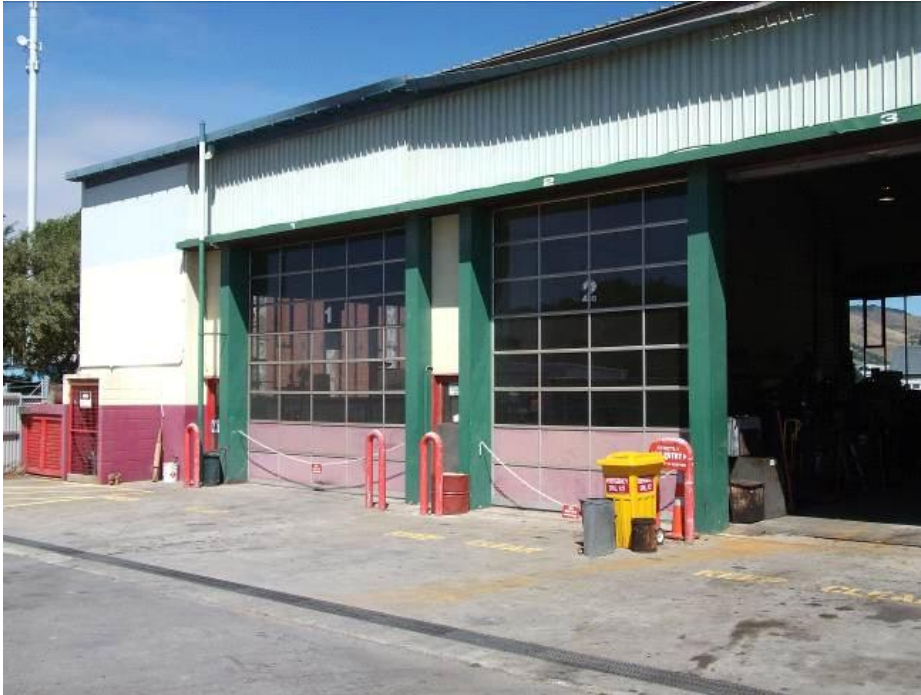
Photo 1: External view of Plant Maintenance Workshop

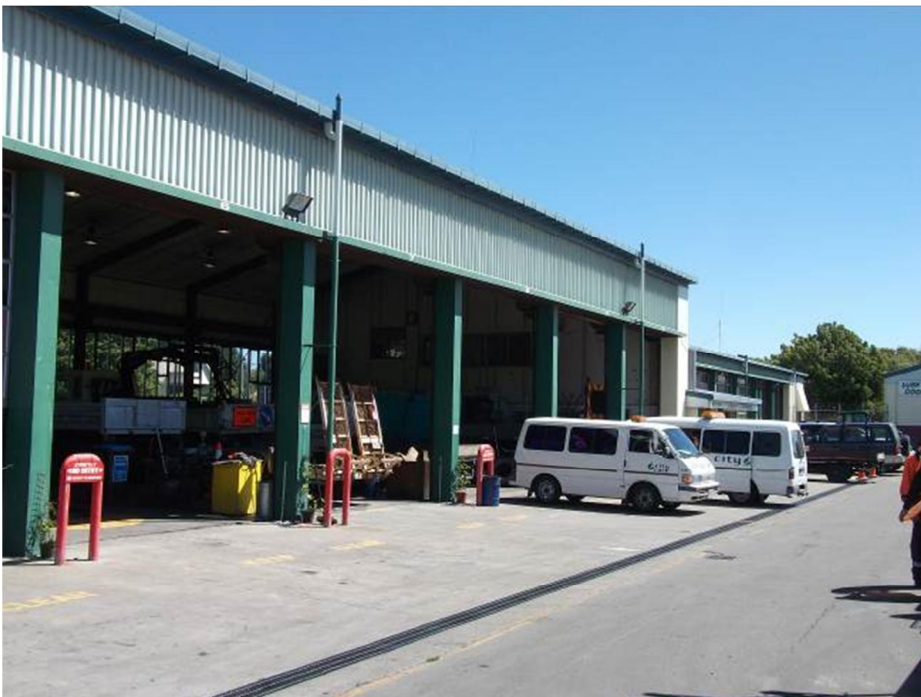
Photo 2: External view of Plant Maintenance Workshop

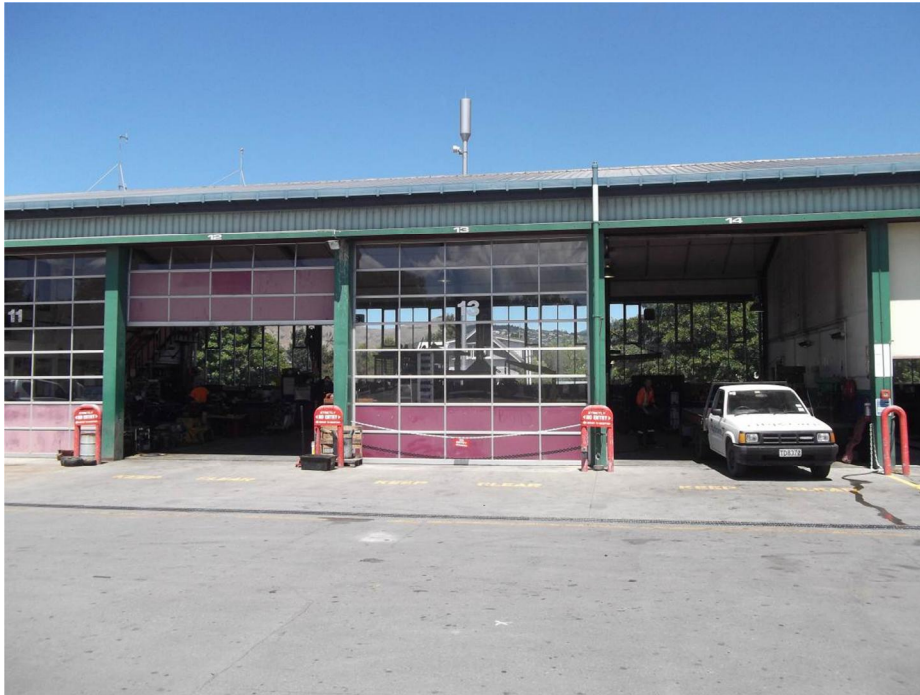
Photo 3: External view of Plant Maintenance Workshop

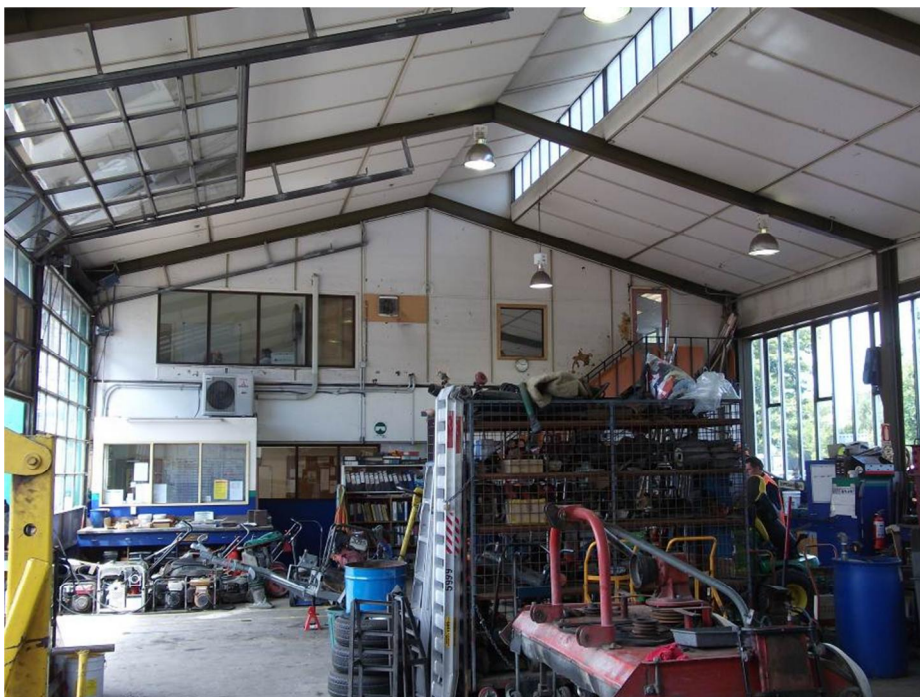
Photo 4: Internal view of Plant Maintenance Workshop.
