Christchurch City Council

Reg Stillwell Place PRO 1320

**Detailed Engineering Evaluation
Quantitative Assessment Report**

189 Palmers Road, New Brighton

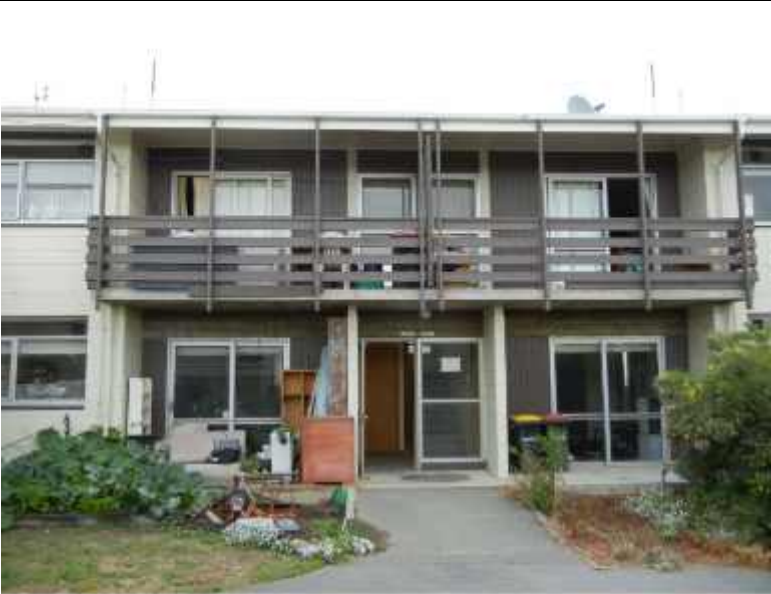
Reg Stilwell Place – 189 Palmers Road		
No.	Item description	Photo
<u>Block A</u>		
1.	North elevation of Block A showing the two-storey portion

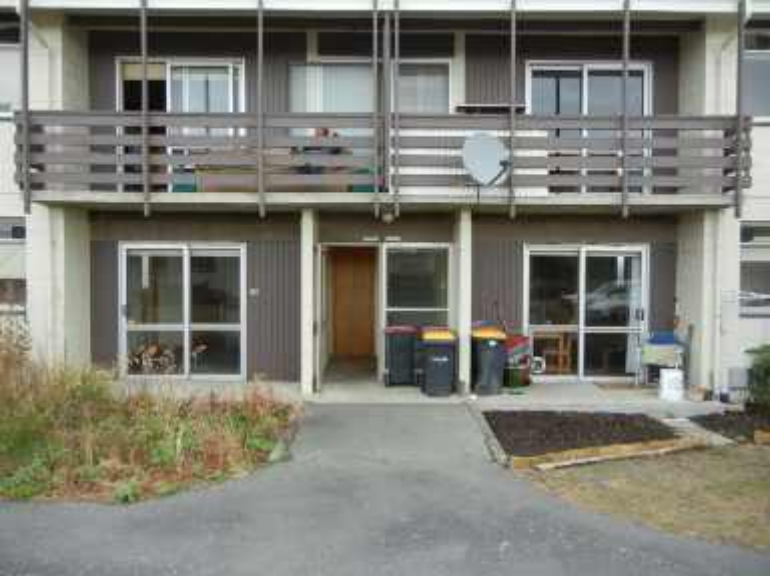
Block B		
7.	North elevation of 2-storey portion of Block B. Identical to Block A

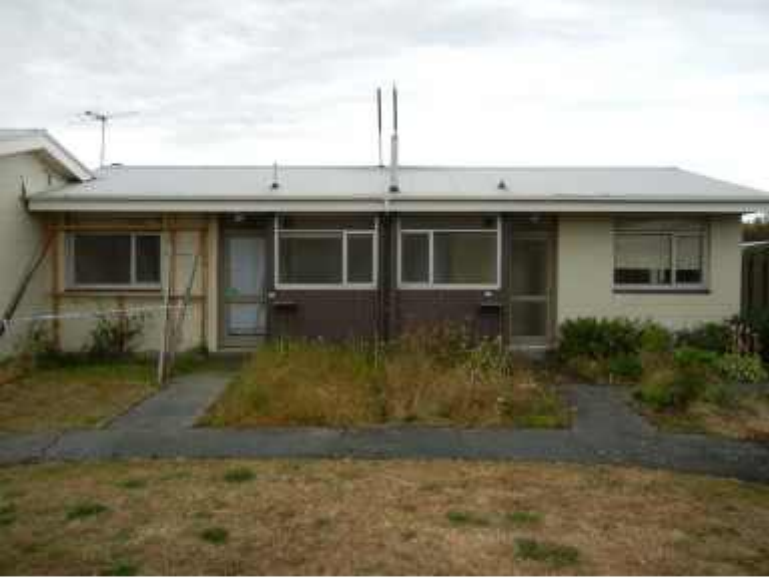
Block C		
17.	South elevation of block C

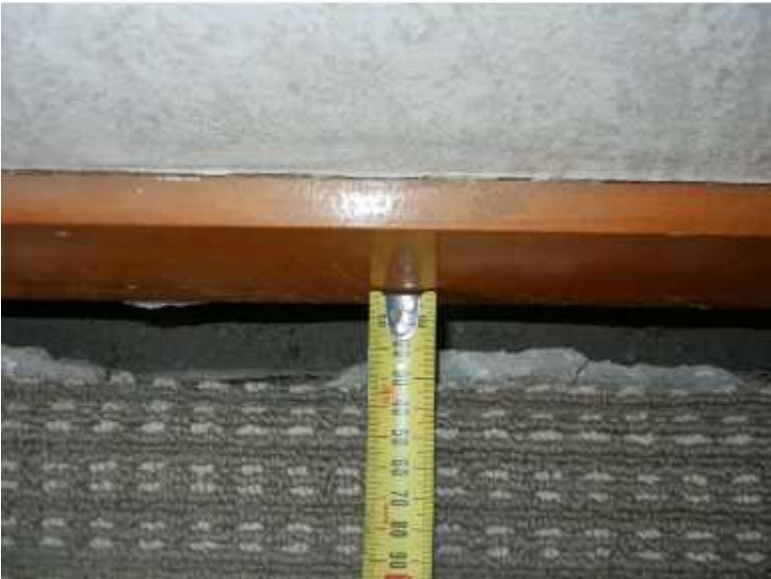
20.	Gap at slab on grade along base of partial wall between Unit 18 and 19

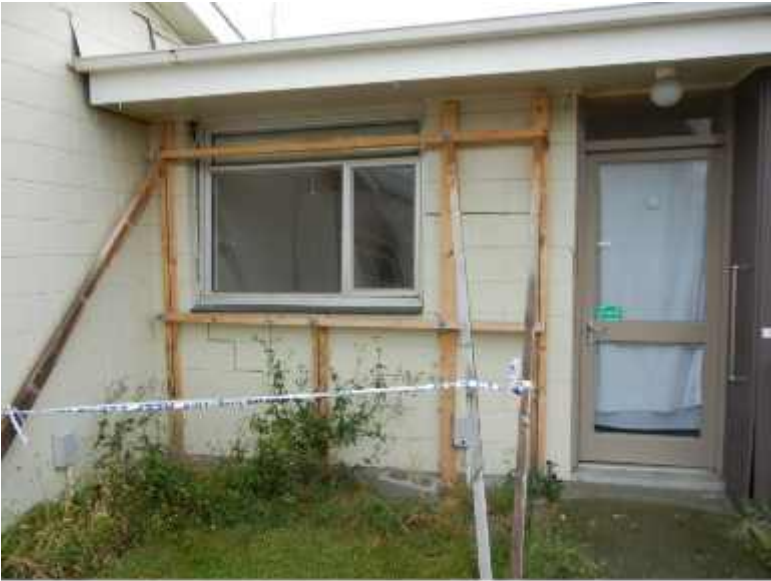
21.	Temporary bracing of exterior block veneer in front of Unit 19

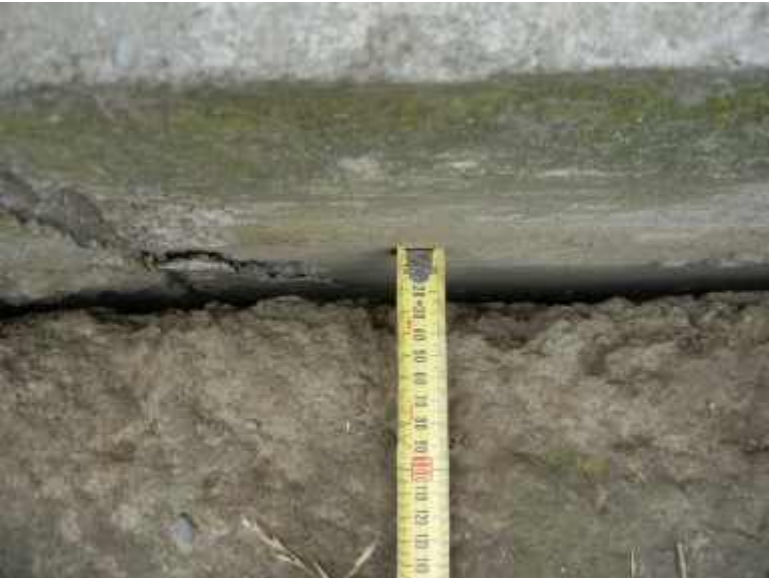
<u>Block E</u>		
27.	Gap between footing and soil

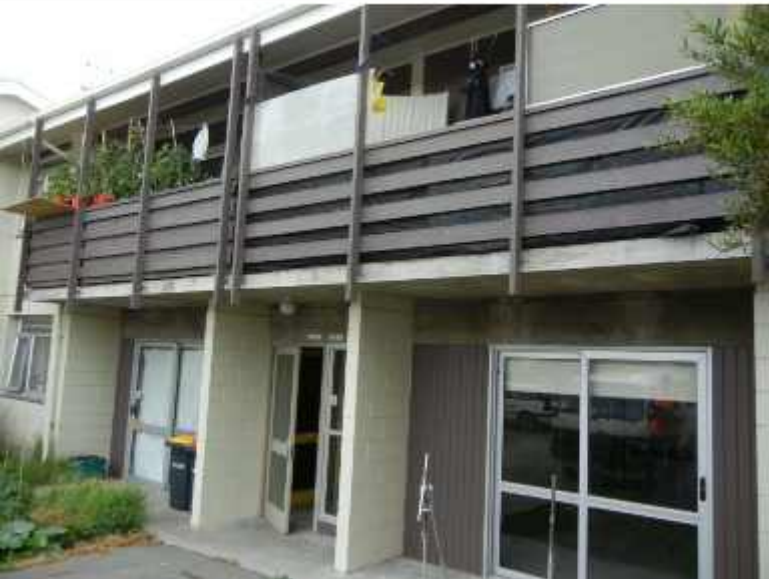
<u>Block F</u>		
28.	North elevation of Block F (identical to 2-storey portions of Block A and B)

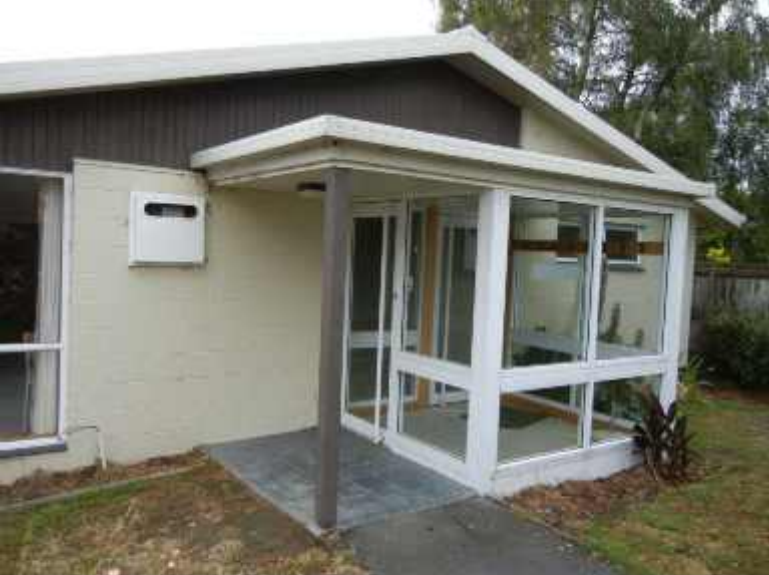
Resident's Lounge		
33.	Front elevation of Residents Lounge
